REPORT ON
DETAILED
ROAD SAFETY AUDIT
OF FIVE ROAD SECTIONS
(500 KM)

ROAD SAFETY AUDIT REPORT FY 2017-2018

Road Design & Safety Circle
Roads & Highways Department
Government of the People's Republic of Bangladesh
SARM Associates and HeptaTech Limited JV

Detailed Road Safety Audit of Road Sections of Joydebpur – Mymensingh (N3), Kanchpur- Daudkandi (N1) and Chattogram – Cox's Bazar (N1), Kashinathpur – Rajshahi (N6) and Dhaka – Aricha (N5) (Total 500 km) National Highway During FY 2017 -2018

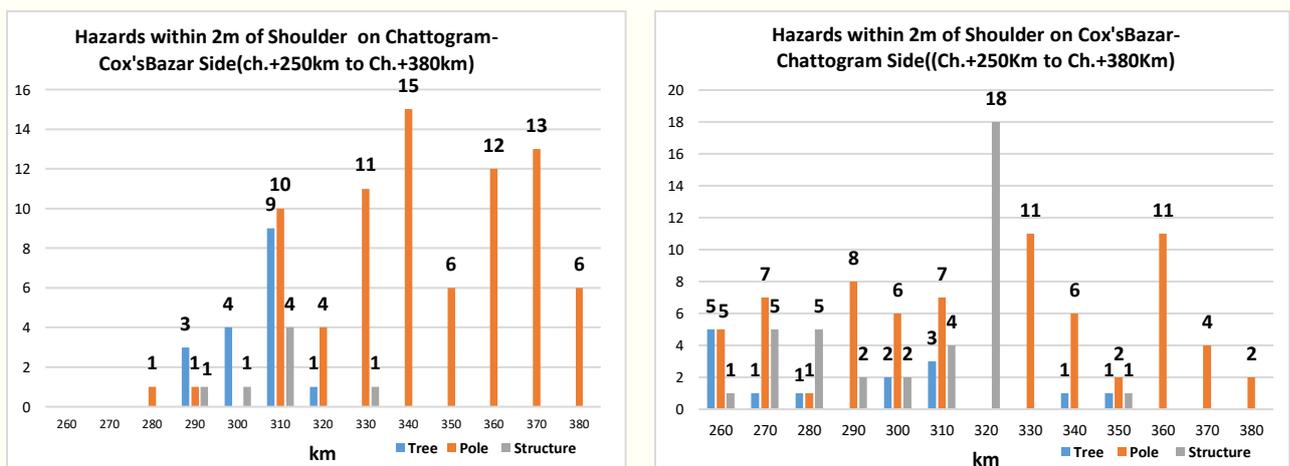
Figure 5.3: Hazards within 2m of Shoulder on Chattogram-Cox'sBazar Highway (N1) (Both Sides)

- Combining both sides, surveyed road of N1 consisted 31 trees and 149 poles within 2m from hard shoulder edge.
- Average 1 roadside hazard on every 1.25km and maximum 23 hazards on every 10km were identified on Chattogram- Cox'sBazar Highway. Along the Cox'sBazar to Chattogram side, average 1 roadside hazard on every 0.8km and maximum 18 hazards on every 10km were identified.

- Immediate measure required chainages of roadside hazards are given in ANNEXURE-A.

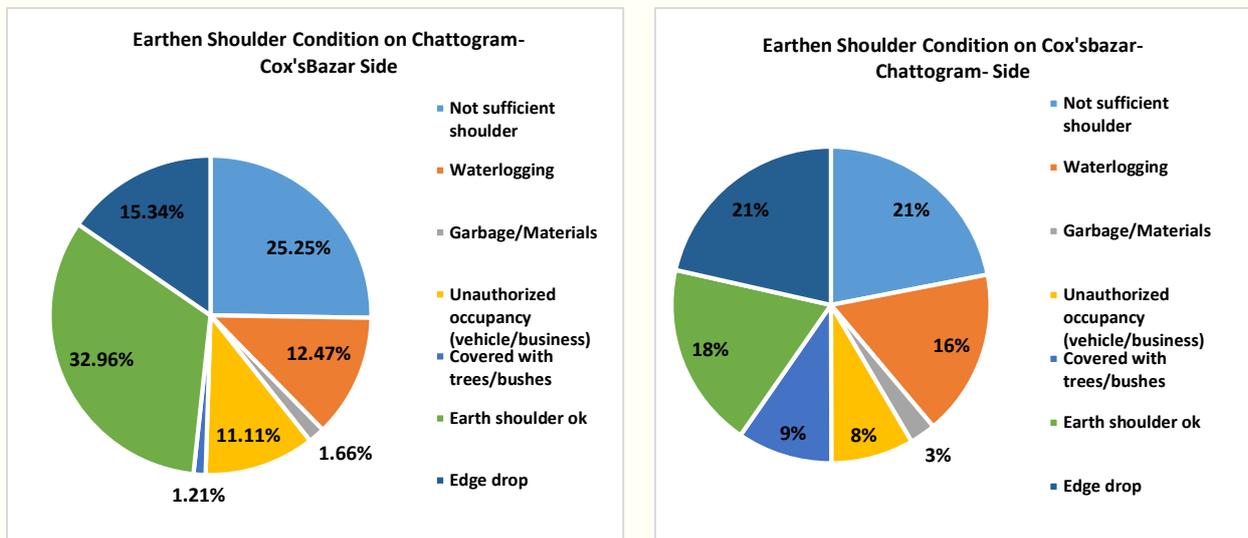
Figure 5.4: Earthen Shoulder Condition on Chattogram-Cox'sBazar Highway (N1) (Both Sides)

- On Chattogram-Cox'sBazar highway, 33.4 km (25.5%) verge/earthen shoulder was either missing or less than standard dimension of 1m for any emergency traffic movement. 16.5km (12.47%) was found waterlogged, 1.6km (1.21%) was covered by bushes and 16.9km (12.77%) was occupied by parked vehicles, materials and garbage. A total of 43.6km (32.96%) earthen shoulder was found sufficient (at least 1m width) but 20.3km (15.34%) had highly risky edge drop (more than 3-inch height) which were creating traffic vulnerability.

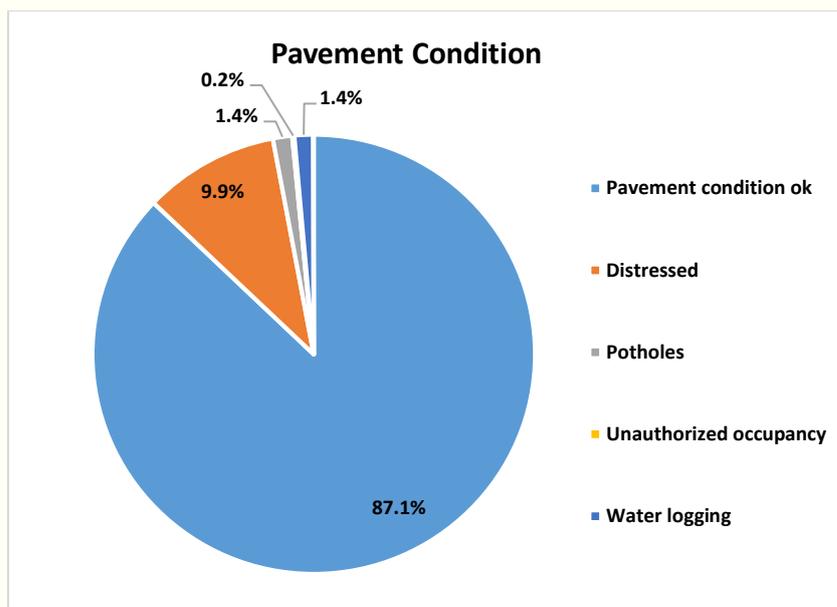
Figure 5.5: Pavement Condition on Chattogram-Cox's Bazar Highway (N1)

- 141.1 km (87.1%) of the pavement of 131km was workable whereas 13.1km (9.9%) was distressed 1.8 km (1.4%) pavement had potholes (N.B: ANNEXURE-A) which were creating serious vulnerability.
- 1.85km pavement found waterlogged. (N.B: ANNEXURE-A)

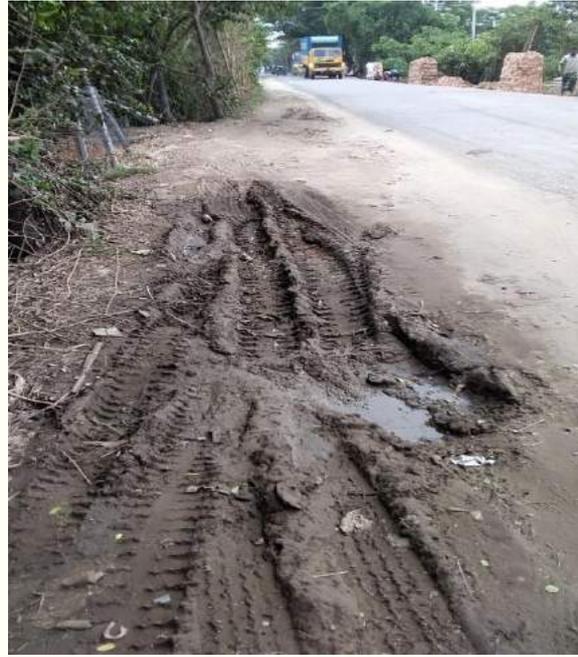
Defective shoulder due to rain within Ch.+252.5 to Ch.+255

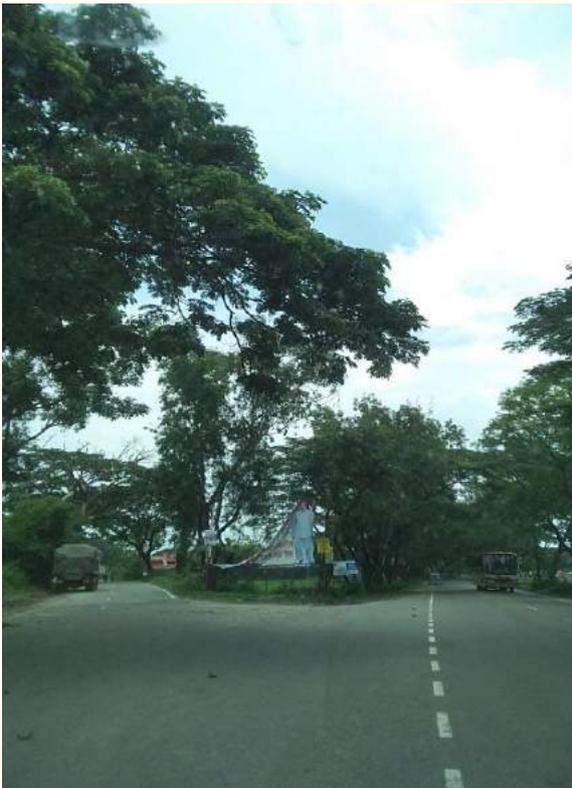
Y-intersection without warning sign within Ch.+255 to Ch.+257 causing high risk

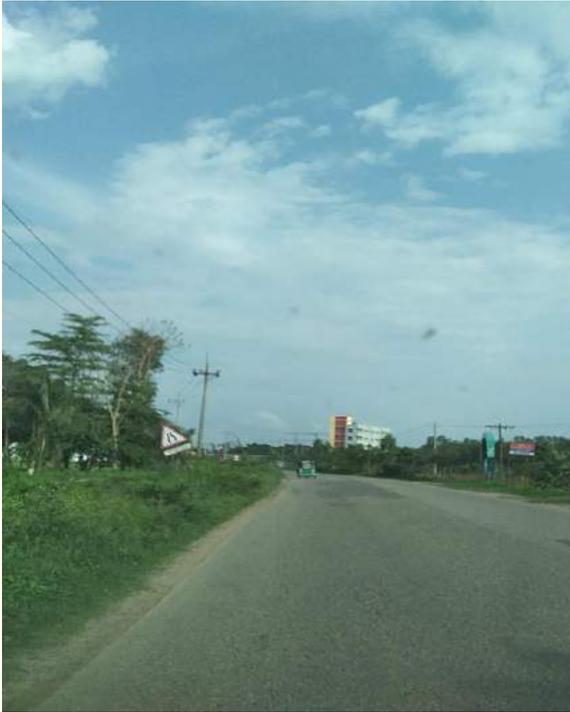
Defective road sign at Ch.+269 to Ch.+271

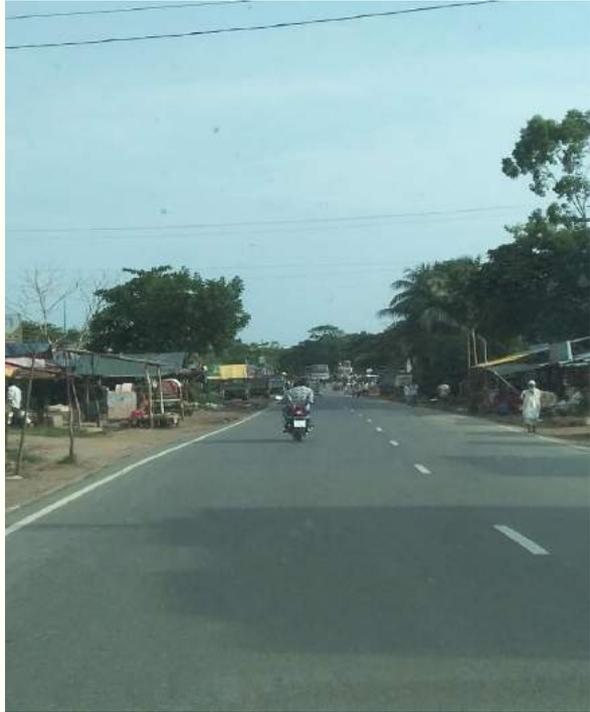
Unauthorized roadside business within clear zone at Ch.+ 271 to Ch.+272

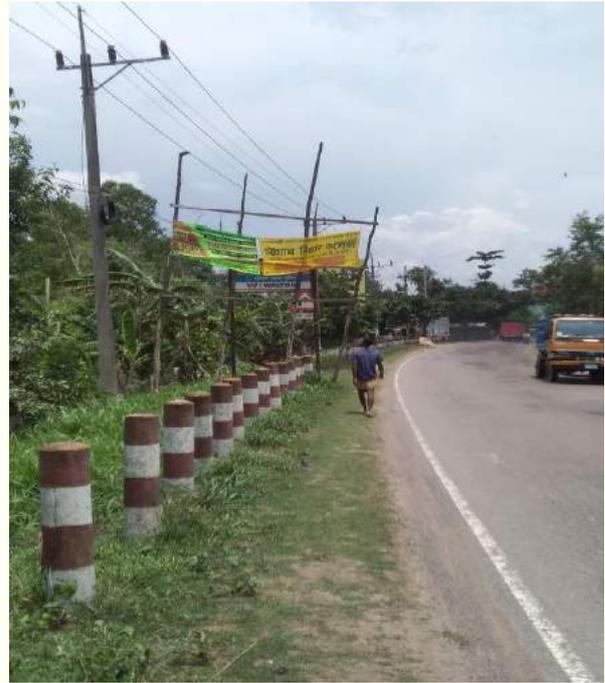
Inadequate shoulder within Ch.+293 to Ch.+295

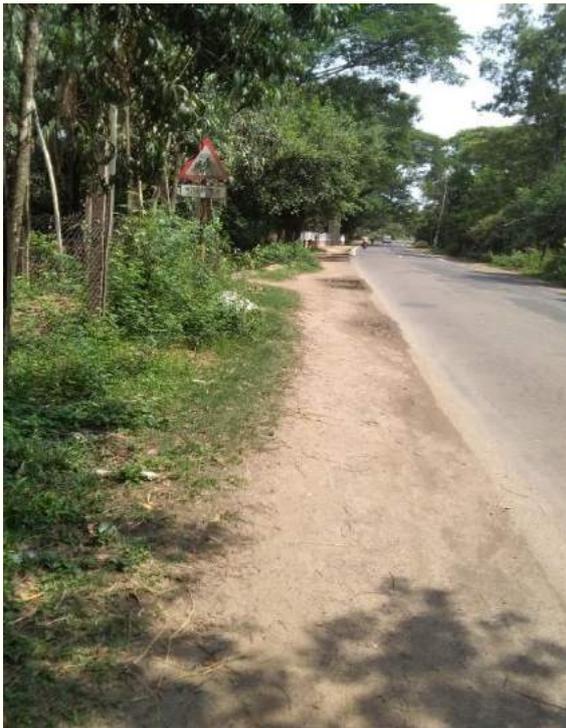
Less visible road sign at Ch.+295 to Ch.+297

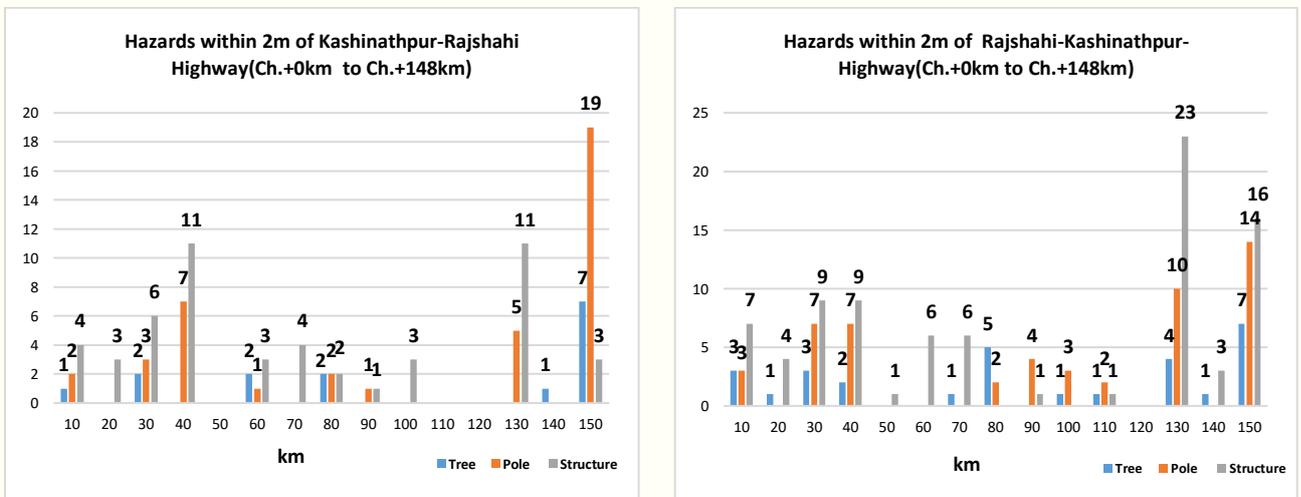
Figure 5.9: Hazards within 2m of Kashinathpur - Rajshahi Highway (N6) (Both Sides)

- Combining both sides, surveyed road of N6 consisted of 44 trees and 92 poles within 2m from hard shoulder edge.
- Average 1 roadside hazard on every 1.40km and maximum 29 hazards on every 10km were identified on Kashinathpur to Rajshahi Highway. On the other side, on Rajshahi - Kashinathpur Highway, average 1 roadside hazard on every 0.8km and maximum 37 hazards on every 10km were identified.

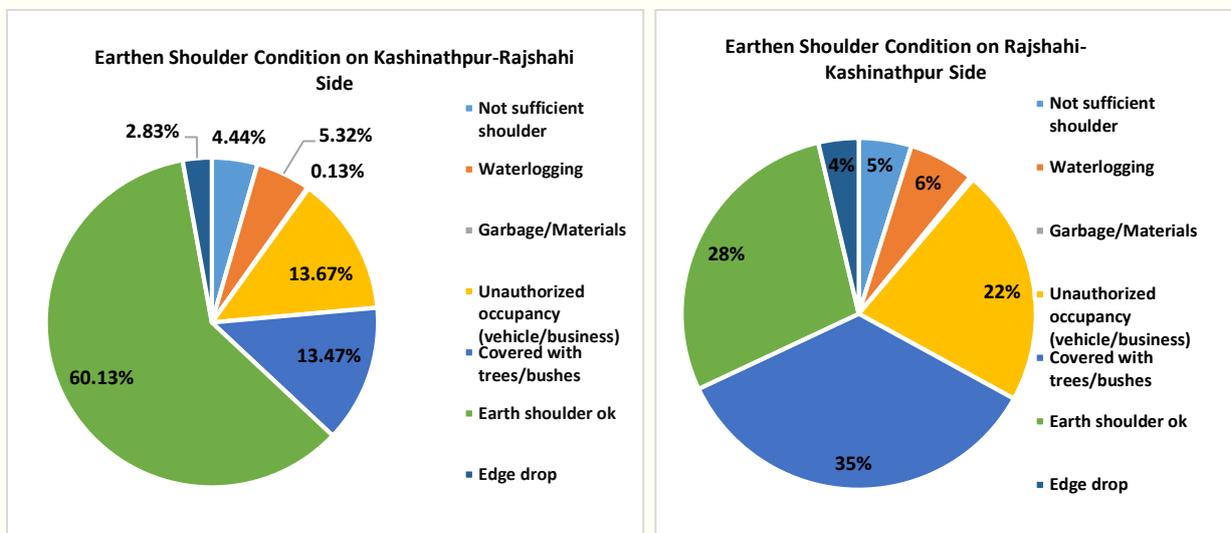
Figure 5.10: Earthen Shoulder Condition on Kashinathpur - Rajshahi Highway (N6) (Both Sides)

- On Rajshahi-Kashinathpur Highway, 7.2km (5%) earthen shoulder was either missing or insufficient for any emergency traffic movement. 9km (6%) was waterlogged, 52.3km (35%) was covered by bushes and 33.2km (22%) was occupied by parked vehicles, materials and garbage. Out of total, 131km earthen shoulder, 42.4km (28%) was sufficient but 5.5km (4%) had risky edge drop which were creating traffic vulnerability.
- Immediate measure required chainages of roadside hazards are given in ANNEXURE-A.

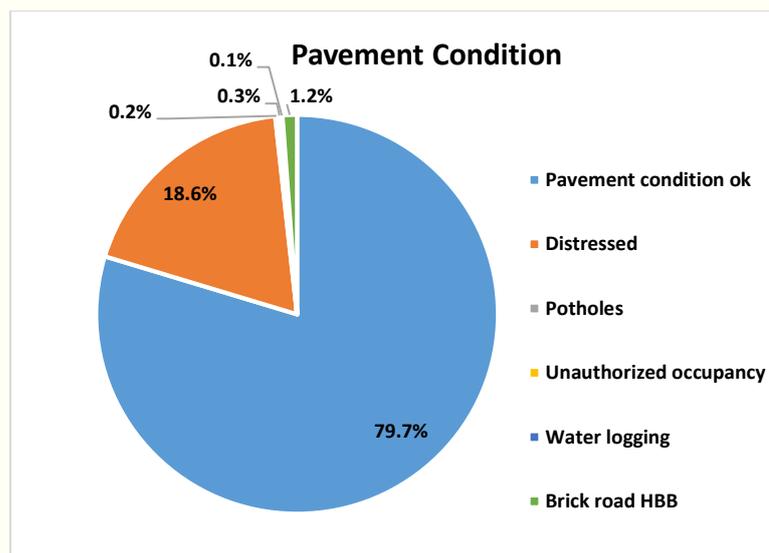
Figure 5.11: Pavement Condition on Kashinathpur - Rajshahi Highway (N6)

- Among 146.9km pavement 118 km (79.7%) was workable whereas 26.5km (18.6%) was distressed.1.8 km (1.4%) pavement had potholes(N.B: ANNEXURE-A) which were creating serious vulnerability.
- 1.14km pavement found waterlogged (N.B: ANNEXURE-A), 4.2km was illegally occupied by vehicles, unauthorized maintenance work etc.
- 17km was made of Harrington brick road instead of flexible pavement.

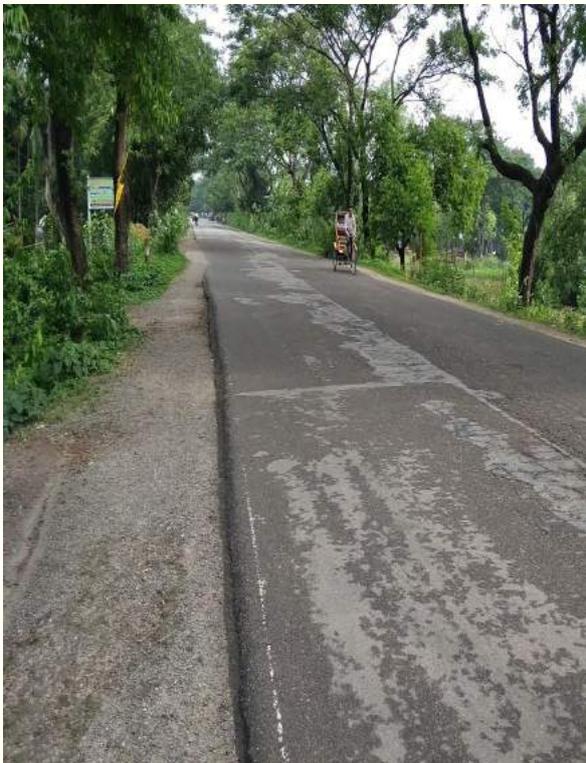
Shoulder within Ch.+46 to Ch.+48 at a risky condition

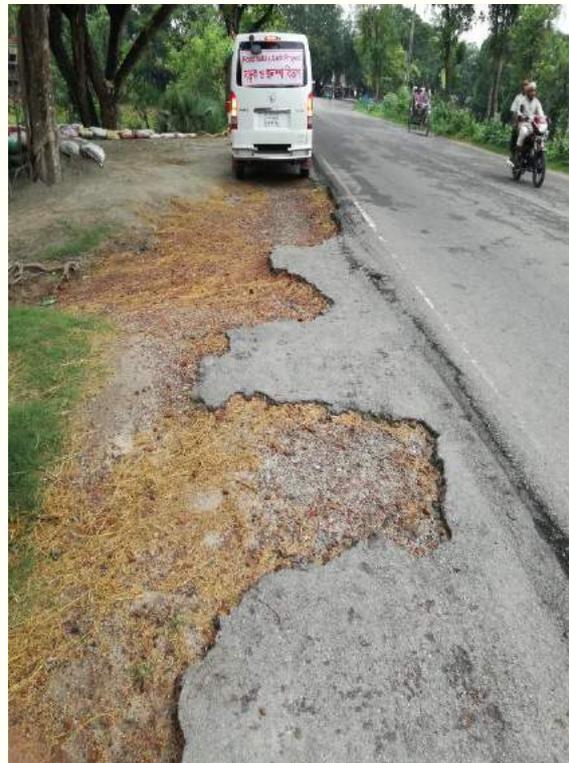
Defective shoulder at Ch.+48 to Ch.+50

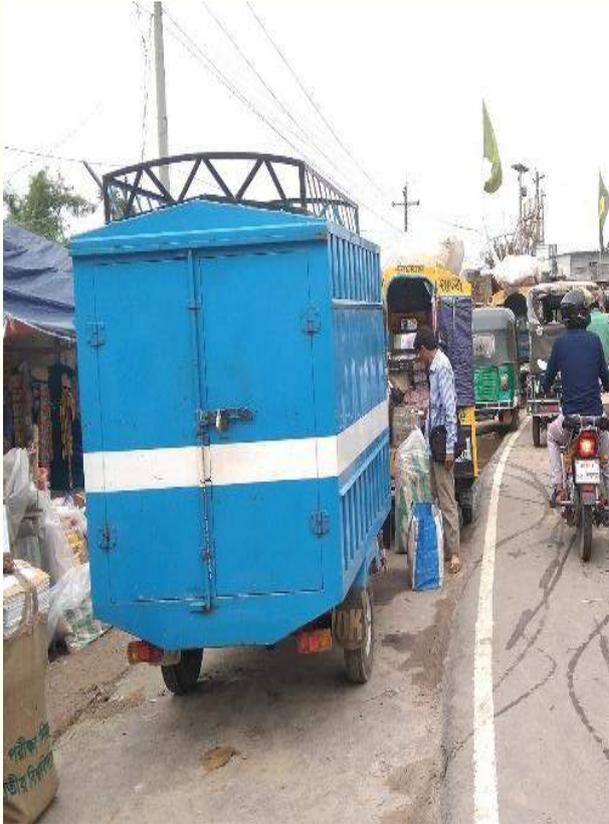
Unauthorized roadside activities within Ch.+50 to Ch.+52

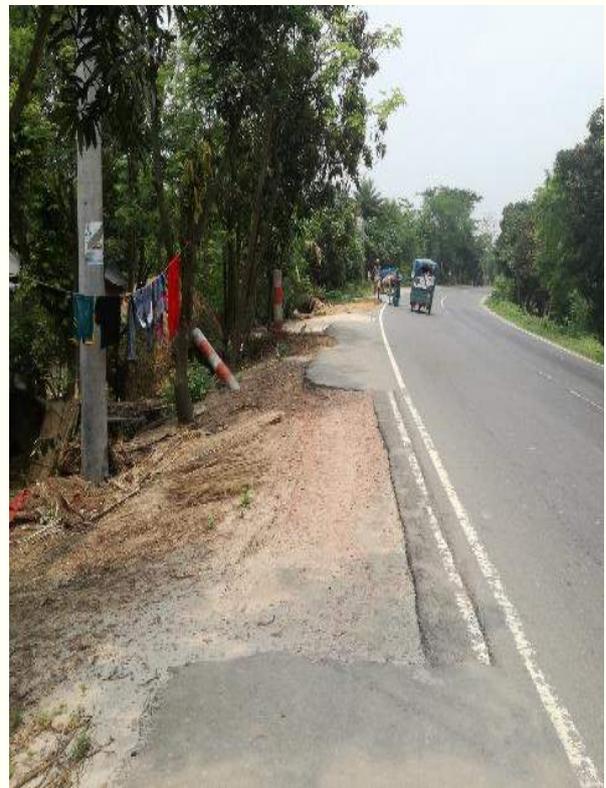
Defective and risky shoulder at Ch.+ 84 to Ch.+86

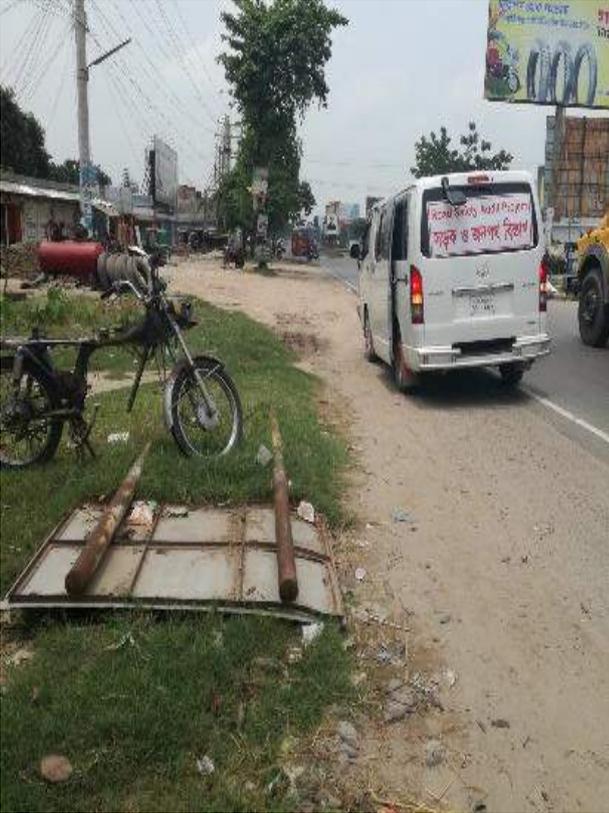
Broken sign within Ch.+84 to Ch.+86

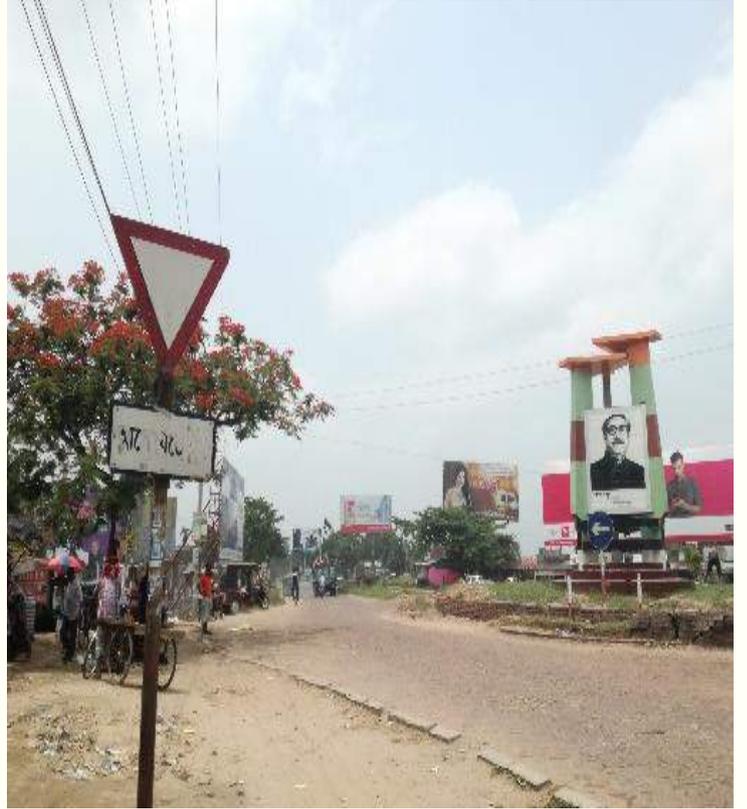
Faded sign within Ch.+84 to Ch.+86

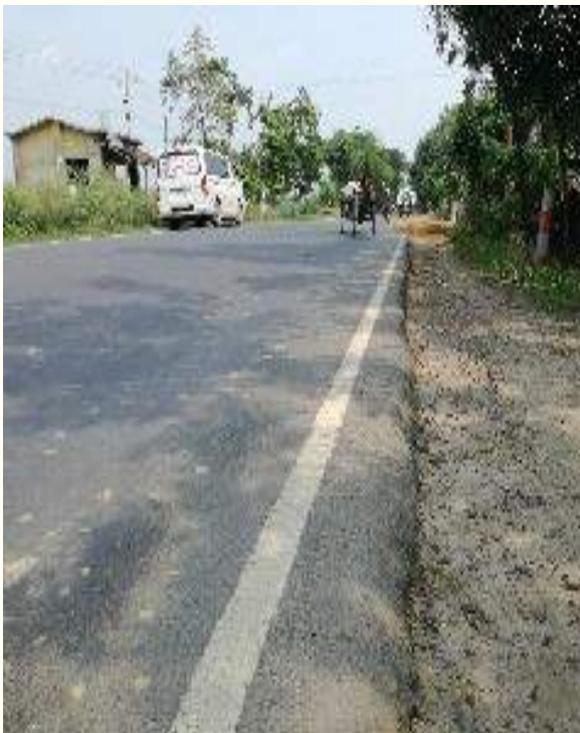
Defective shoulder within Ch.+74 to Ch.+76 causing risk

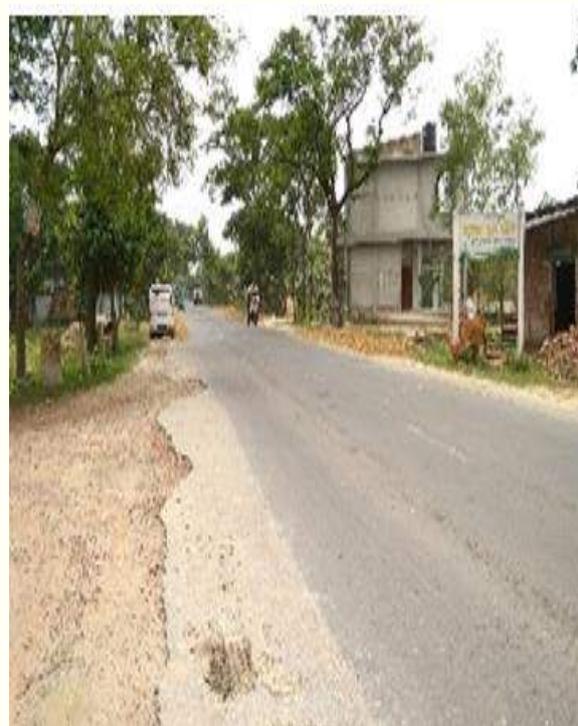
Broken and risky within Ch.+106 to Ch.+208

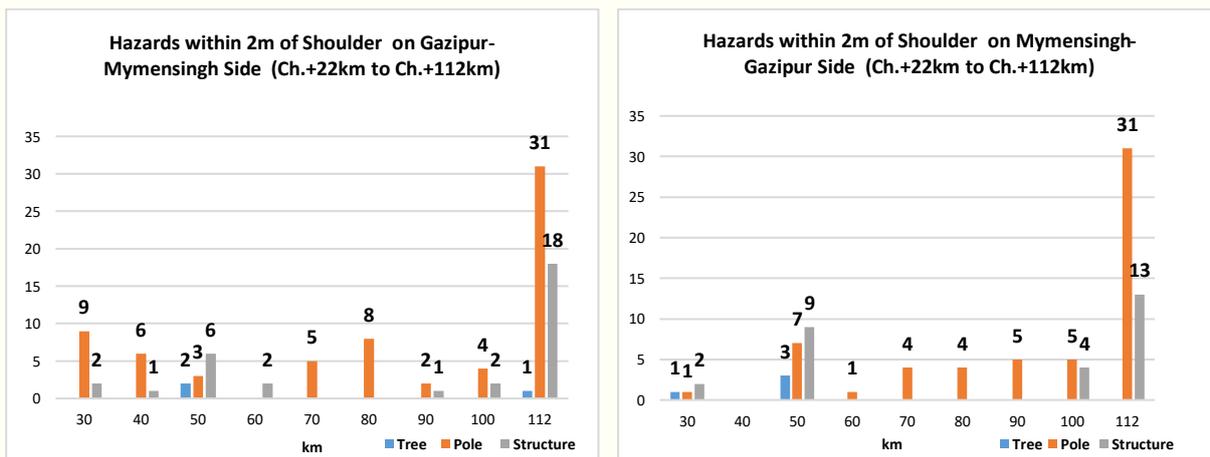
Figure 5.15: Hazards within 2m of Shoulder on Gazipur-Mymensingh Highway (N3) (Both Sides)

- Combining both sides, surveyed road of N3 consisted of 2 trees and 117 poles within 2m from hard shoulder edge.
- Average 1 roadside hazard on every 0.9km and maximum 50 hazards on every 12km were identified on Gazipur to Mymensingh Highway. Along the Mymensingh to Gazipur side, average 1 roadside hazard on every 1.25km and maximum 43 hazards on every 10km were identified. Maximum road hazard was at the built-up area of Mymensingh city.

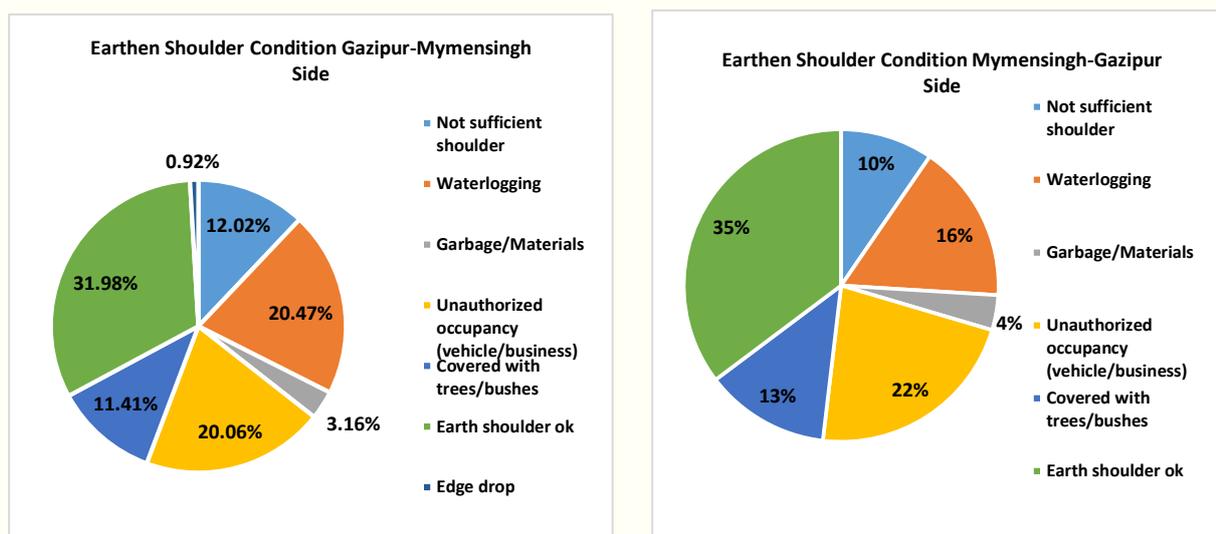
Figure 5.16: Earthen Shoulder Condition on Gazipur-Mymensingh Highway (N3) (Both Sides)

- On Mymensingh-Gazipur Highway, 8.84km (10%) earthen shoulder was either missing or less than standard dimension of 1m for any emergency traffic, 18.1km (16%) was waterlogged, 14.7km (13%) was covered by bushes and 29.4km (26%) was occupied by parked vehicles, materials and garbage. Out of total 131km earthen shoulder, 39.6km (35%) was sufficient.
- Immediate measure required chainages of roadside hazards are given in ANNEXURE-A.

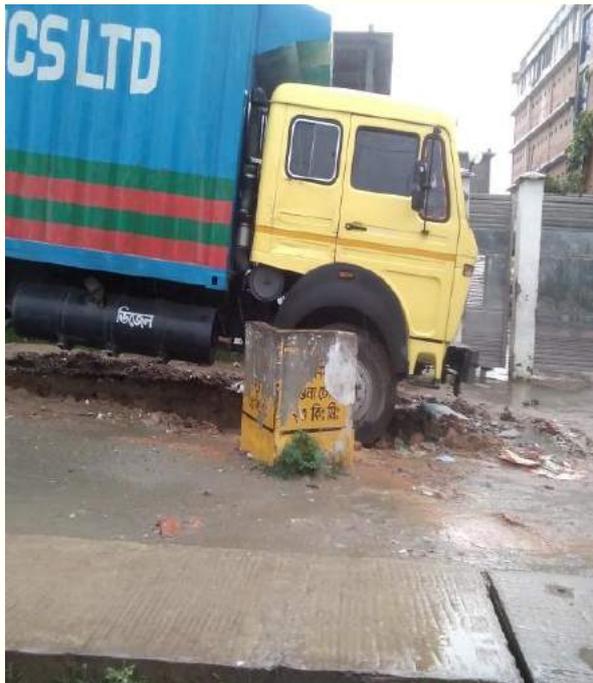
Hazardous km post installed on roadside area within Ch.+25.8 to Ch.+27.8

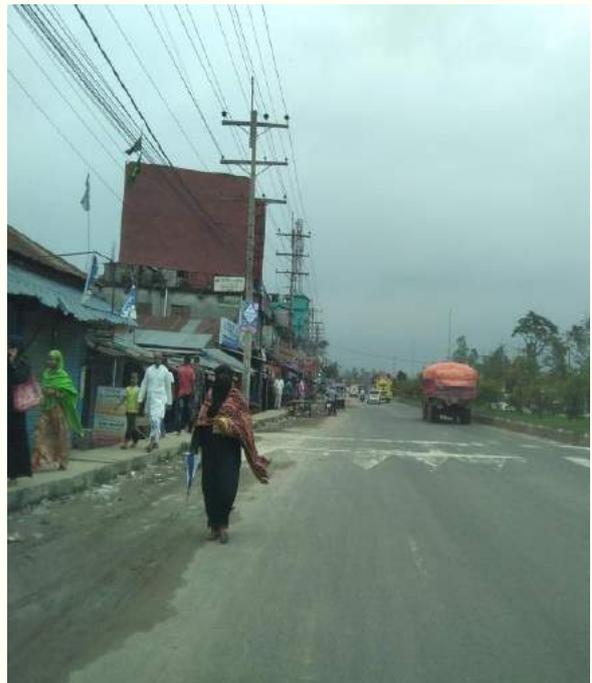
Faded risky pedestrian crossing within Ch.+27.8 to Ch.+29.8

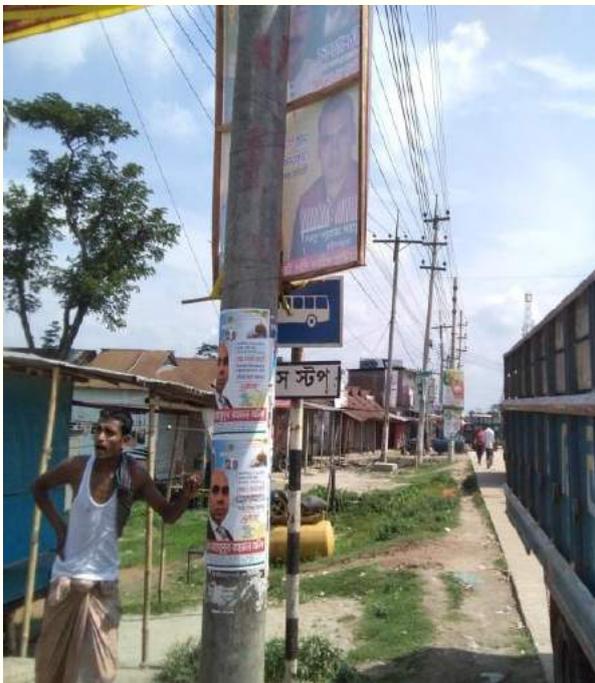
**Improper placement of sign within
Ch.+93.5 to Ch.+95.5**

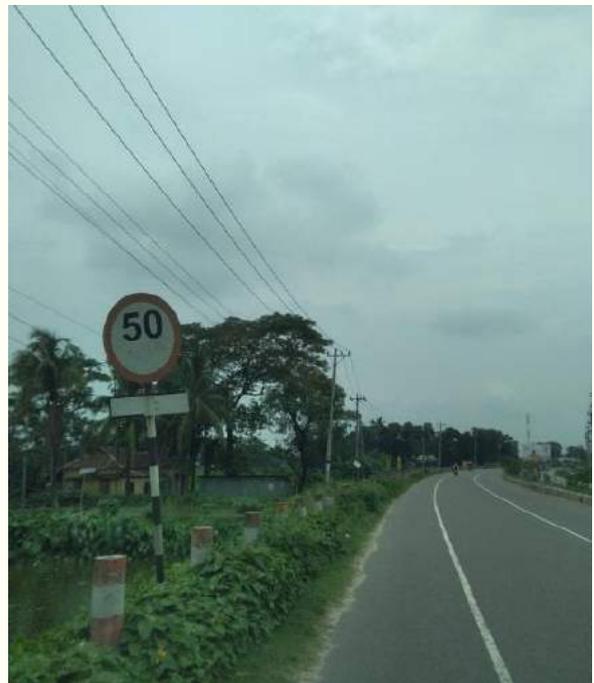
**Roadside bushes & wrong marking on curve
within Ch.+95.5 to Ch.+97.5**

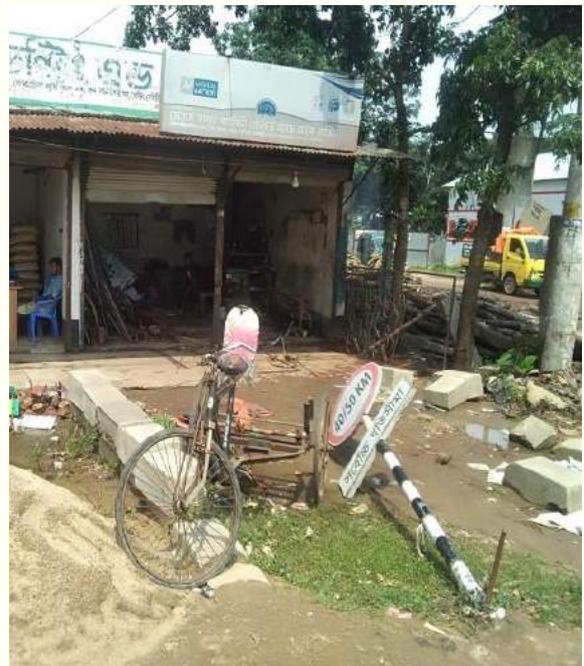
Disturbed & broken sign within Ch.+53.6 to Ch.+55.6

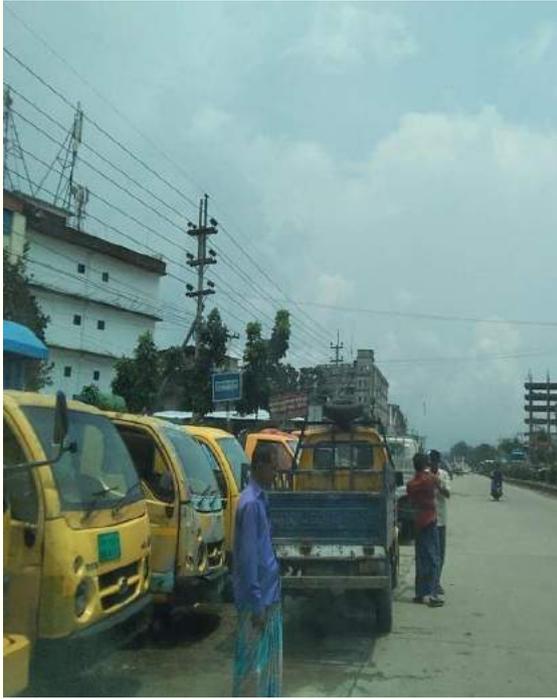
Illegal parking within Ch.+55.6 to Ch.+57.6

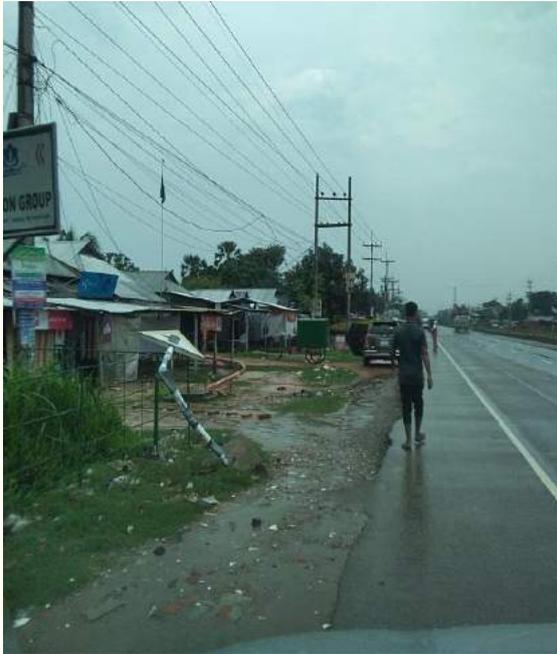
Disturbed & broken sign within Ch.+57.6to Ch.+59.6

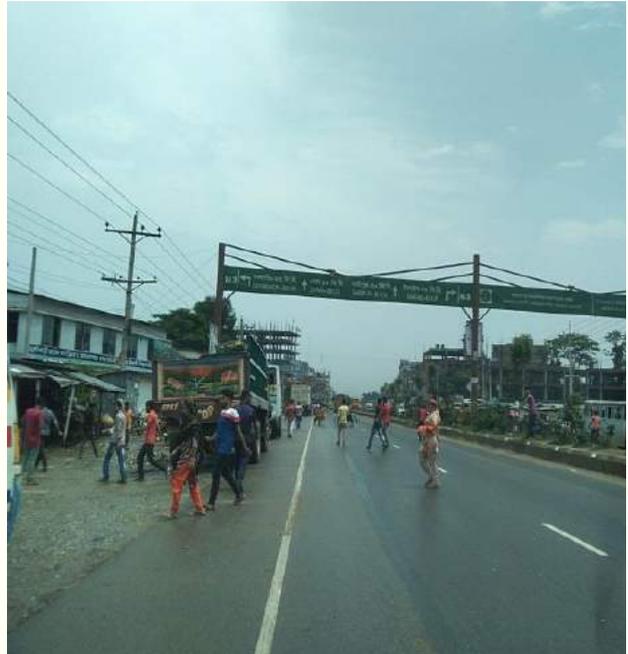
Illegal pedestrian crossing at Ch.+57.6 to Ch.+59.6

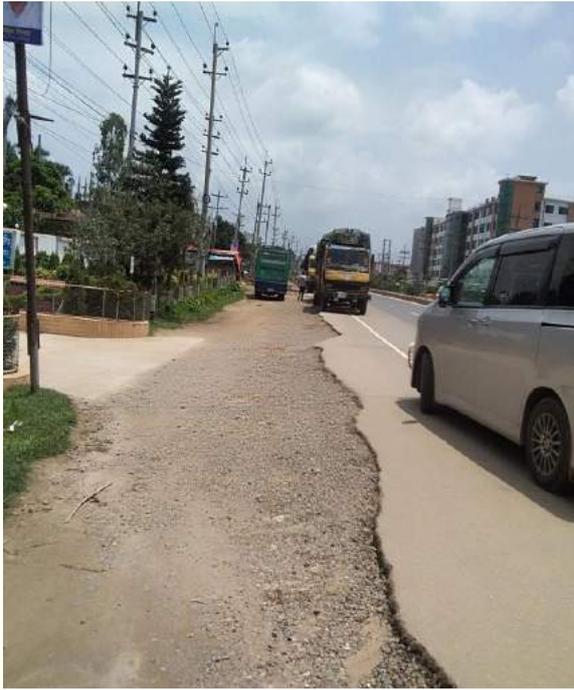
Broken hard shoulder within Ch.+65.6 to Ch.+67.5

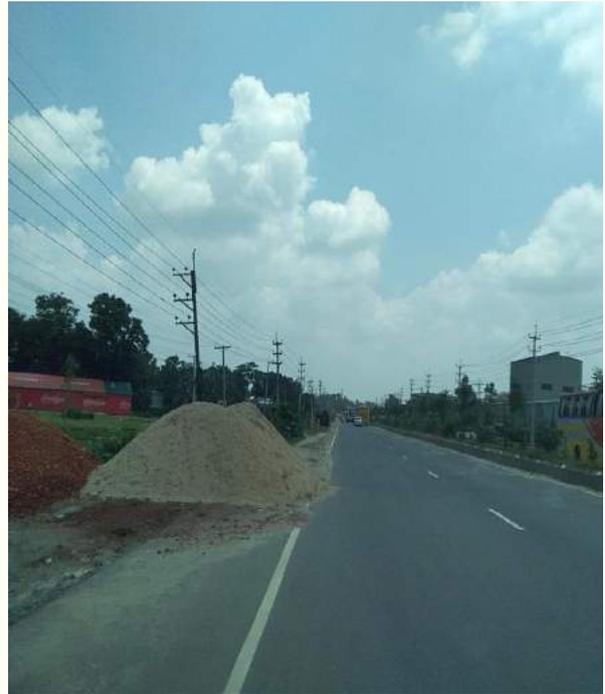
Unauthorized occupancy by construction materials within Ch.+67.5 to Ch.+69.5

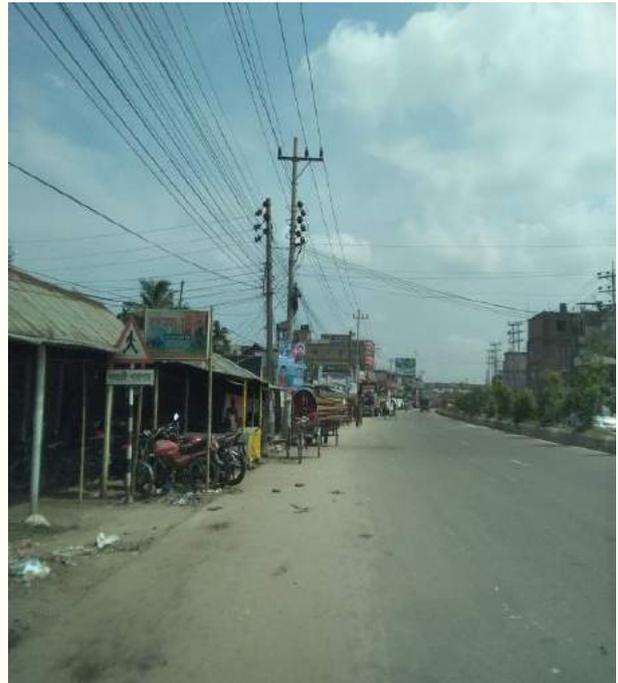
Improper placement of sign & unauthorized occupancy within Ch.+89.5 to Ch.+91.5

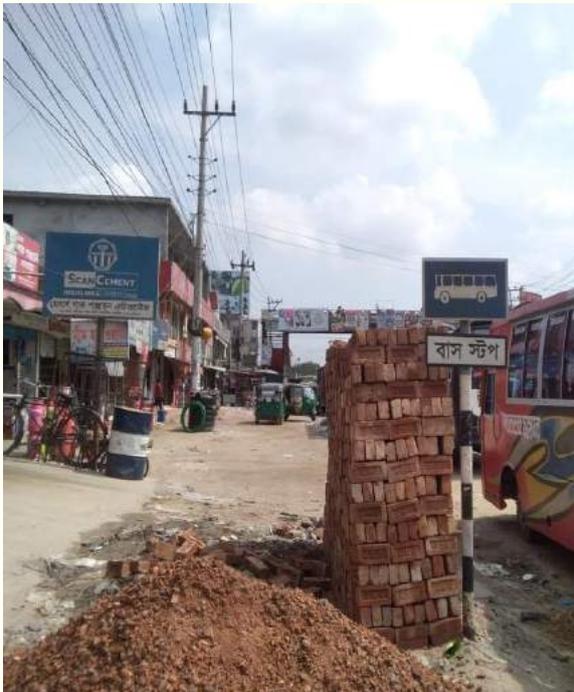
Construction materials kept on roadside area illegally within Ch.+89.5 to Ch.+91.5

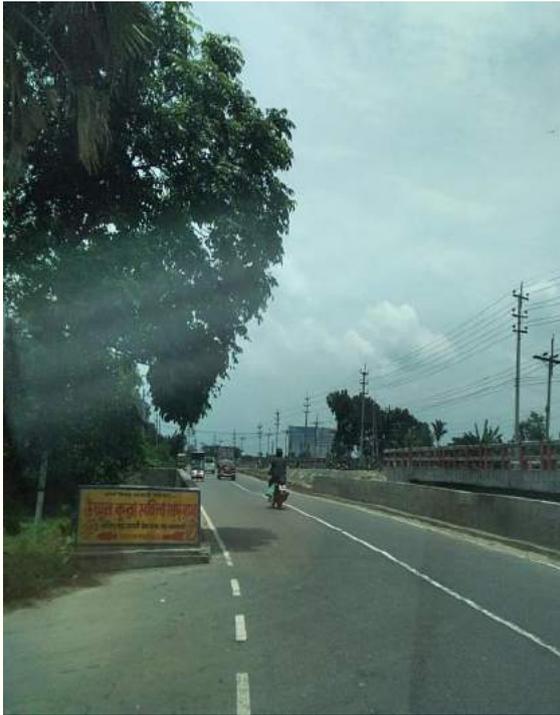
Unauthorized hazardous roadside structure within Ch+101.5 to Ch+103.5

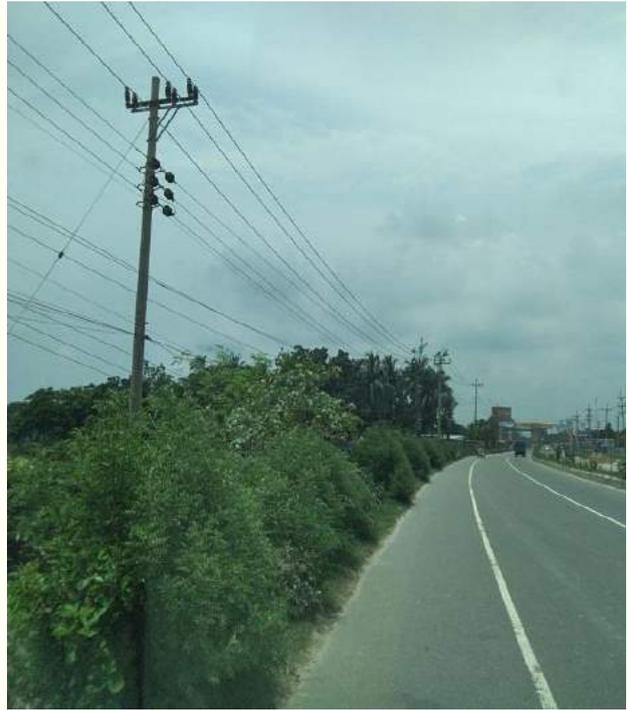
Roadside bushes & wrong marking on curve within Ch+103.5 to Ch+105.5

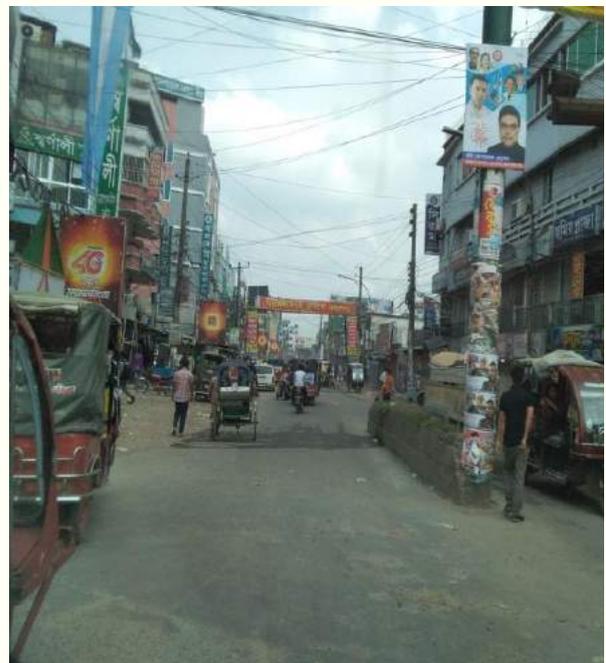
Hazardous pole & faded road marking within Ch.+107.5 to Ch.+109.5

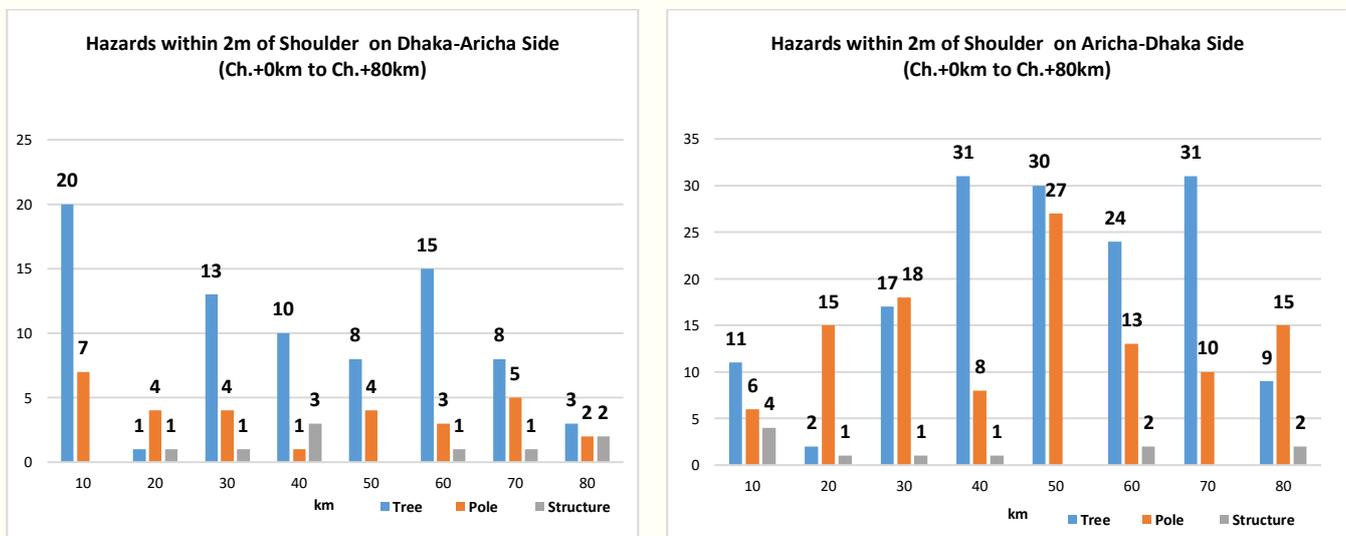
Figure 5.21: Hazards within 2m of Shoulder on Dhaka-Aricha Highway (N5) (Both Sides)

- Combining both sides, surveyed road of N5 consisted of 233 trees and 142 poles within 2m from hard shoulder edge.
- Average 1 roadside hazard on every 0.6km and maximum 27 hazards on every 10km were identified on Dhaka-Aricha Highway. Along the Aricha to Dhaka side, average 1 roadside hazard on every 0.3km and maximum 57 hazards on every 10km were identified.

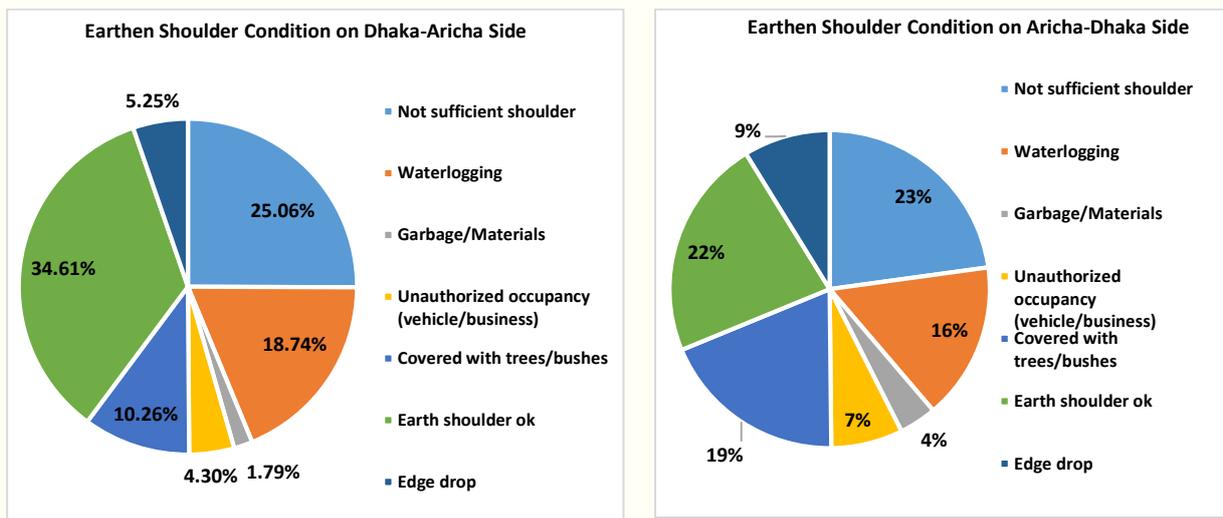
Figure 5.22: Earthen Shoulder Condition on Dhaka-Aricha Highway (N5) (Both Sides)

- On Dhaka-Aricha Highway, 19.6 km (25.06%) verge/earthen shoulder was either missing or less than standard dimension of 1m for any emergency traffic movement. 14.7km (18.74%) was found waterlogged, 8km (10.26%) was covered by bushes and 4.7km (6.09%) was occupied by parked vehicles, materials and garbage. A total of 27.1km (34.61%) earthen shoulder was found sufficient (at least 1m width) but 4.11km (5.25%) had highly risky edge drop (more than 3-inch height) which were creating traffic vulnerability.

- Immediate measure required chainages of roadside hazards are given in ANNEXURE-A.

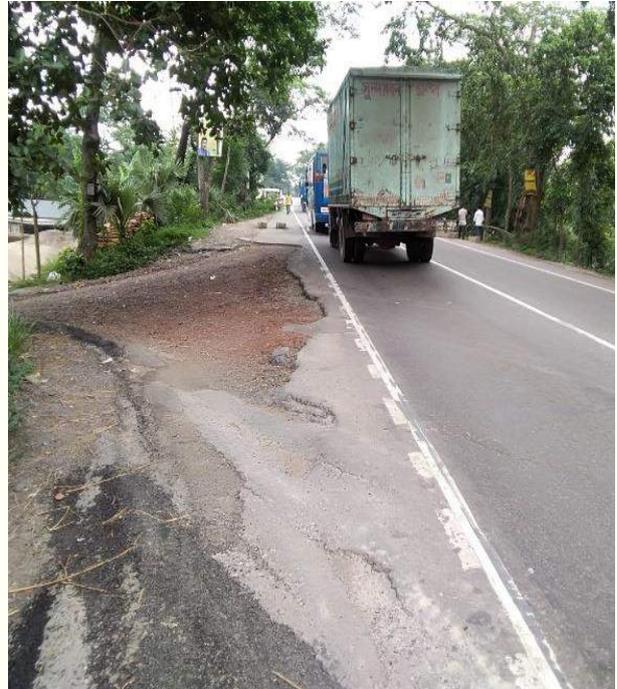
Defective roadside area within Ch.+42 to Ch.+44

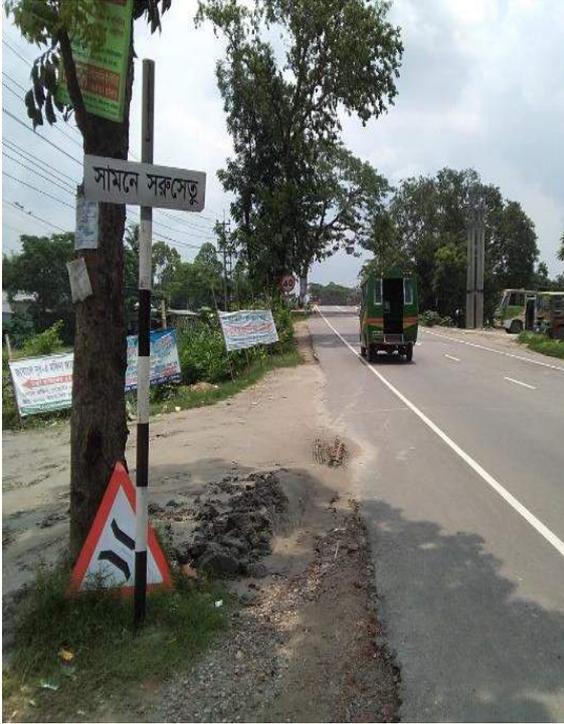
Disturbed road sign within Ch.+42 to Ch.+44

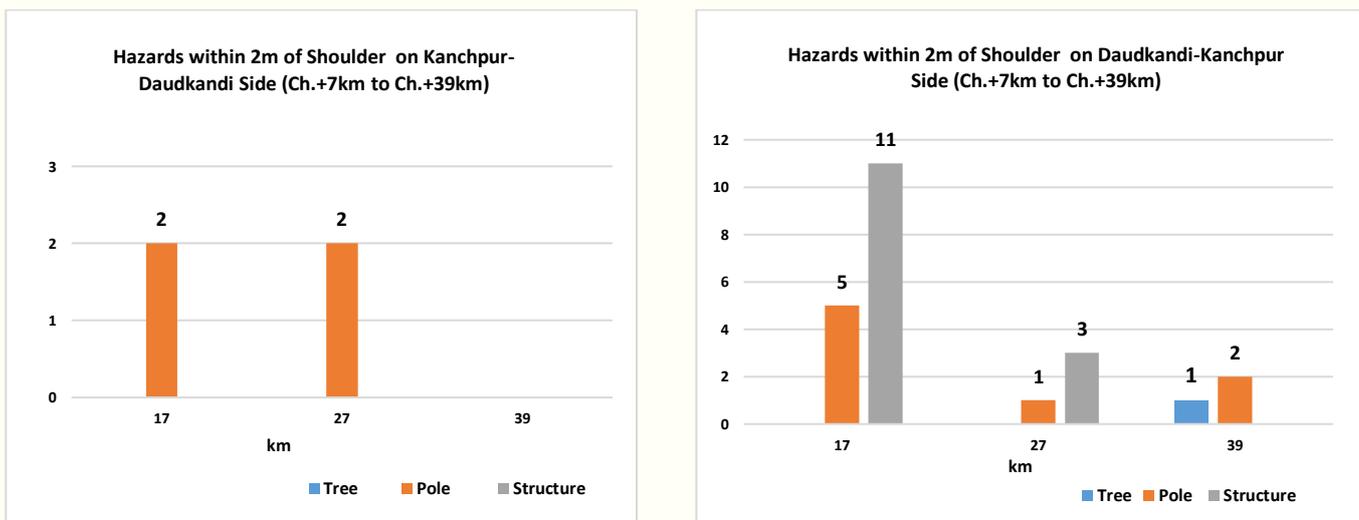
Figure 5.27: Hazards within 2m of Shoulder on Kanchpur-Daudkandi Highway (N1) (Both Sides)

- Roadside hazards are those temporary /permanent structures along the road which might increase crash severity if hit by vehicle. Audit team considered 2m width after the pavement and counted permanent / temporary structures, trees (diameter more than 6cm) and steel poles.
- There was no temporary/permanent structure on left side during journey from Kanchpur to Daudkandi. On Daudkandi to Kanchpur, temporary structures occupied 1.4km (4.4%).
- Combining both sides, surveyed road of N1 consisted of 1 tree and 12nos poles within 2m from hard shoulder edge.
- Average 1 roadside hazard on every 0.1km and maximum 2 hazards on every 10km were identified on Kanchpur to Daudkandi Highway. Along the Daudkandi to Kanchpur side, average 1 roadside hazard on every 0.75km and maximum 16 hazards on every 10km were identified. Maximum roadside hazards were at the built-up area of Daudkandi city area.
