REPORT ON
DETAILED
ROAD SAFETY AUDIT
OF FIVE ROAD SECTIONS
(500 KM)

ROAD SAFETY AUDIT REPORT FY 2017-2018

Road Design & Safety Circle
Roads & Highways Department
Government of the People's Republic of Bangladesh
SARM Associates and HeptaTech Limited JV

Detailed Road Safety Audit of Road Sections of Joydebpur – Mymensingh (N3), Kanchpur- Daudkandi (N1) and Chattogram – Cox's Bazar (N1), Kashinathpur – Rajshahi (N6) and Dhaka – Aricha (N5) (Total 500 km) National Highway During FY 2017 -2018

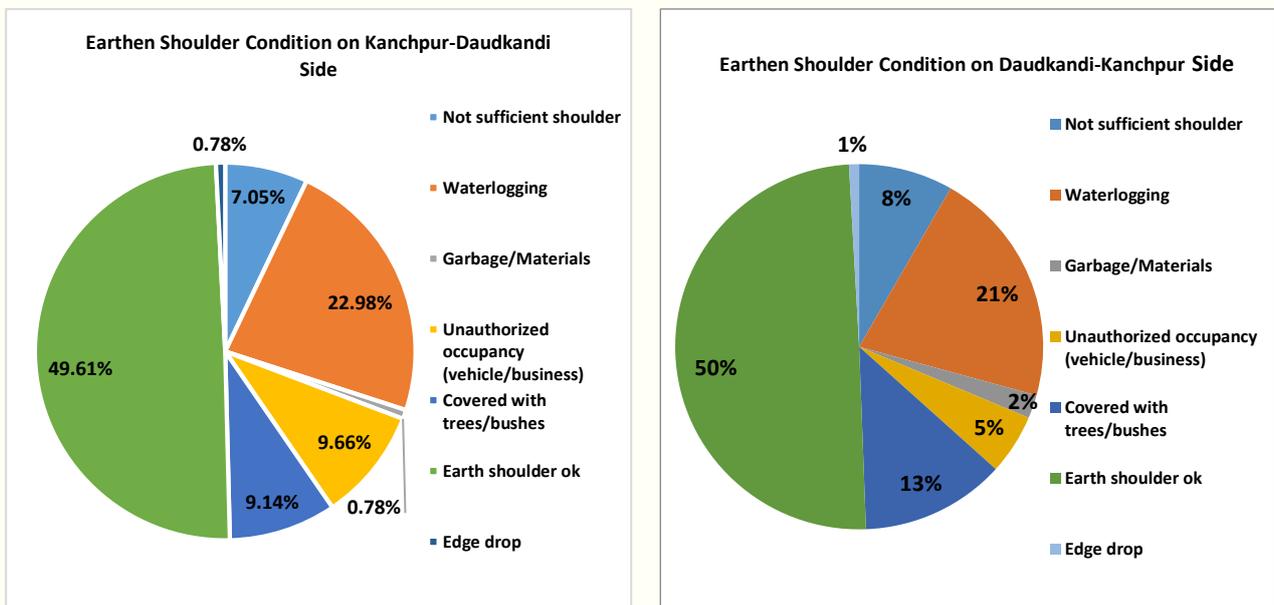
Figure 5.28: Earthen Shoulder Condition on Kanchpur-Daudkandi Highway (N1) (Both Side)

- On Kanchpur-Daudkandi Highway, 2.7 km (8.4%) earthen shoulder was either missing or less than standard dimension of 1m for any emergency traffic movement. 6.1km (19.1%) was found waterlogged, 0.9km (2.8%) was covered by bushes and 3km (9.3%) was occupied by parked vehicles, materials and garbage. A total of 19km (59.4%) earthen shoulder was found sufficient (at least 1m width) but 0.03km (0.9%) had highly risky edge drop (more than 3-inch height) which were creating traffic vulnerability.

- Immediate measure required chainages of roadside hazards are given in ANNEXURE-A.

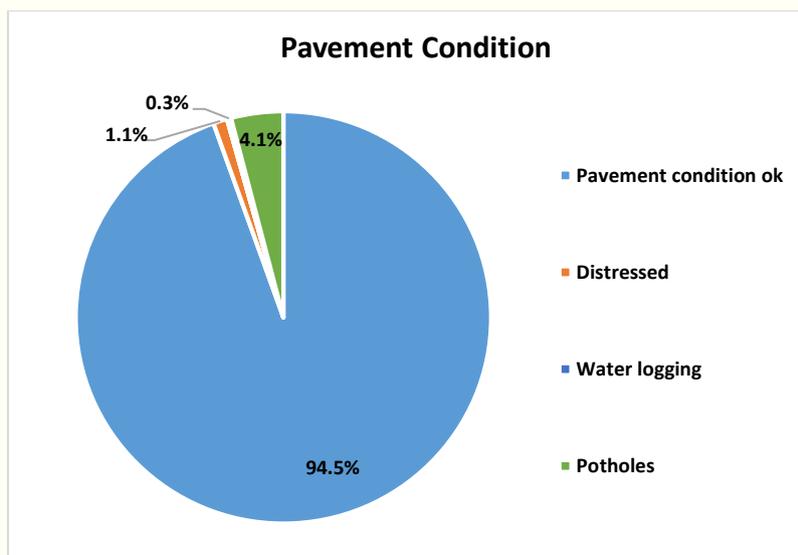
Figure 5.29: Pavement Condition on Kanchpur-Daudkandi Highway (N1)

- From Kanchpur to Daudkandi Highway, 30.4km (97.8%) of the pavement of 31.1km was workable whereas 0.1km (0.3%) was distressed, 0.2 km (0.6%) pavement had waterlogging (N.B: ANNEXURE-A), 0.4km (1.3%) pavement had potholes (N.B: ANNEXURE-A), which were creating serious vulnerability.

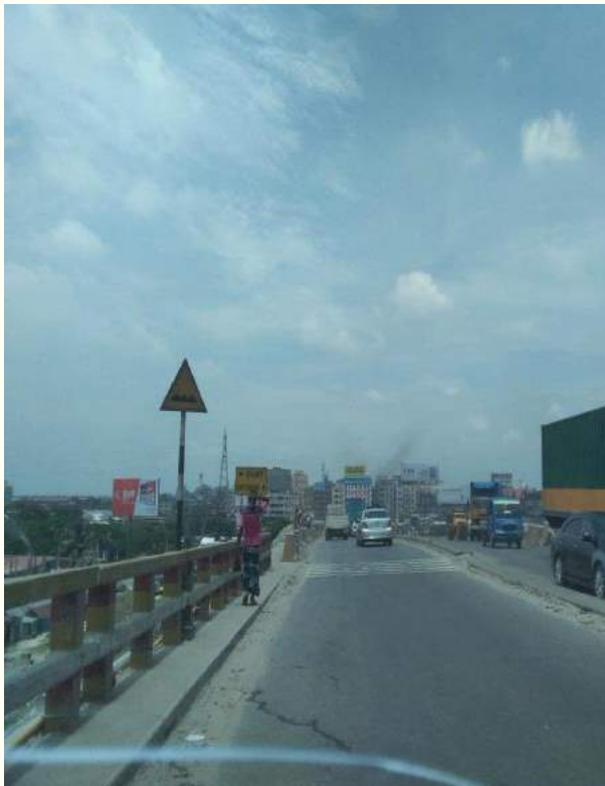
Improper bridge facilities within Ch.+7 to Ch.+9

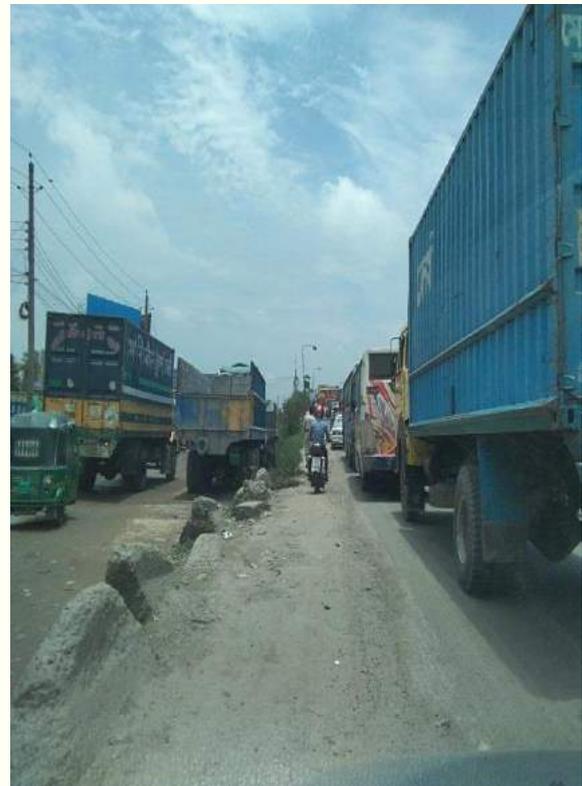
Risky and broken blocks on middle road Ch.+ 9 to Ch.+11

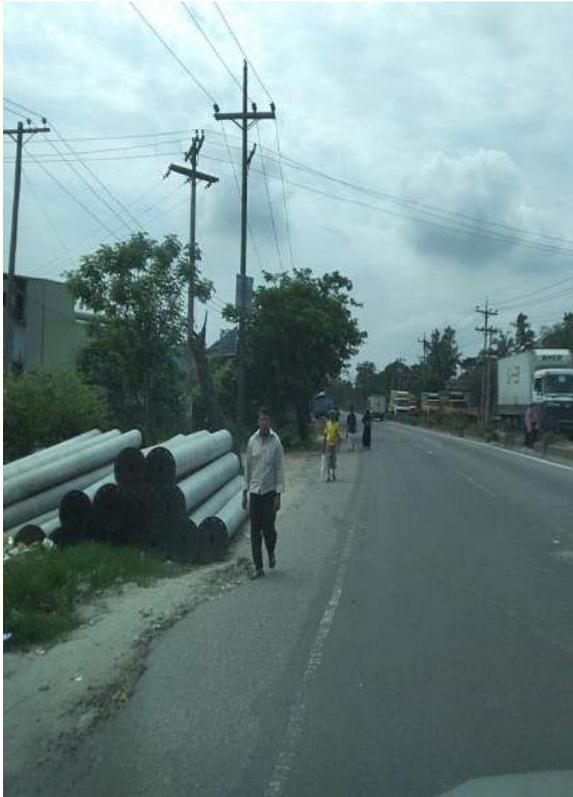
Unauthorized roadside activities within Ch.+13 to Ch.+15

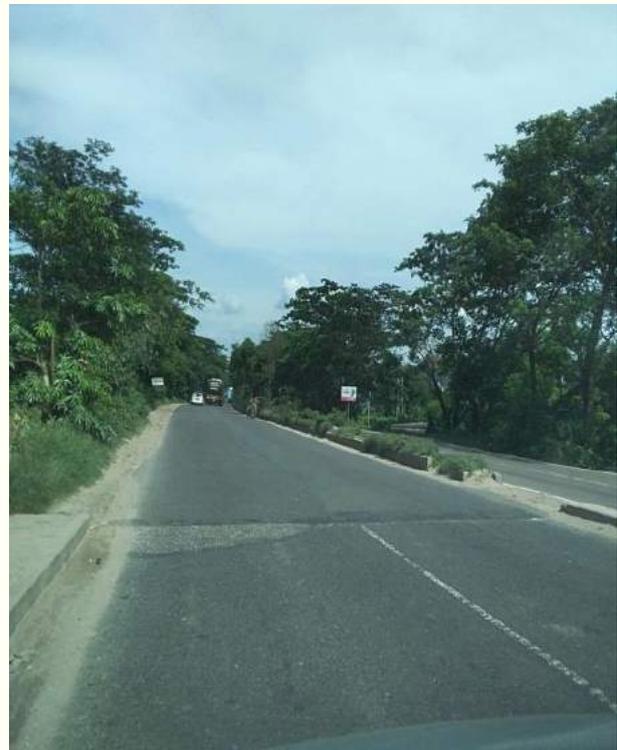
Poor and broken median within Ch.+15 to Ch.+17

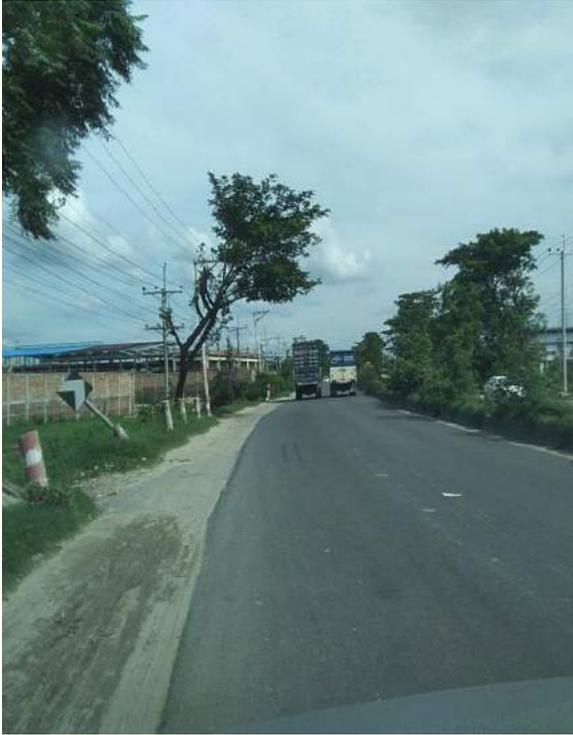
Disturbed sign within Ch.+17 to Ch.+19

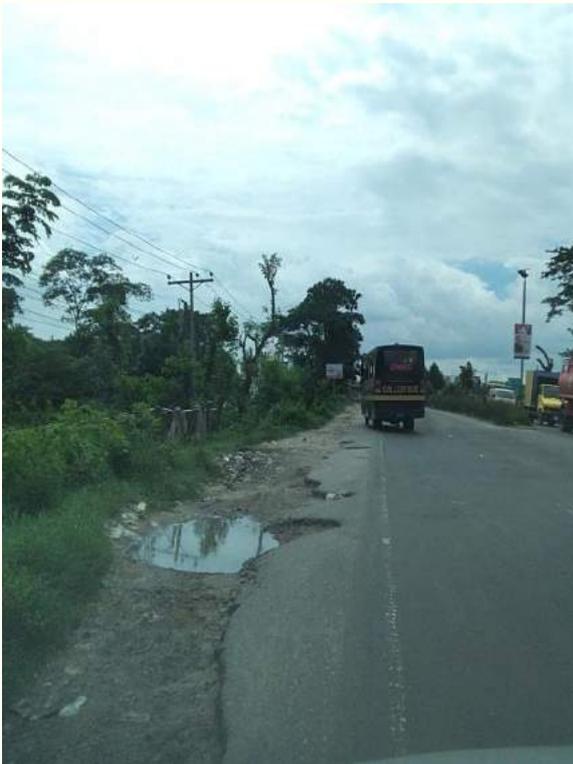
Broken shoulder and waterlogging within Ch.+19 to Ch.+21

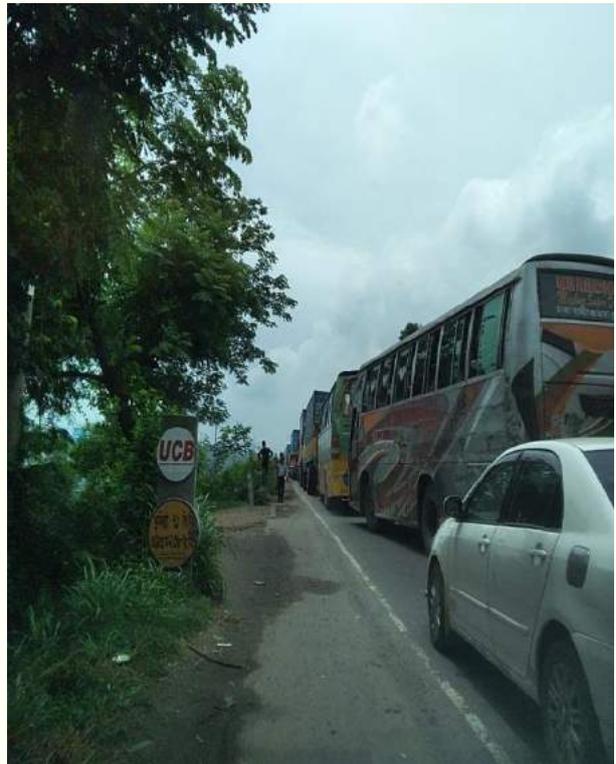
km post within clear zone at Ch.+21 to Ch.+23

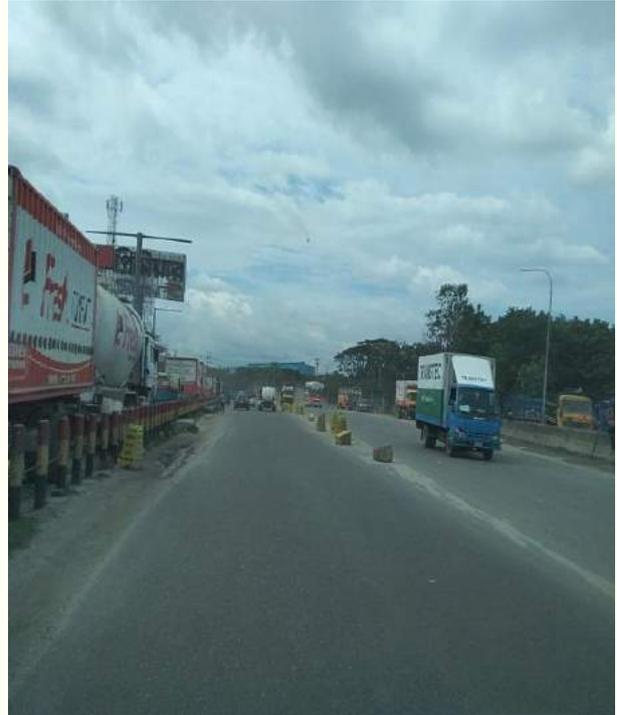
Hazardous median blocks within Ch.+23 to Ch.+25

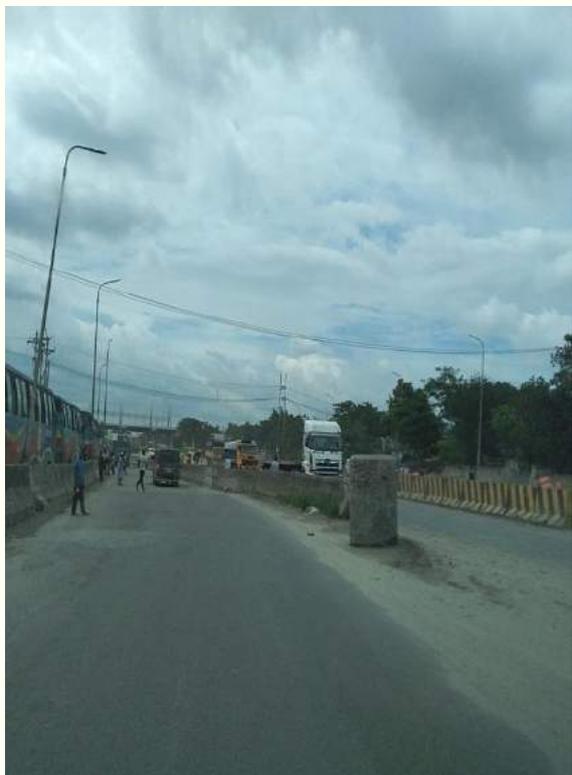
Hazardous concrete block within Ch.+23 to Ch.+25

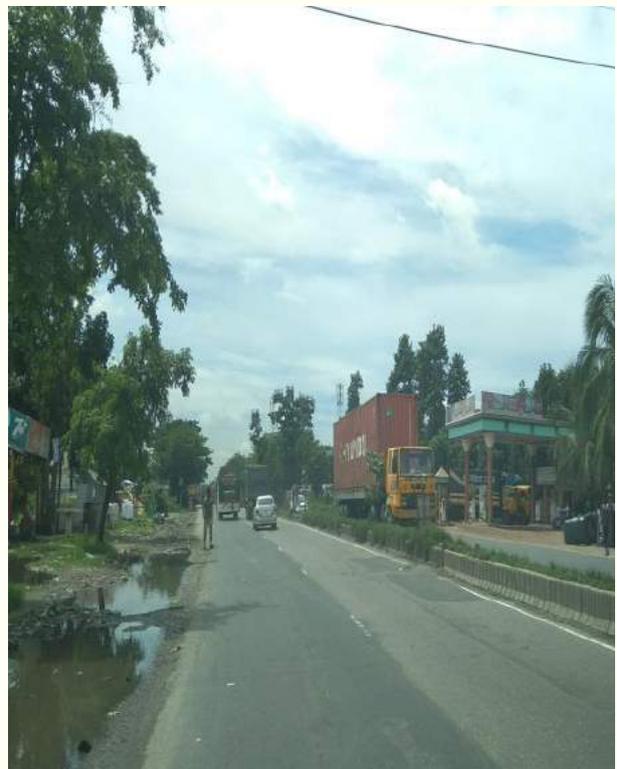
Waterlogged roadside within Ch.+25 to Ch.+27

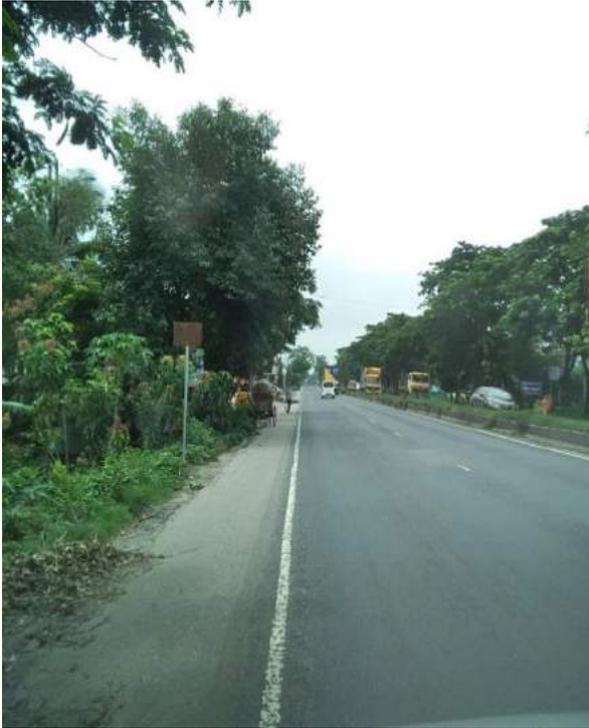
Damaged road sign within Ch.+33 to Ch.+35

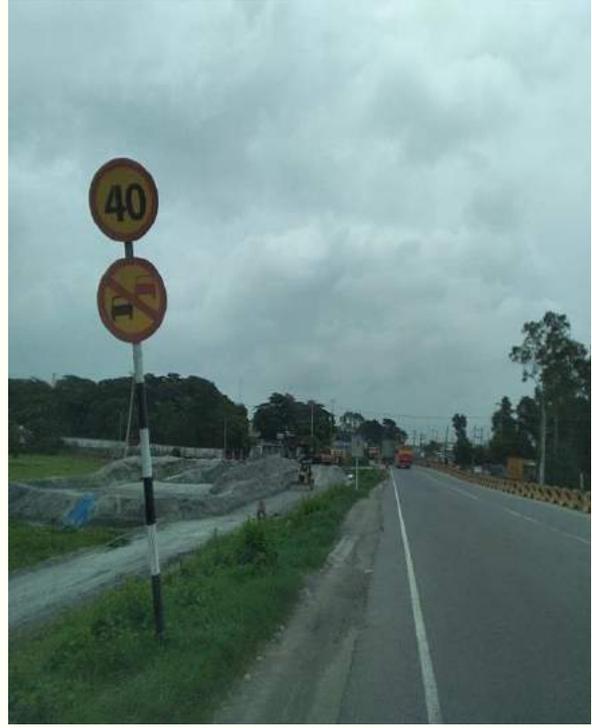
Wrongly colored road sign within Ch.+35 to Ch.+37

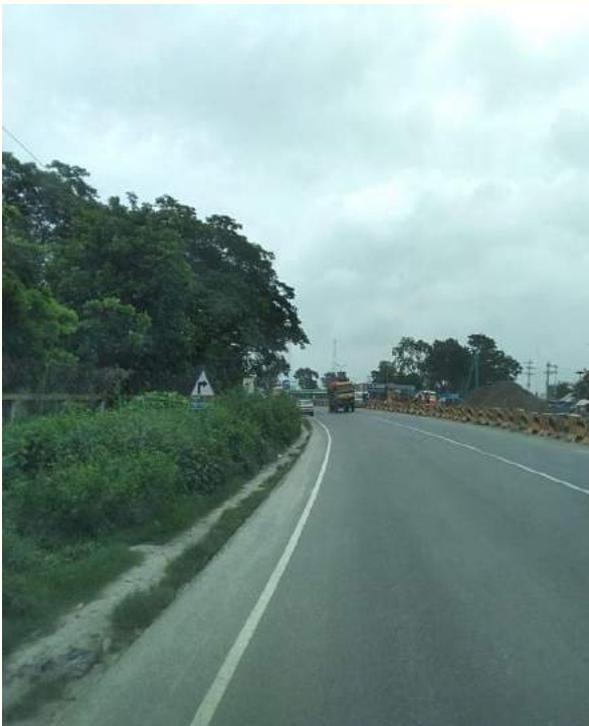
Improper placement of sign within Ch.+35 to Ch.+37

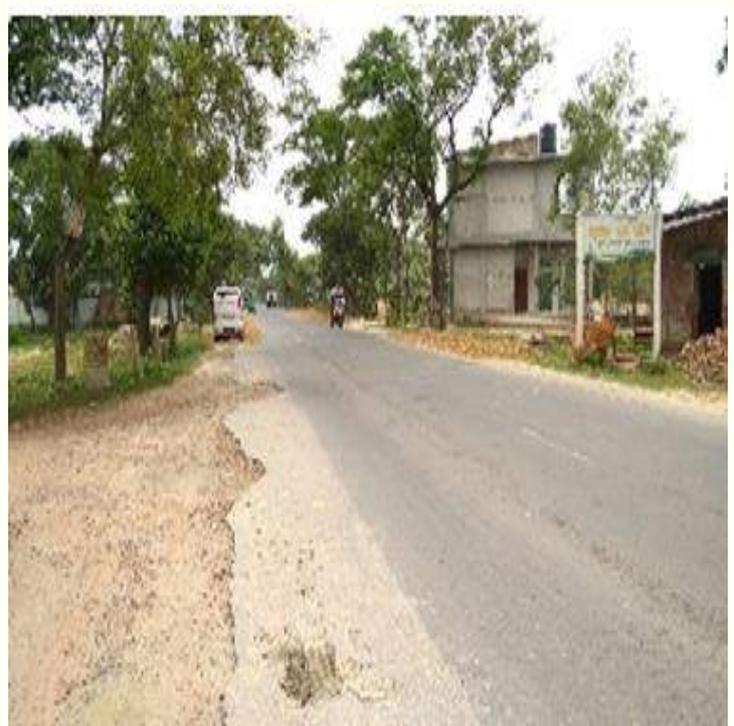
Broken shoulder within Ch.+106 to Ch.+208

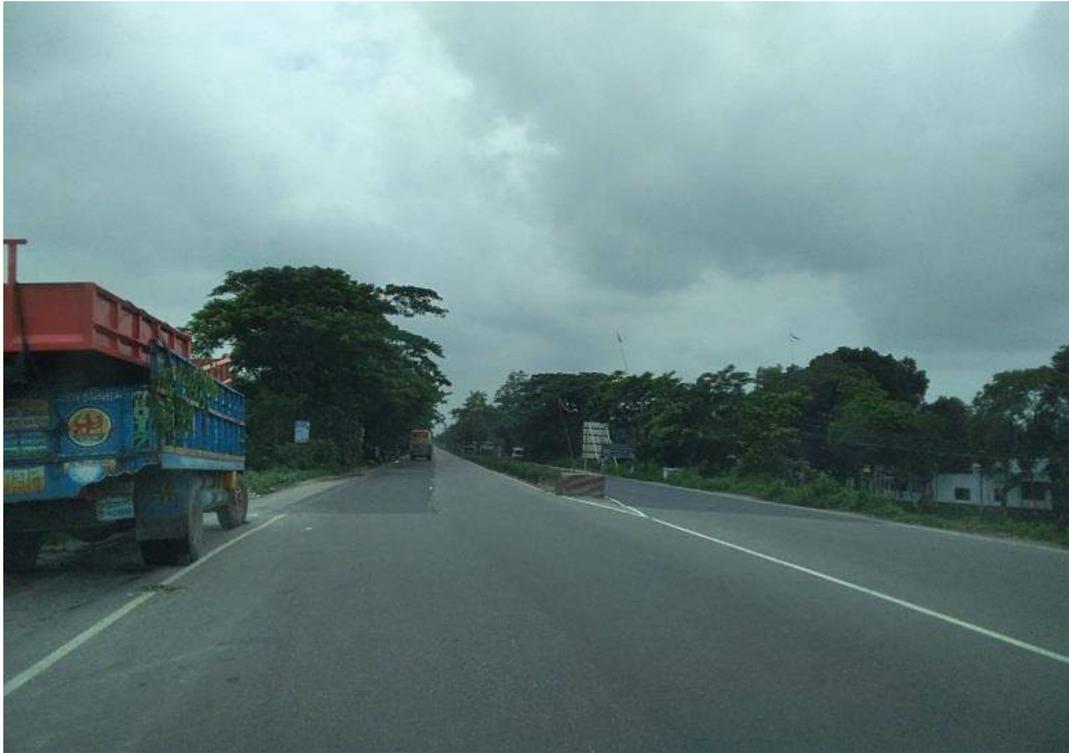
Hazardous median protection block within Ch.+35 to Ch.+37

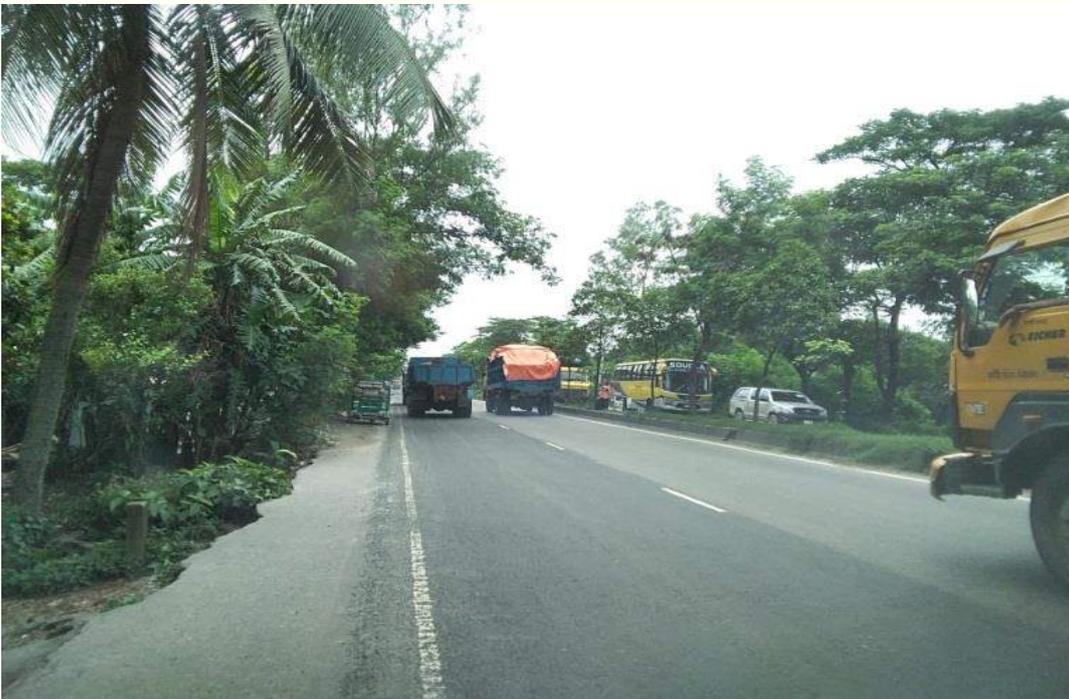
Risky edge drop within Ch.+35 to Ch.+37
