Road Safety Audit Report

Road Name: Bhanga-Bhatiapara-Mollahhat-
Fakirhat- Noapara National Highway (N805)
Audited Length: 111 Km

**Road Safety Division
Road Design and Safety Circle
Elenbari, Tejgaon , Dhaka**

May, 2019

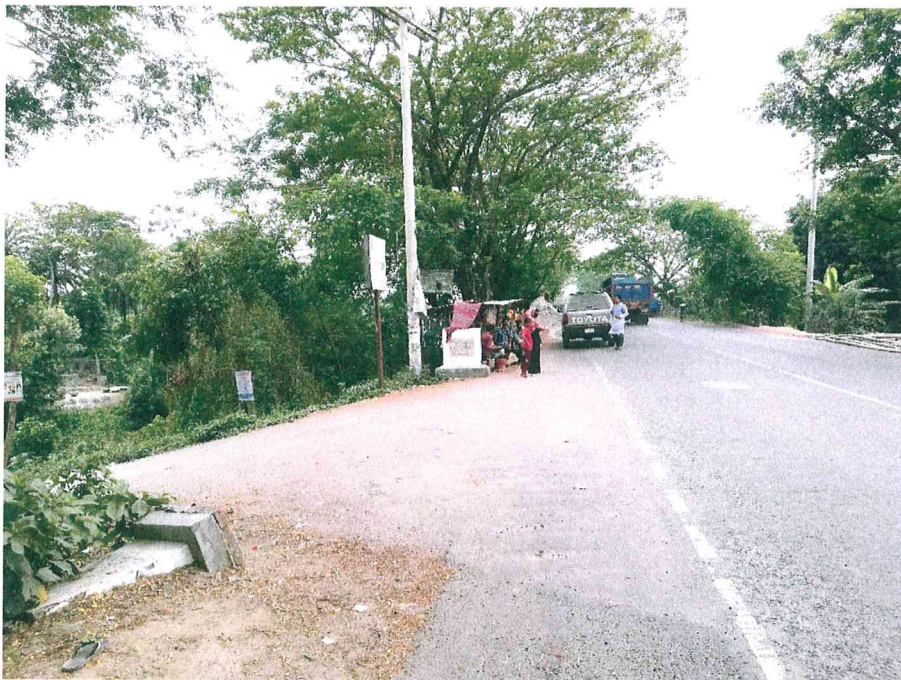
Problem: Most of the side road either connecting in Y shape or T, are found to be risky due to poor layout and visibility. They are too steep and sometimes the risk would be too high when their visibility is severely hampered due to road side trees, unauthorized billboard etc.

Figure 01a: Too Steep Side Road (Near LRP 002)

Recommendation: Minor roads (Side roads) should be connected to Major Road in such a way that the 3-wheeler non-motorized vehicle cannot enter directly to the Highway. Moving vehicle from side road needs to enter in main Highway through merging lane. RHD minor road and other (e.g LGED, Pouroshova etc) roads should not directly connect to the highway, rather it should follow the typical design given below. More importantly, road side trees, unauthorized billboard etc., needs to be removed to improve the visibility of the driver. It should be noted that as Y and X type junctions are more dangerous, the layout should be re-aligned in such a way that it turns to T and + type at junction.

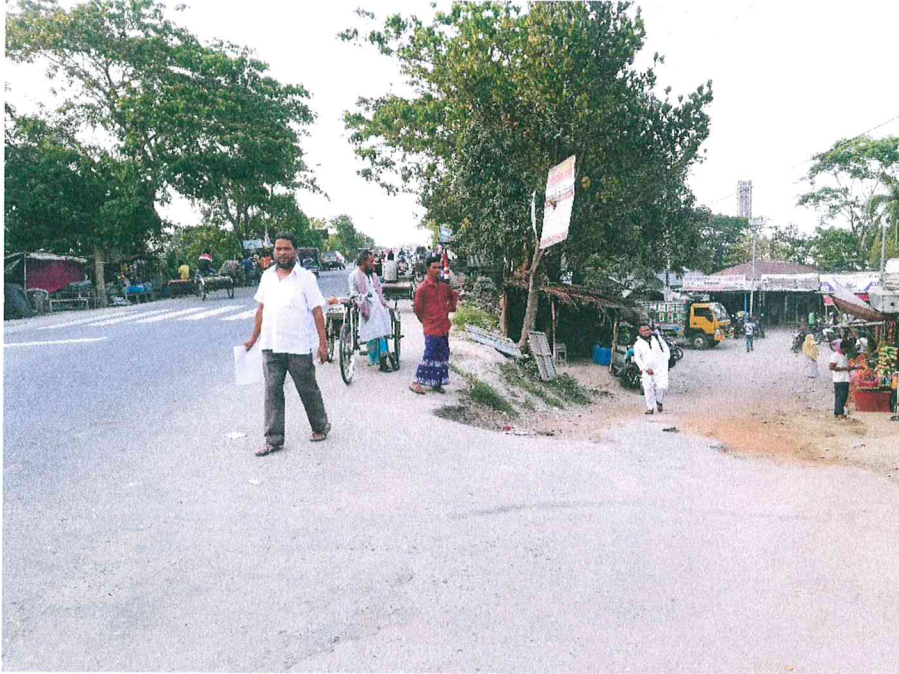
Figure 01b: Side Road with Visual Obstruction (Near LRP 093)

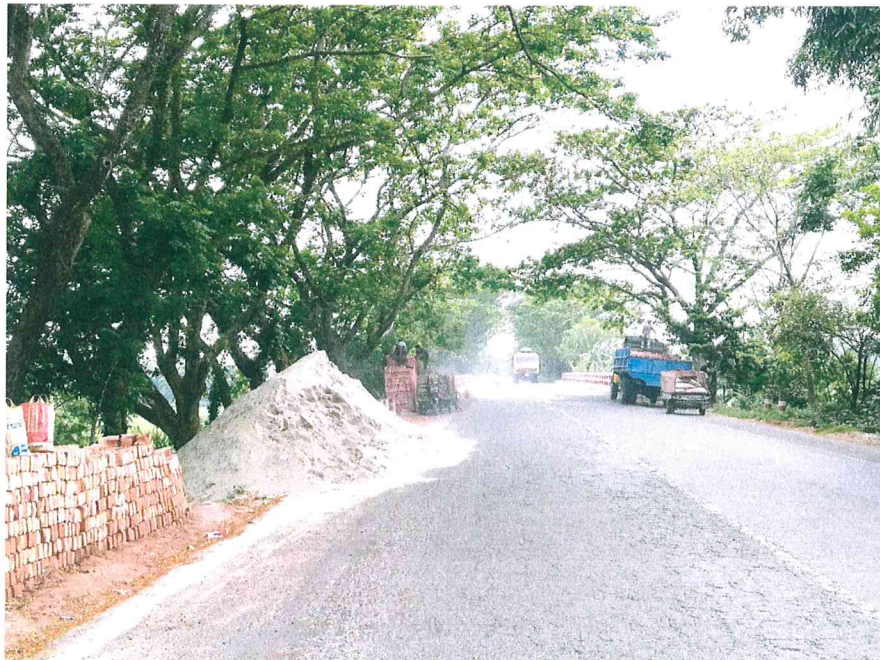
Problem: Different types of hazardous items are stacked either in the soft shoulder or sometimes in the carriageway at different chainages throughout the Highway. Even at some chainages the highway is experiencing unauthorized construction work.

Figure 02a: Hazardous Item (Near LRP 002)

Recommendation: Road side hazards should be cleared with the help of local administration, if needed. Moreover, continuous monitoring is needed to keep road side free, to ensure safe clear zone. If any object cannot be relocated or immovable in nature within the clear zone, hazard marking should be ensured, so that it can be visible particularly at night. Regular eviction is needed to discourage such illegal encroachment.

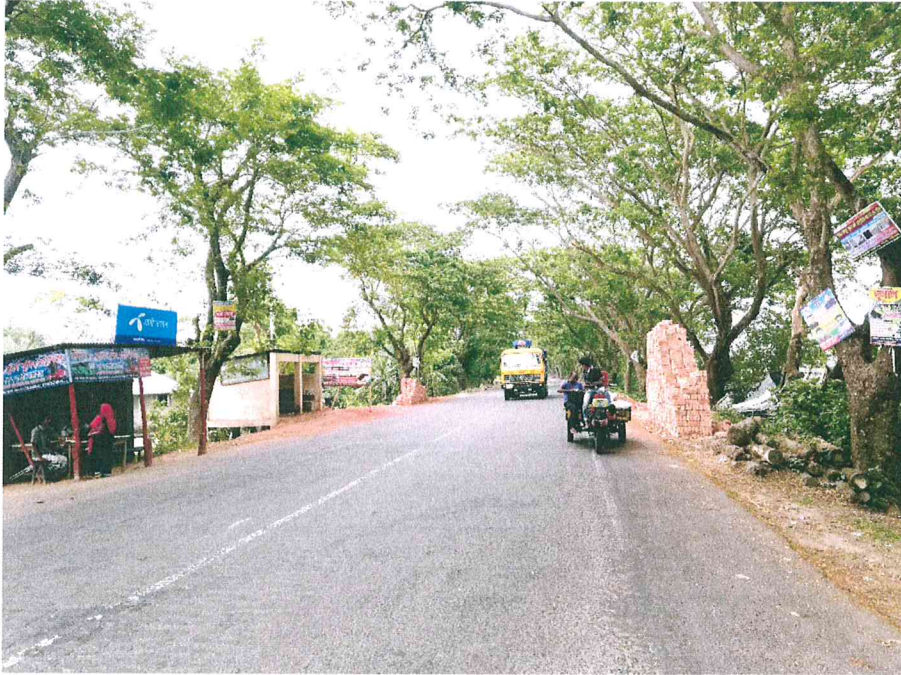
Figure 02b: Hazardous Item (Near LRP 003)

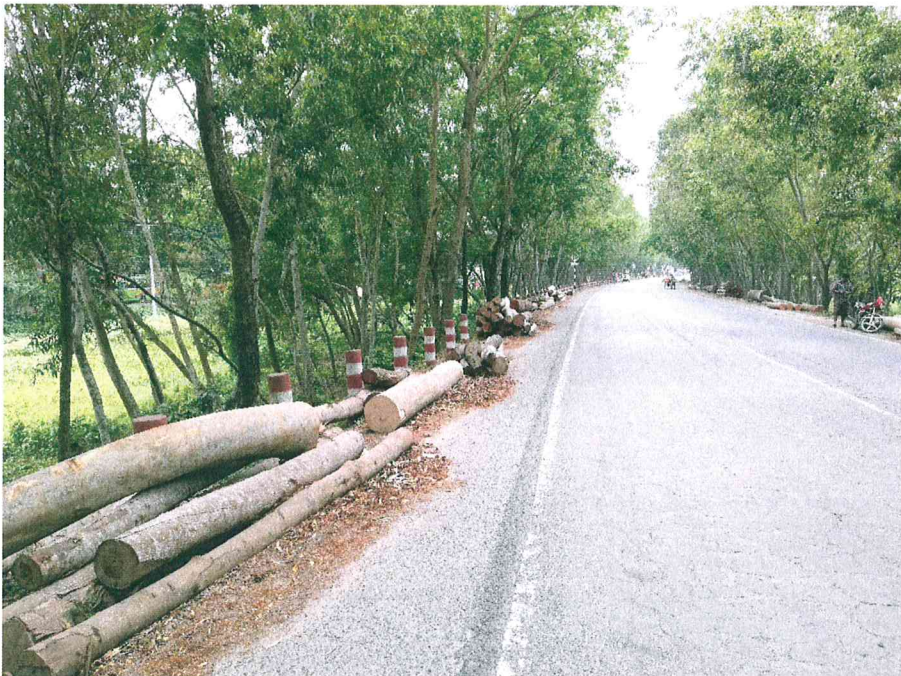
Figure 02c: Hazardous Item (Near LRP 010)

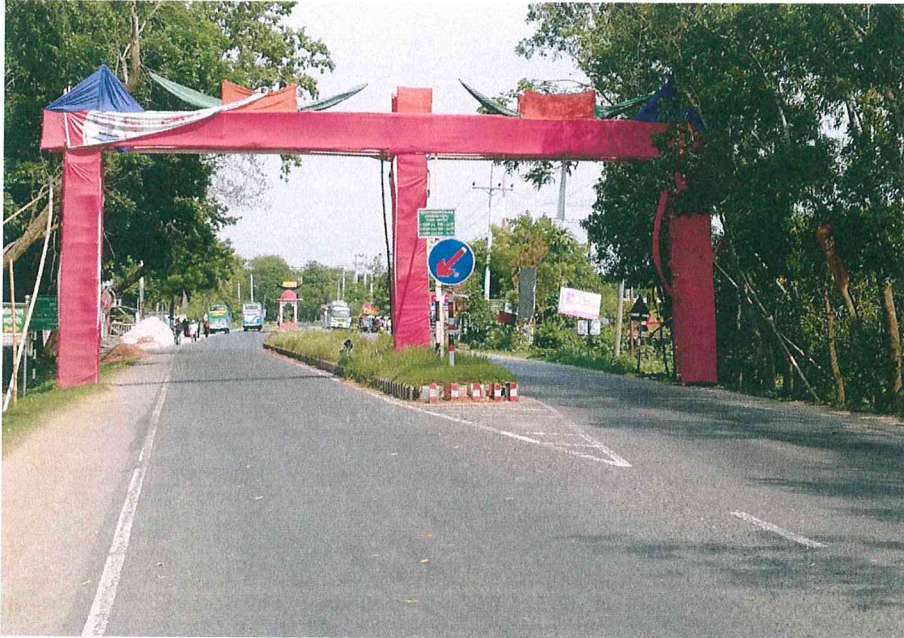
Figure 02d: Unauthorized Structure (Near LRP 038)

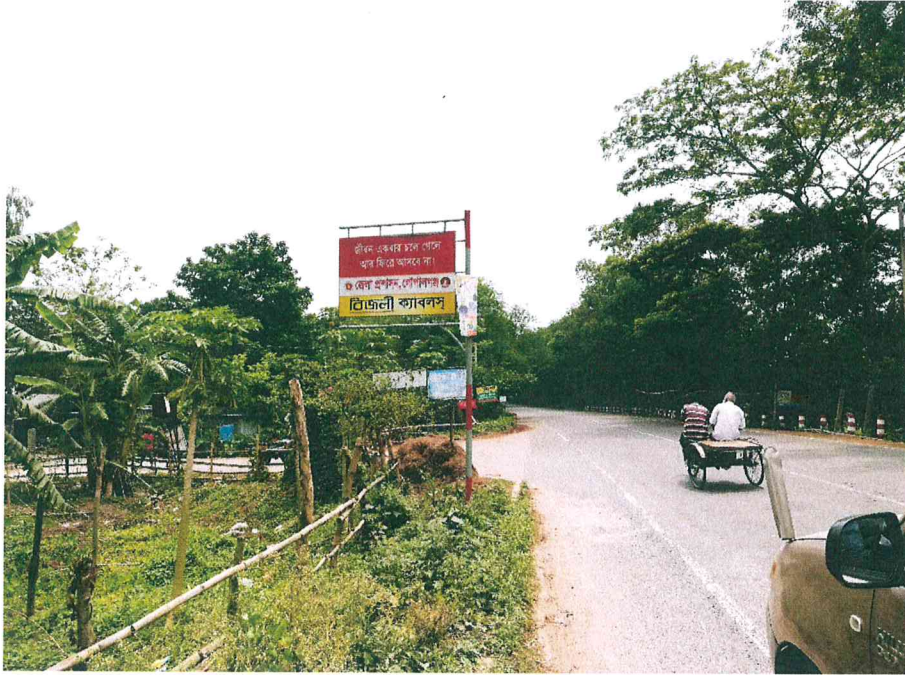
Problem: Various unauthorized information boards have been seen which does not match with the traffic sign manual, considered as illegal. This type of billboards become more risky when it is situated very close to pavement and obstruct the visibility of the other road sign and side roads. Besides, too many boards with various informations distract the attention of the driver.

Figure 03a: Unauthorized Billboard (Near LRP 004)

Recommendation: Road side unauthorized boards should be cleared with the help of local administration, if needed. Moreover, continuous monitoring is needed to keep the road side free, particularly at clear zone. Information sign should be provided following the traffic sign manual.

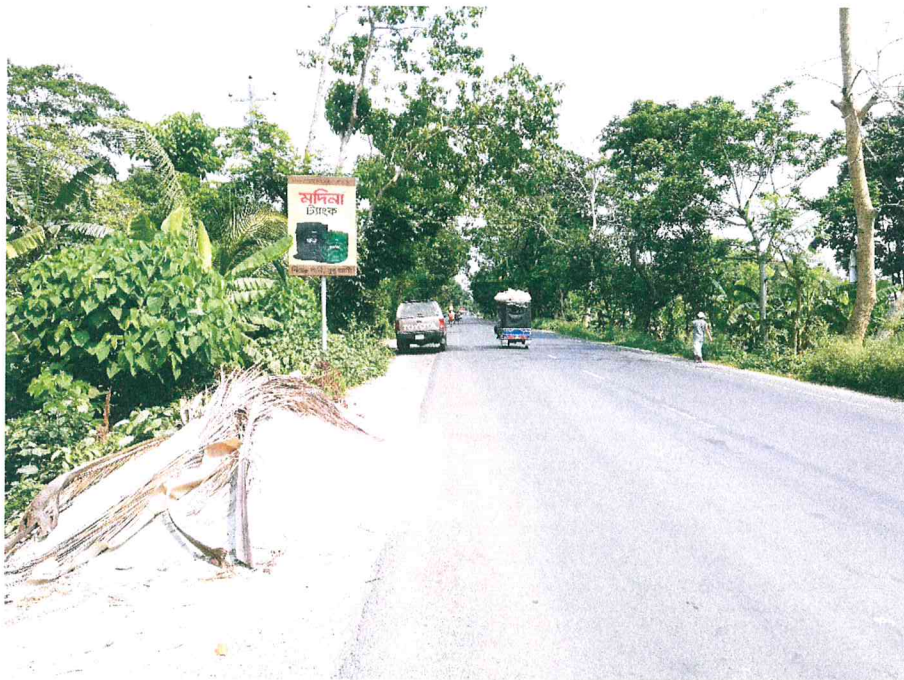
Figure 03b: Unauthorized Billboard (Near LRP 020)

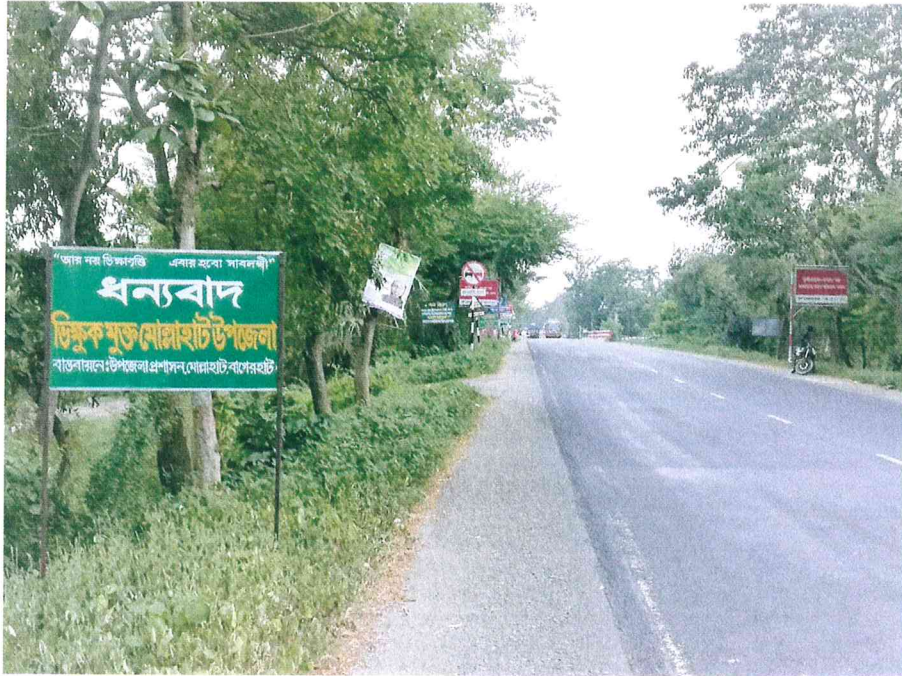
Figure 03c: Unauthorized Billboard (Near LRP 108)

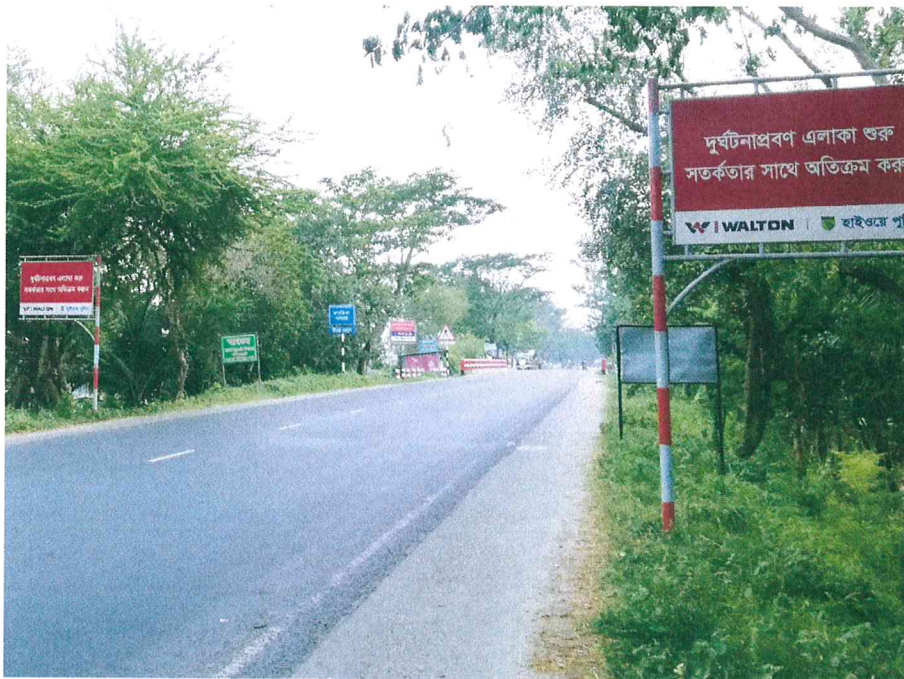
Figure 03d: Unauthorized Billboard (Near LRP 108)

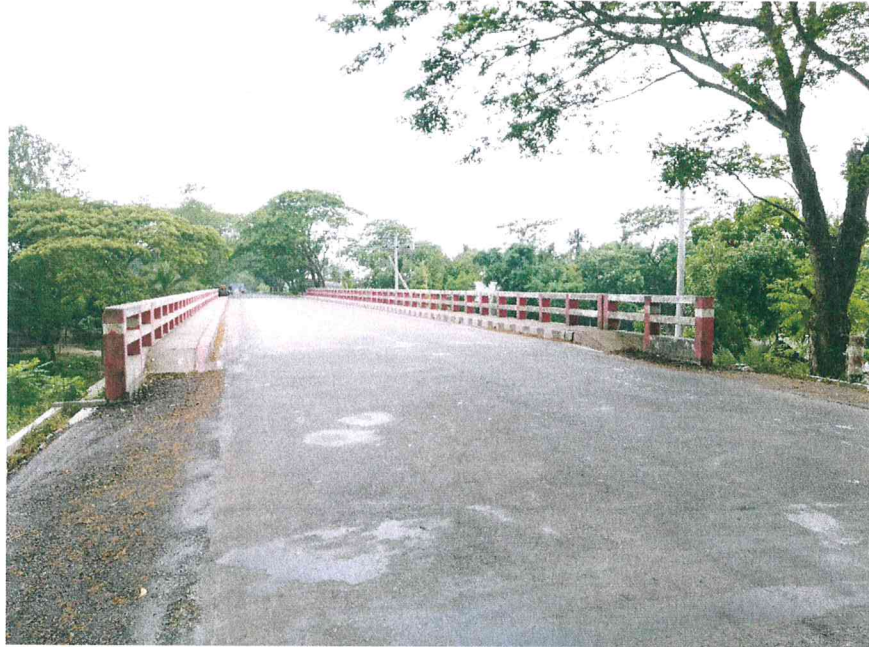
Figure 04a: Bridge (Near LRP 006)

Problem: Almost all bridges on this Highway is found without any types of Road Marking. Some bridges seem freshly painted but none of them are reflective. Some of the bridge approaches are without proper delineation/ guide post and other safety barriers. At the chainage of 101+ 500 two consecutive bridges were found to be more hazourdous due to lack of proper safety measures.

Recommendation: Bridge approaches should have adequate safety measures though installation of guide post and/or crush barrier, especially in high embankment. Moreover, the entry post of the bridge railing should have appropriate hazard marking to improve conspicuity of railing at night. *No Overtaking Sign* along with marking is mandatory of such bridges and approaches.

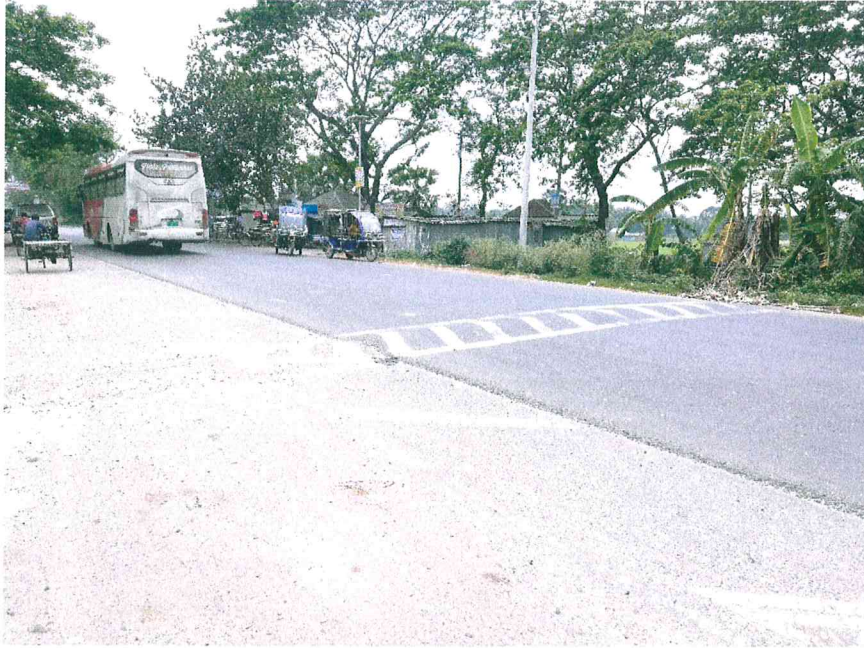
Problem: Numerous speed breakers are found in different locations throughout the N805 which are unspecified and are creating stress to the drivers.

Figure 05a: Unauthorized Speed Breaker (Near LRP 015)

Recommendation: Any unauthorized speed breaker should be dismantled. Speed hump or table can be installed, depending on speed limit. Speed table can be installed with raised pedestrian crossing (if pedestrian crossing needed) with sets of rumble strips ahead of such speed reducer with appropriate traffic sign and marking.

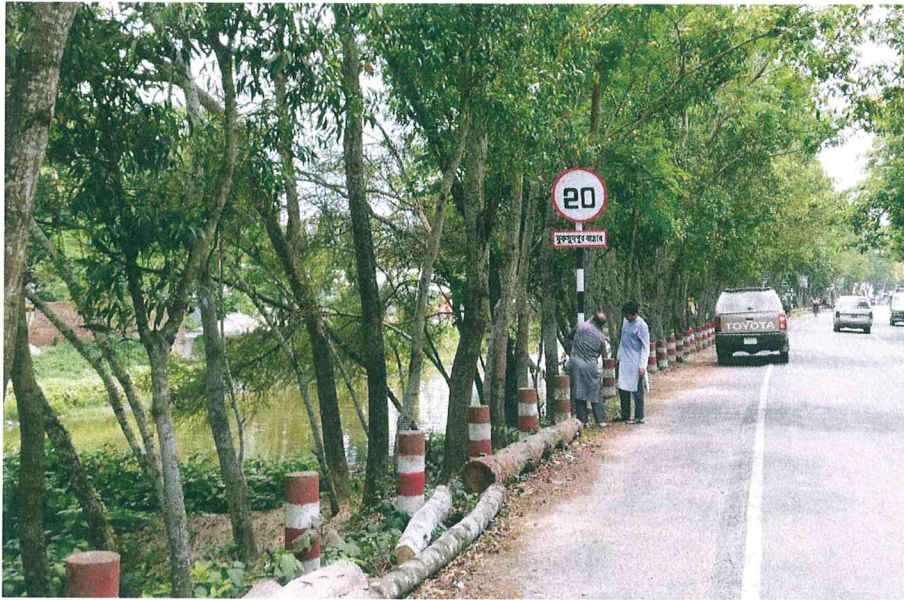
Problem: At some chainage the road Markings and traffic signs are found to be unspecified in their dimensions and at some chainage they are found to be incorrect. Adequate *chevron sign* is not given on sharp bend. *No Overtaking Sign* is used in the road, but a *Broken White Center Line* is given instead of *Continuous White Line* which is improper and dangerous. Some identical unspecified speed limit is provided but speed restriction end signs are totally absent. Shoulder and the carriage way are not at the same level which makes the road more susceptible to road crush.

Figure 06a: Unspecified Speed Limit Sign (Near LRP 019)

Recommendation: Road sign size shape and placing should conform the traffic sign manual. To fix the speed limit of any road segment, it should be appropriate as per traffic sign manual, shown in Paragraph E2.3. After imposing appropriate speed limit of any area, speed restriction end sign also needs to be placed at the end. To have better visibility at night, Signs should be retroreflective, therefore it should be diamond grade as per traffic sign manual. Road marking, particularly at sharp bend, it should have continuous center line with chevron marking on the outer side of the road at certain intervals. Any obstructed vegetation needs to be cleared at inner side of the curve. Shoulder drop is dangerous and therefore needs to be same level with the main carriageway.

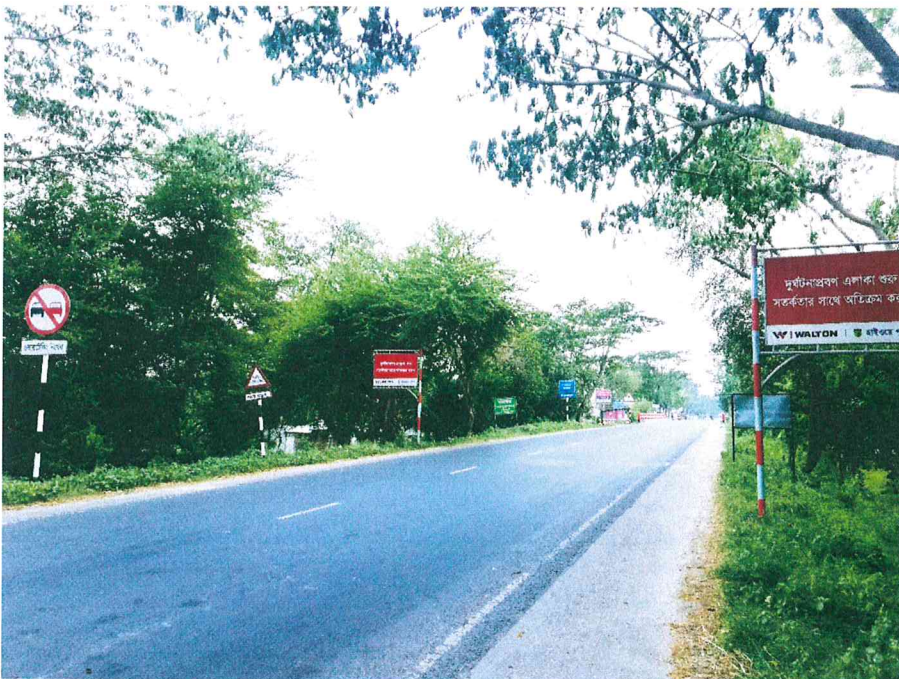
Figure 06b: Incorrect Road Marking at No Overtaking Area (Near LRP 108)

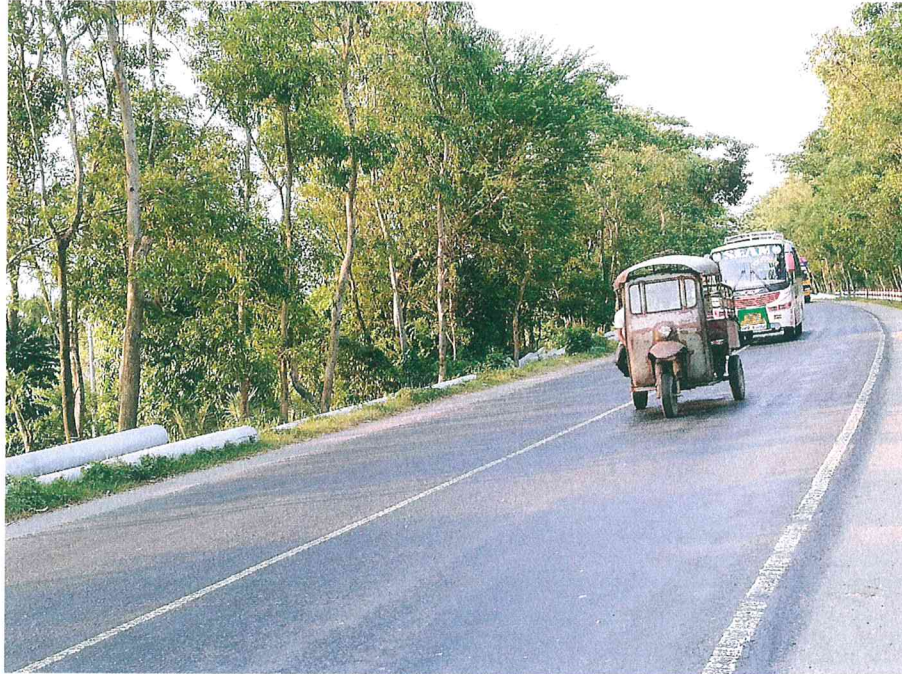
Figure 06c: No road sign at Sharp Bend (Near LRP 030)

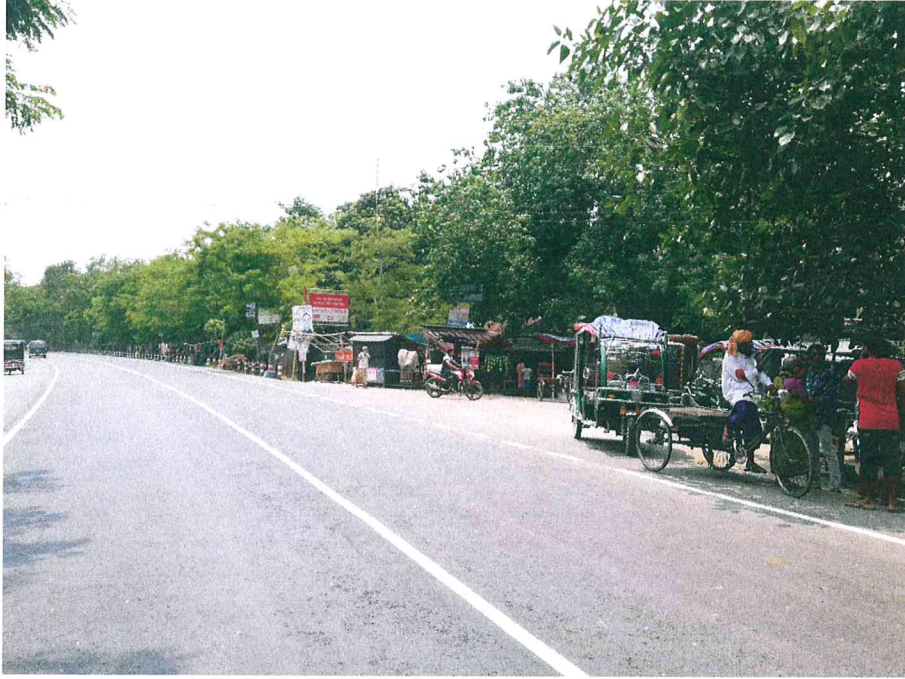
Problem: Unauthorized Parking and illegal Tea Stall, small shops are found in different chainages, especially near the junctions. Slow moving vehicles are found sitting pointlessly even at the sharp bend.

Figure 07a: Unauthorized Parking & Illegal shops at Link Road (Near LRP 022)

Recommendation: Any three wheeler's entry to main highway is totally restricted as per government order. Strict enforcement is needed against unauthorized parking. Any structure within the right of way (ROW) of RHD, should be evicted with the help of administration.

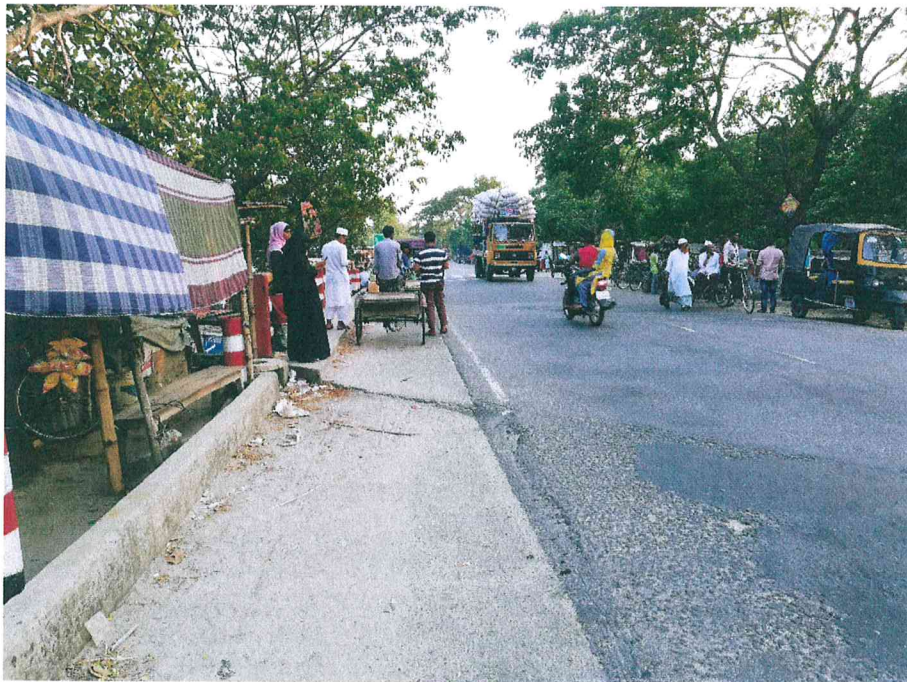
Figure 07 b: Unauthorized Parking & Illegal shops at Bridge site (Near LRP 057)

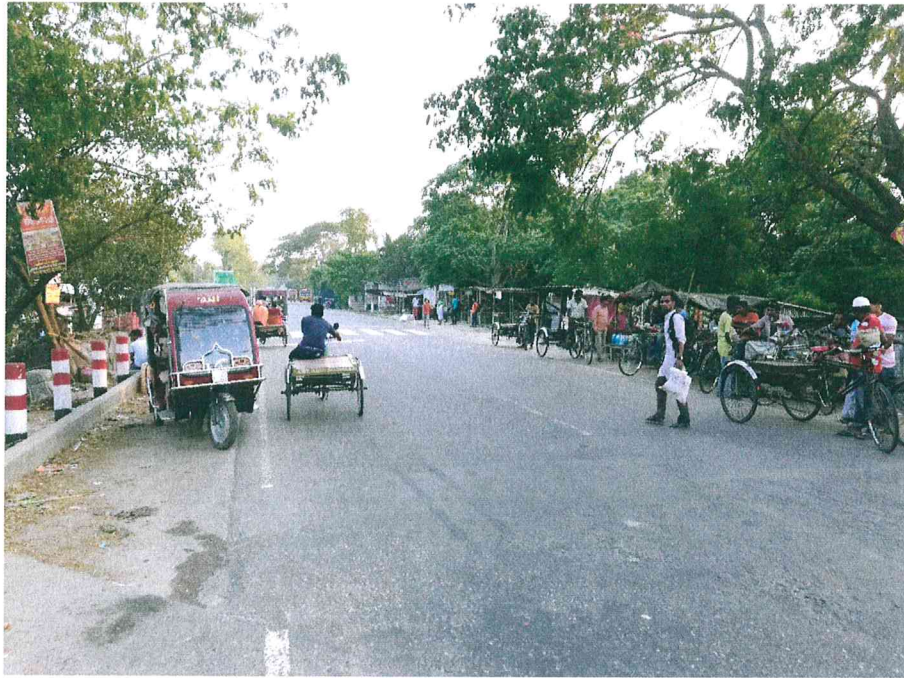
Figure 07 c: Unauthorized Parking & Illegal shops (Near LRP 057)

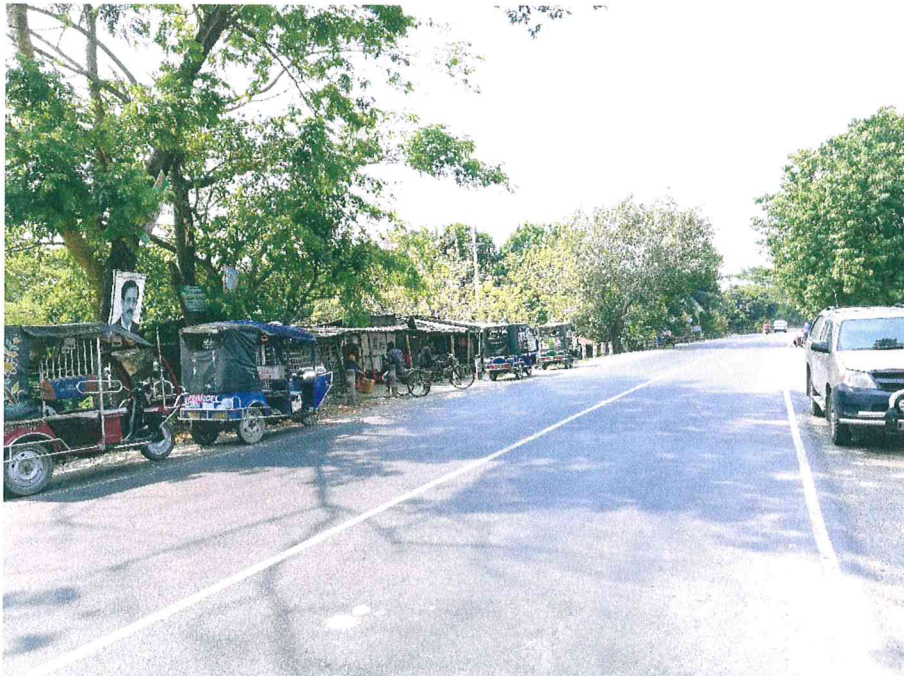
Figure 07 d: Unauthorized Parking & Illegal shops at Sharp Bend (Near LRP 024)

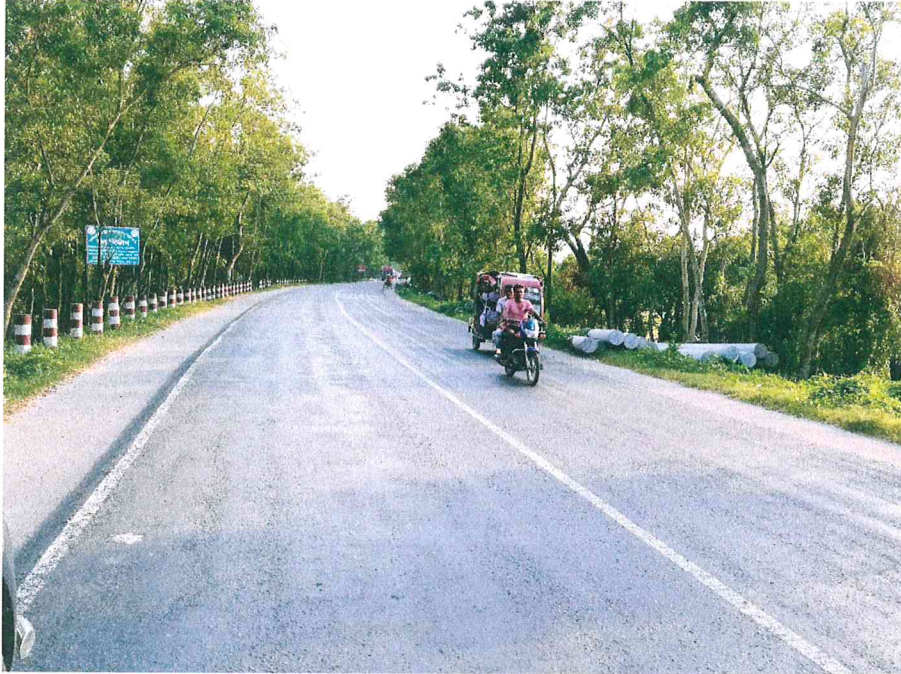
Problem: It is very common to see three wheeler vehicles using the same lane along with the high speed vehicles. These situations are leading to high risk of occurring accident.

Figure 08: Three wheeler plying on Carriage Way at Sharp Bend (Near LRP 030)

Recommendation: Any three wheelers and other NMV entry to main highway are totally restricted as per government order. Strict enforcement is needed against such activities. *No Entry Sign* can be placed at the side road, connecting to main highway to aware these NMVs and other three wheelers of minor road.

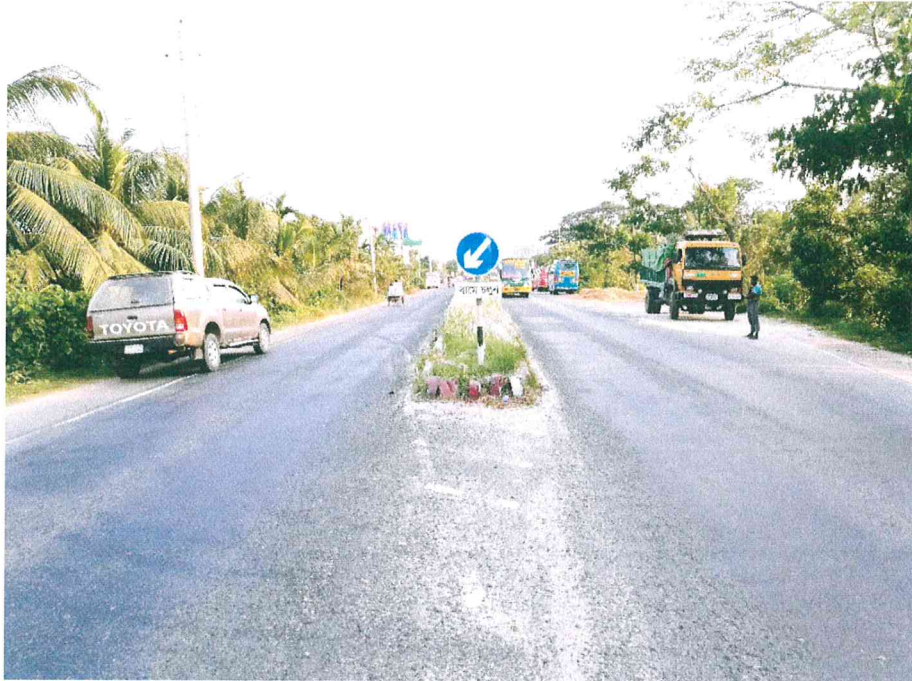
Problem: Almost every nose of road divider is quite tough to get noticeable to the driver. The absence of delineator, road marking with reflective paint is almost common scenario at various divider noses, which had been damaged due to vehicle collision, as perceived.

Figure 09a: Ill Treated Nose (Near LRP 068)

Recommendation: Proper end protection of concrete median is needed to protect the barrier from impact. Moreover it is very important to aware the drivers of such hazard well ahead by providing appropriate Traffic Sign and Rumble Strips. By providing the appropriate *Hazard Marking* with Sand Cushion Drum is also needed to protect the Nose of such medians.

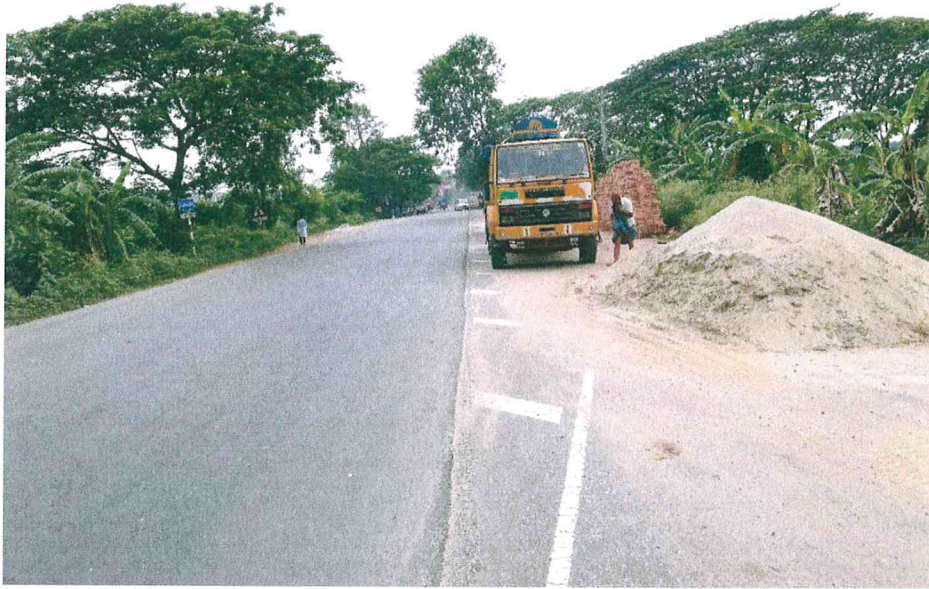
Problem: Every Passenger Shade and Bus Bay are more or less occupied with illegal activities.

Figure 10: Occupied Bus Bay (Near LRP 013)

Recommendation: Designated Bus-Bay should be identified and illegal activities need to be stopped with the help of local administration. Appropriate signs and road marking needs to be placed at the bus stop areas.
