**Roads and Highways Department (RHD)
Bangladesh Road Research Laboratory (BRRL)**

**Final Report
on
Failure investigation, Design correction, Data collection,
Research resource collection etc under BRRL during the
year 2016-2017**

June, 2017

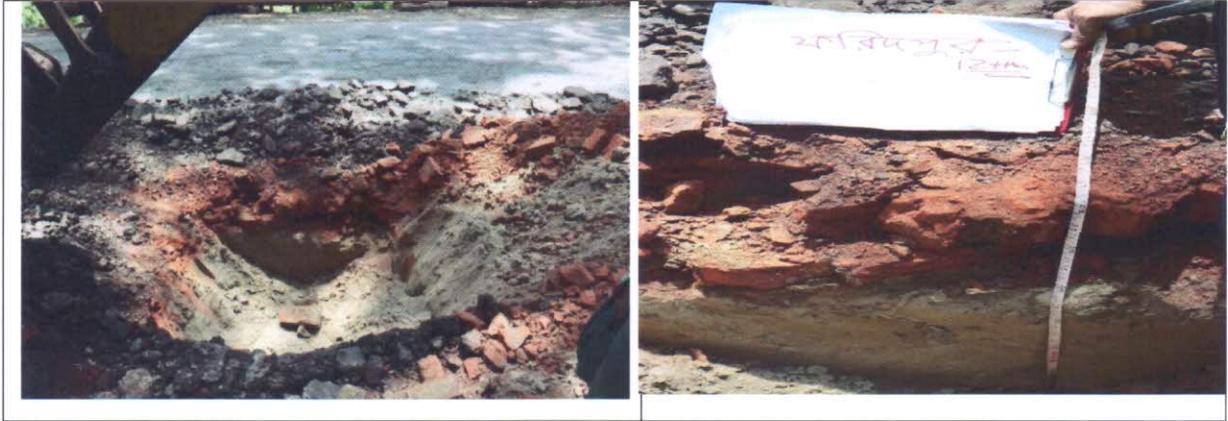
1. This point is 12Km from Faripur (12' central), B.carpeting=75mm to 150mm, Macadam=100mm, HBB+Soling =200mm on Soil

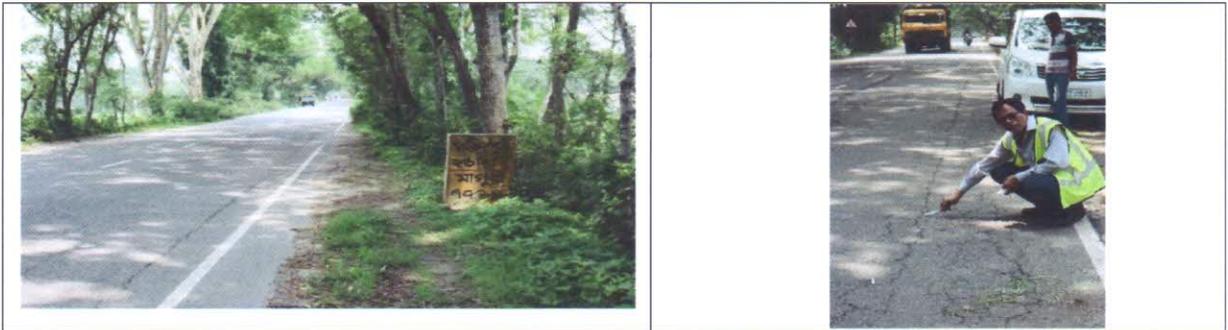
2. Longitudinal cracks, crack along the road and crack between carriage and extension part

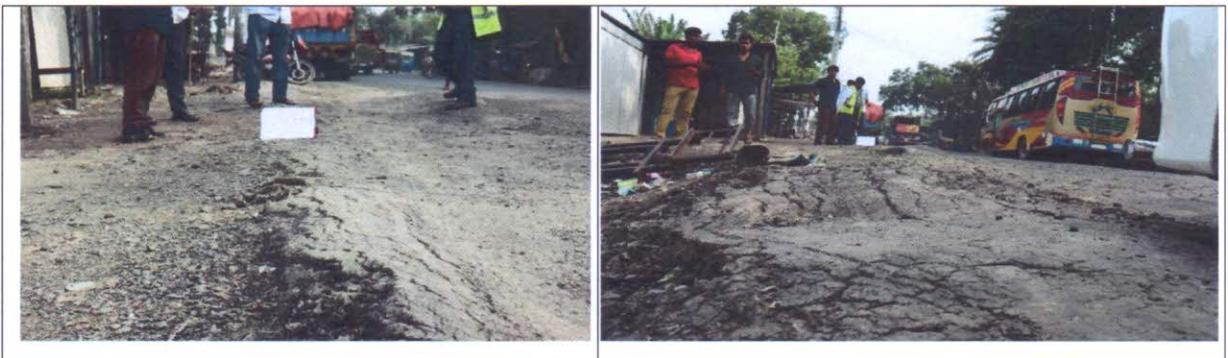
3. Heavy traffic passing (Bakhunda), Severe depression, at ch 23+00 (300m damaged surface)

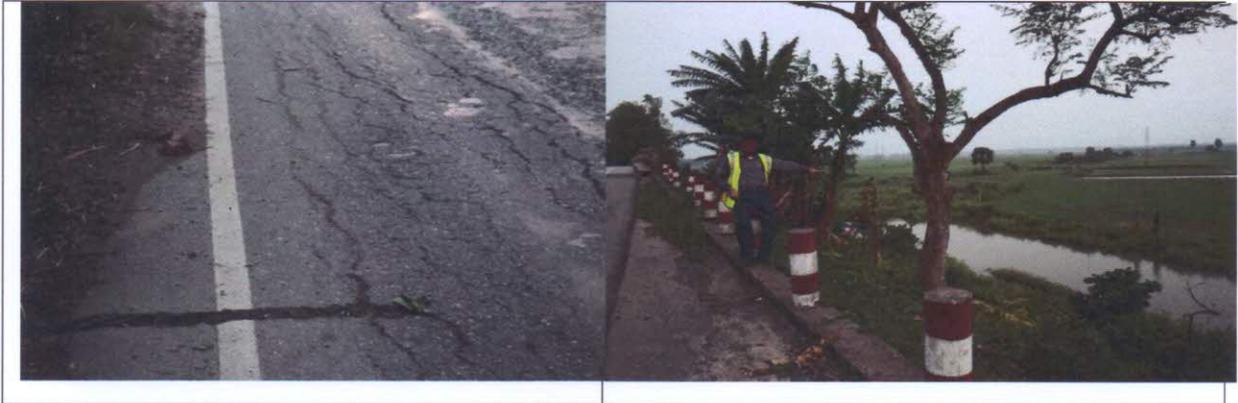
4. Basargari Area (Severe Damage, Depression) and Embankment height around 6m

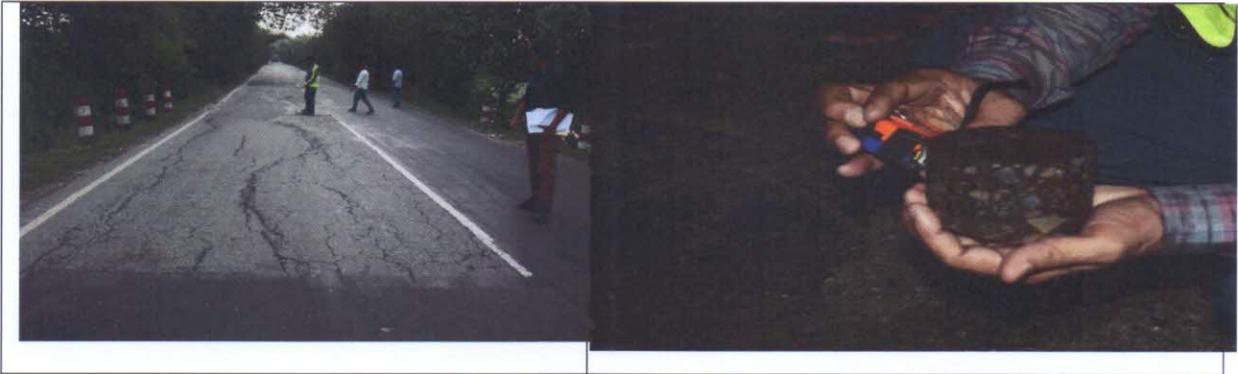
5. At ch 11+800 (Basargari), DBS(WC)>50mm, Base Type-1=200mm

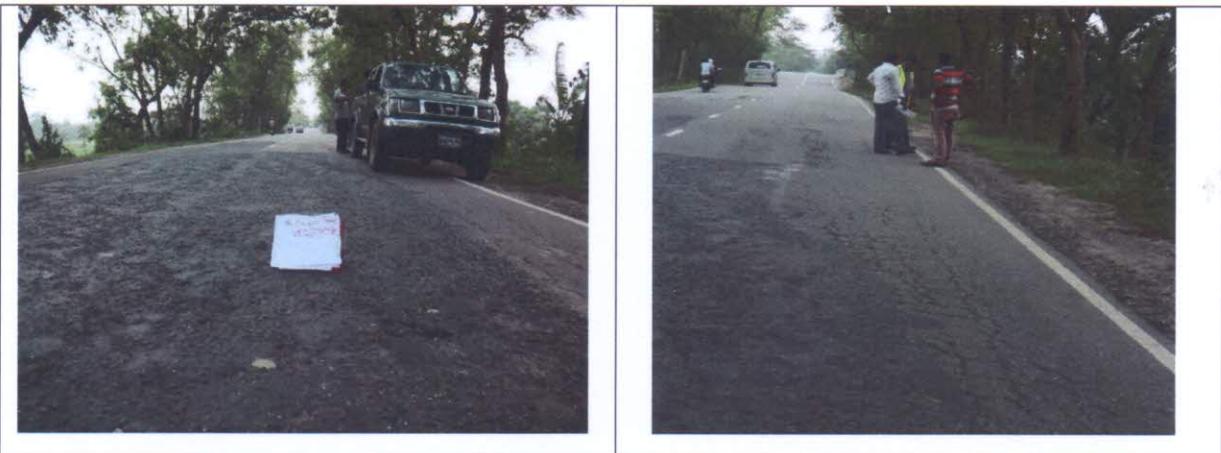
6. Basargari area was repaired recently

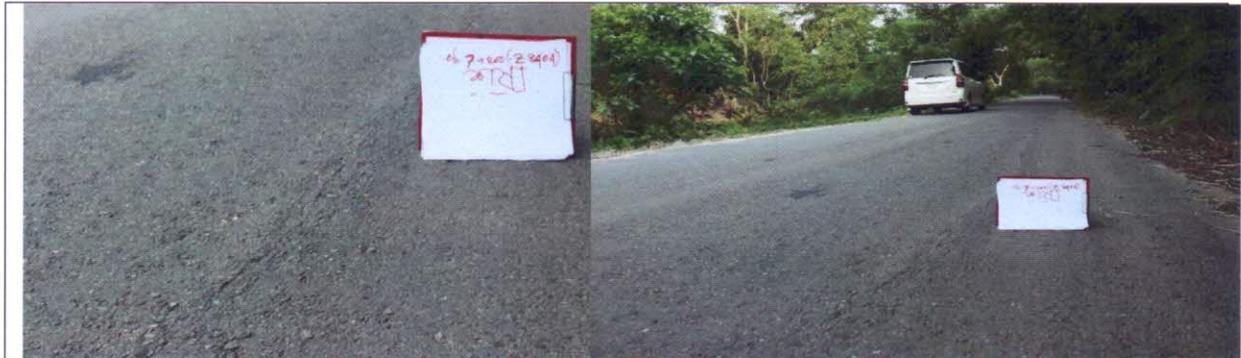
1. Road central area settled by $>150\text{mm}$ (Sosa area, CH-7+200)

1. Hard/Soft shoulder is needed with proper side slope for stability and lateral support of the pavement.
2. Severely damaged areas of ch. 7+200 to 8+800 needs full reconstruction from sub-grade according to RHD Design Manual regarding layer thickness and specification.

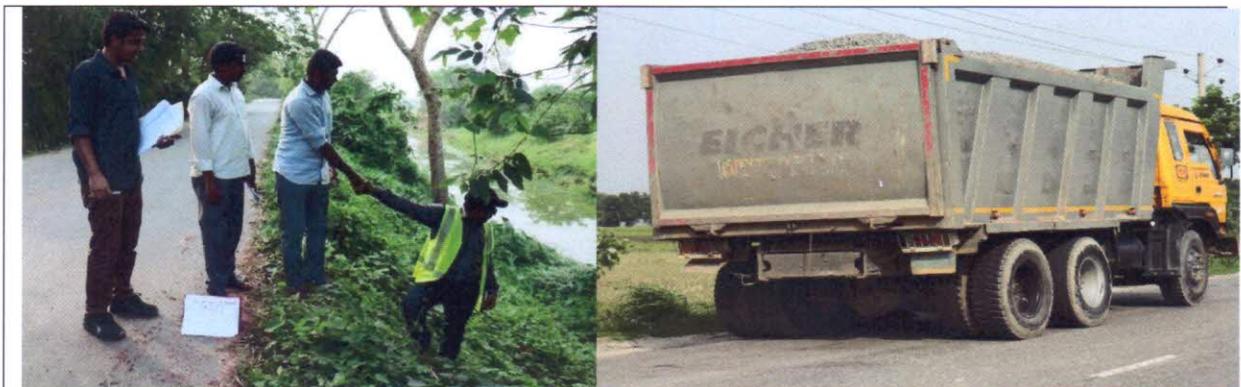
2. High embankment ($>6\text{m}$) at both side of Sosa area
Water ingresses through central settlement area accelerating damages
Heavy loaded vehicle passing this area.

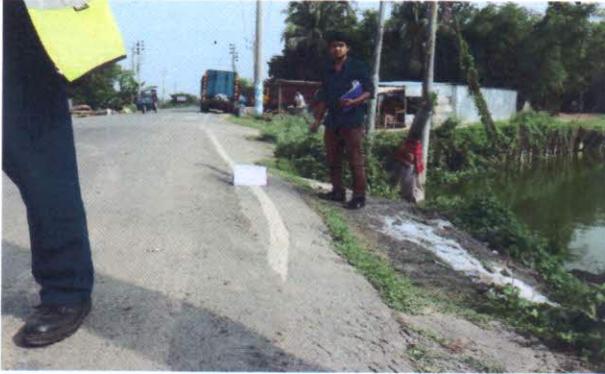
1. Shoulder area sliding

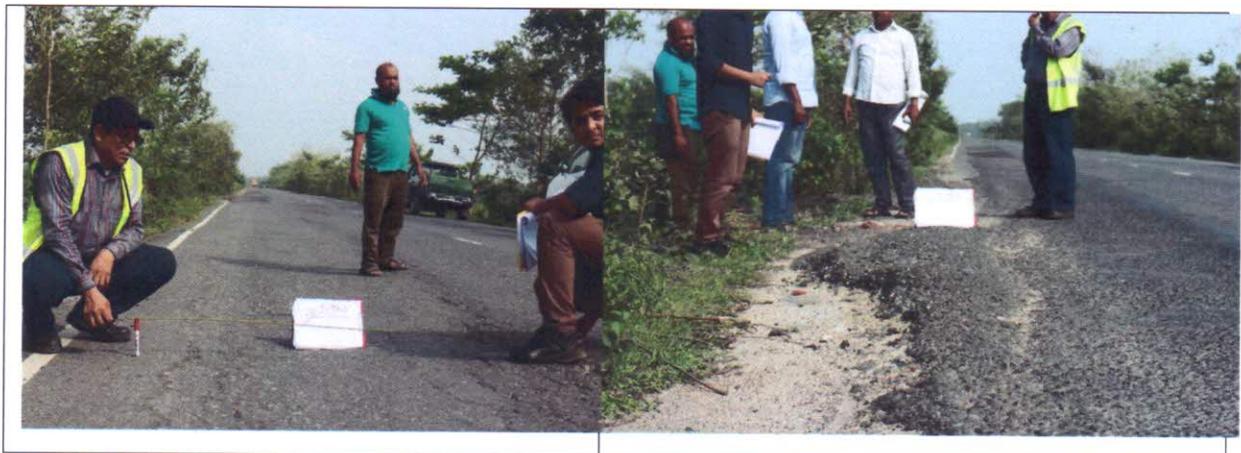
3. Depression area: At chainage 1+900, depression on side by $> 150\text{mm}$

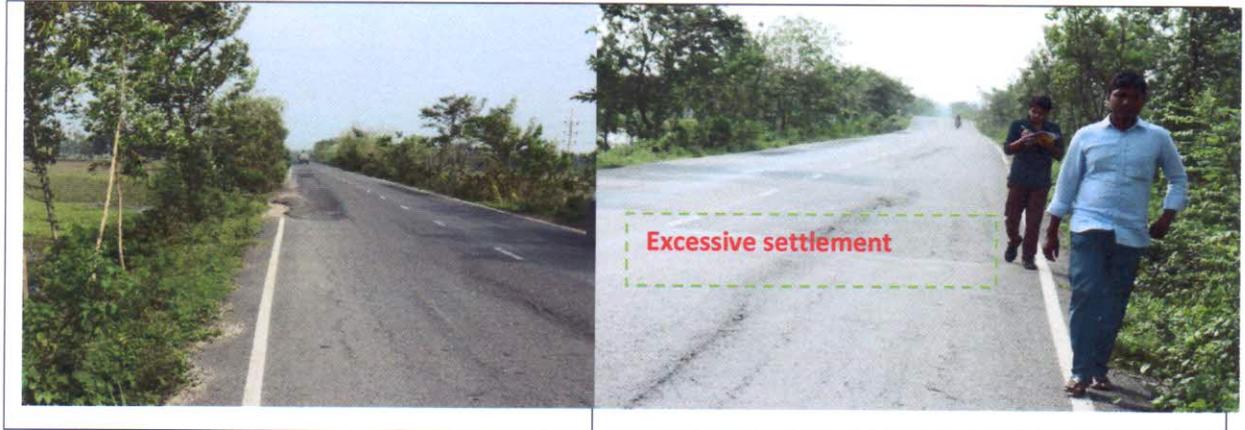
4. Settlement area and Longitudinal crack area

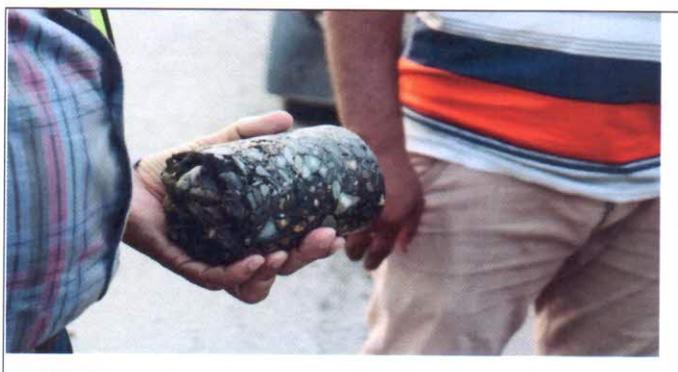
6. Core thickness is >120mm

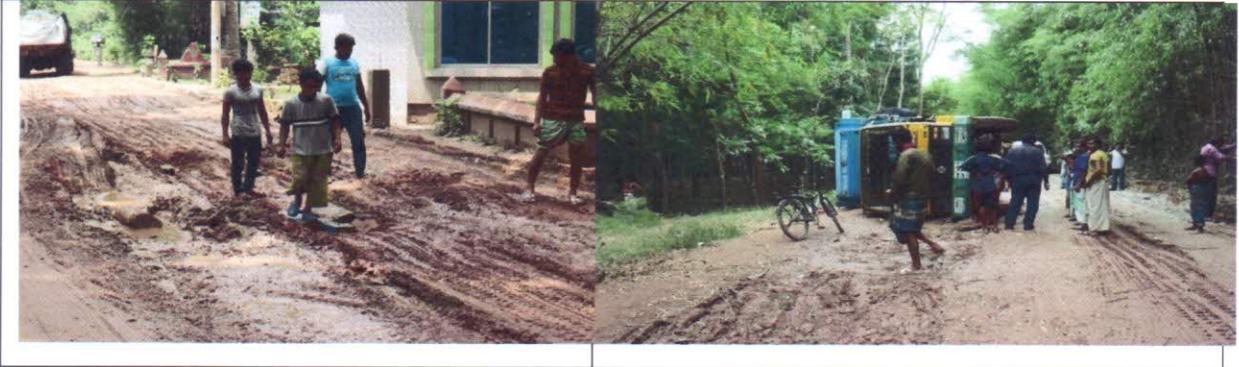
1. Damaged pavement

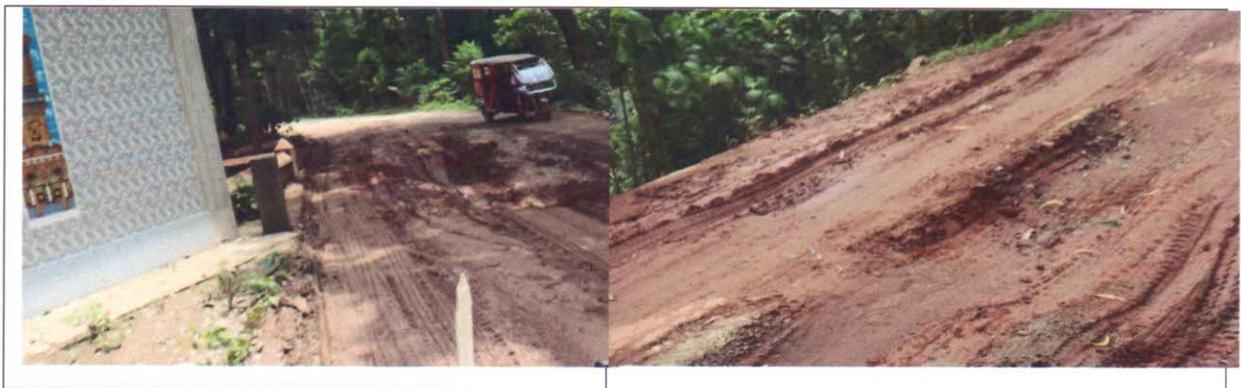
2. Damaged pavement

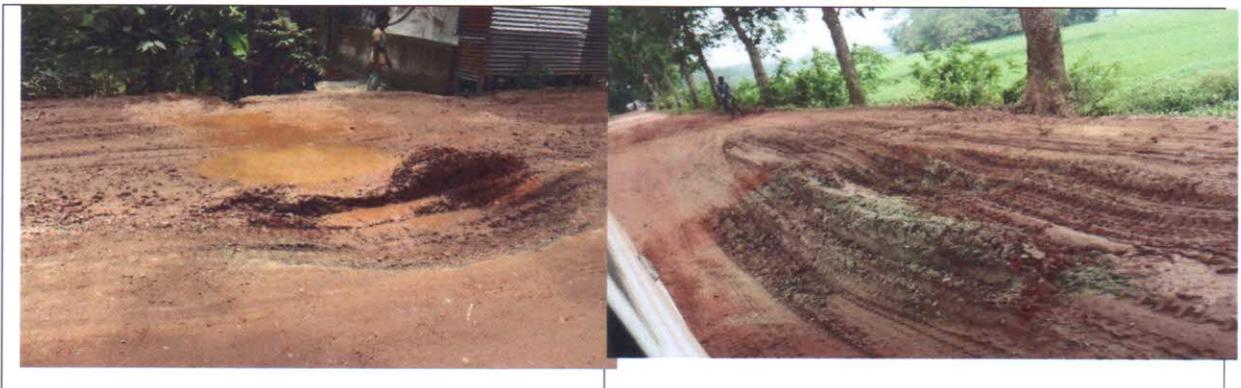
3. Damaged pavement

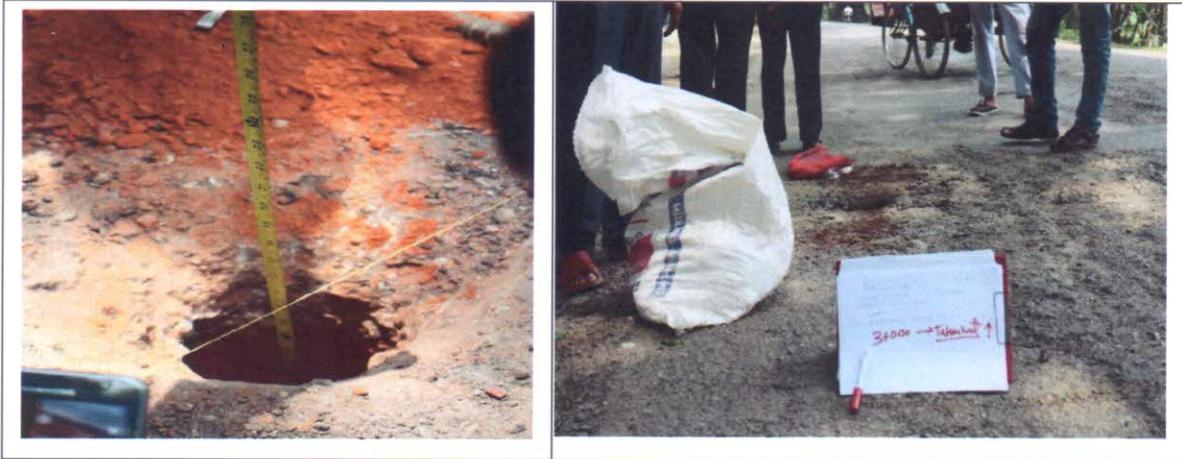
1. At Taker hat (LHS), B/Carpeting=70mm, Sub base=100mm, ISG>400mm

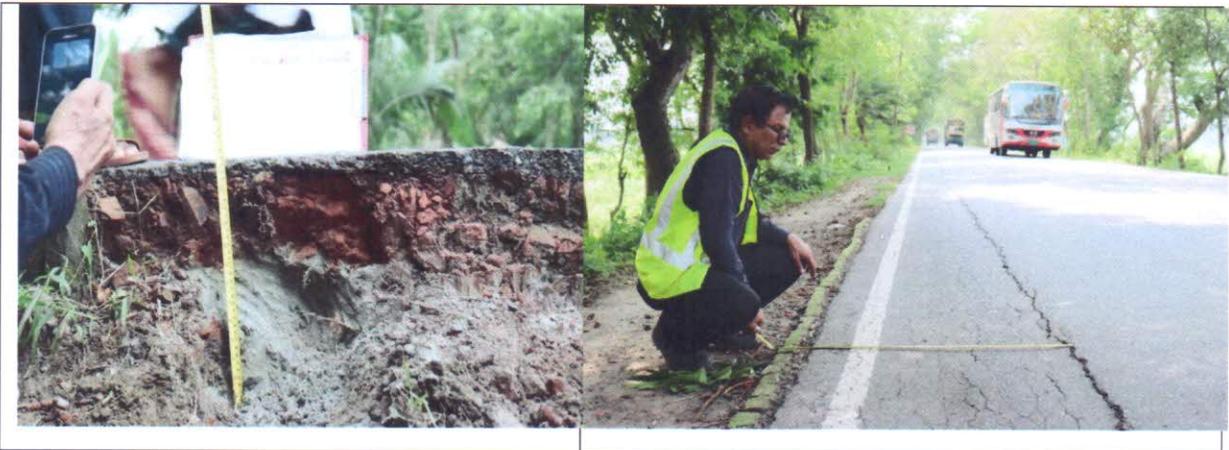
2. At Taker hat (LHS), Bituminous Carpeting = 30-40 mm, Sub Base=120mm, ISG =200mm and more

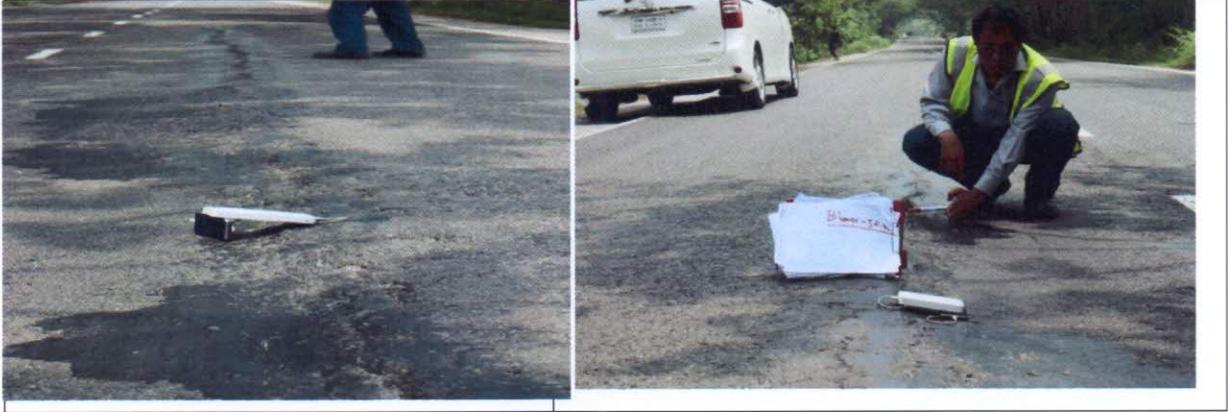
1. One side is settled by 75mm (5Km away from Bhanga)

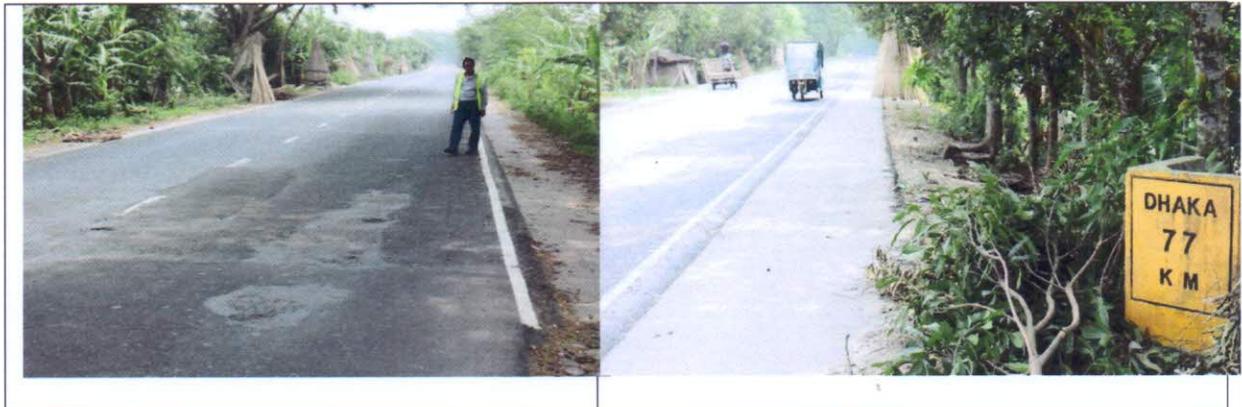
2. Structure approach settlement/damage

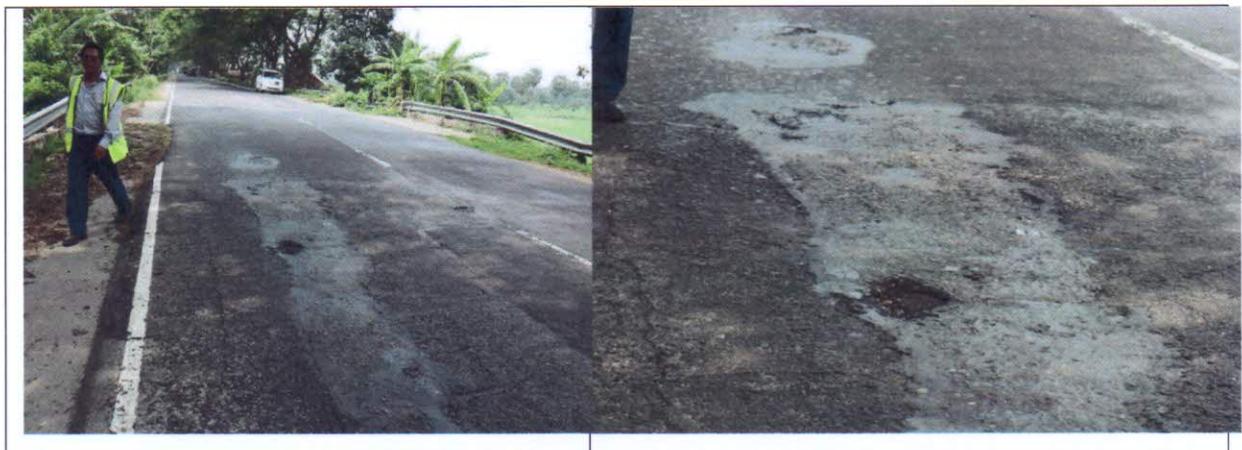
3. Settlement at culvert approach

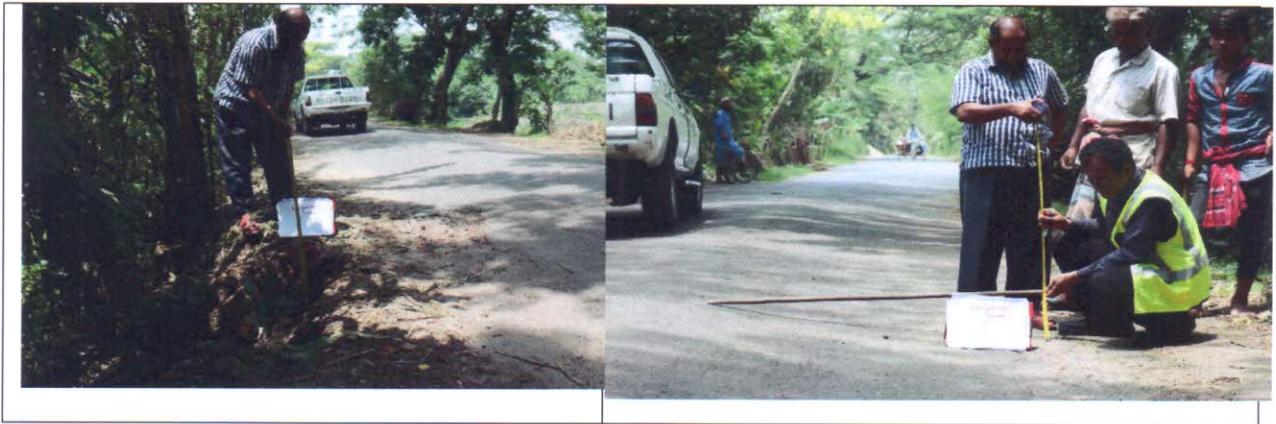
1. Depression of the road at some places are 200mm or more.

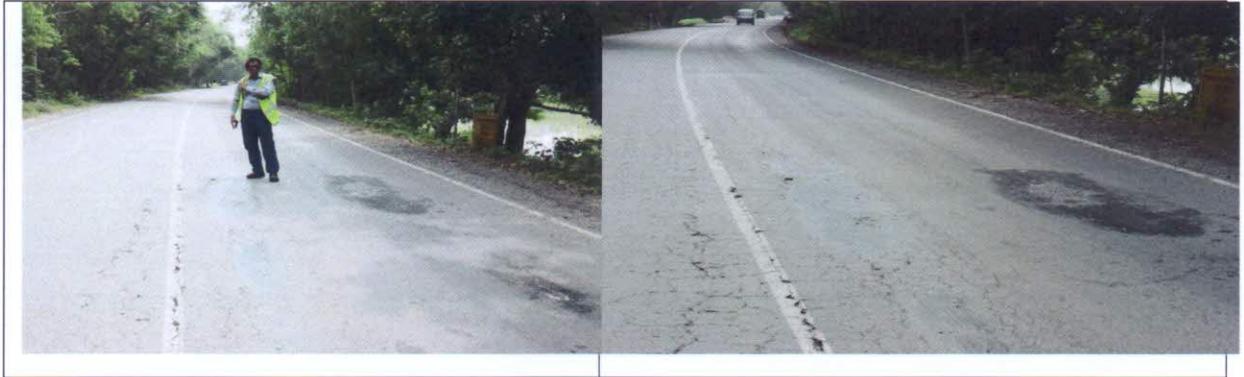
1. Crack/depression/damages at ch 20+00 to ch 55+00Km

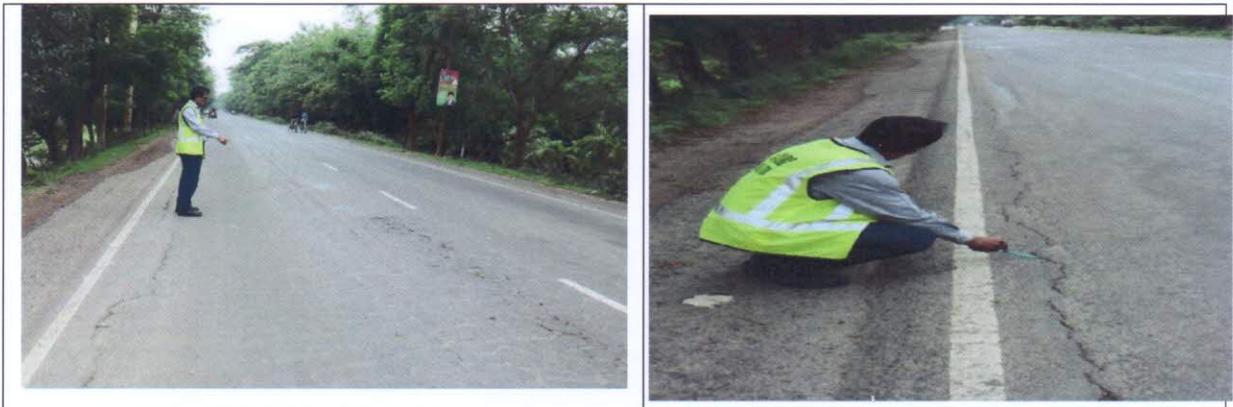
2. Longitudinal crack/carrigeway depression

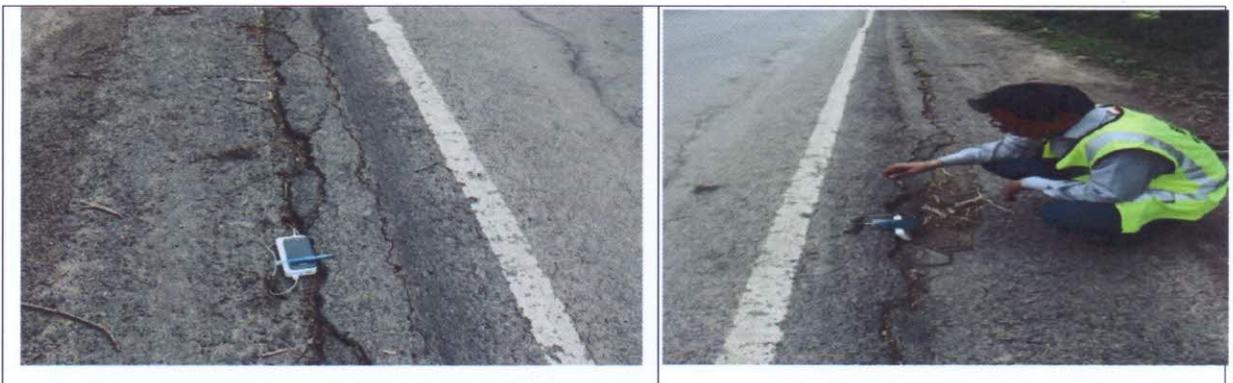
3. Shoulder settlement ranging 50mm to 75mm

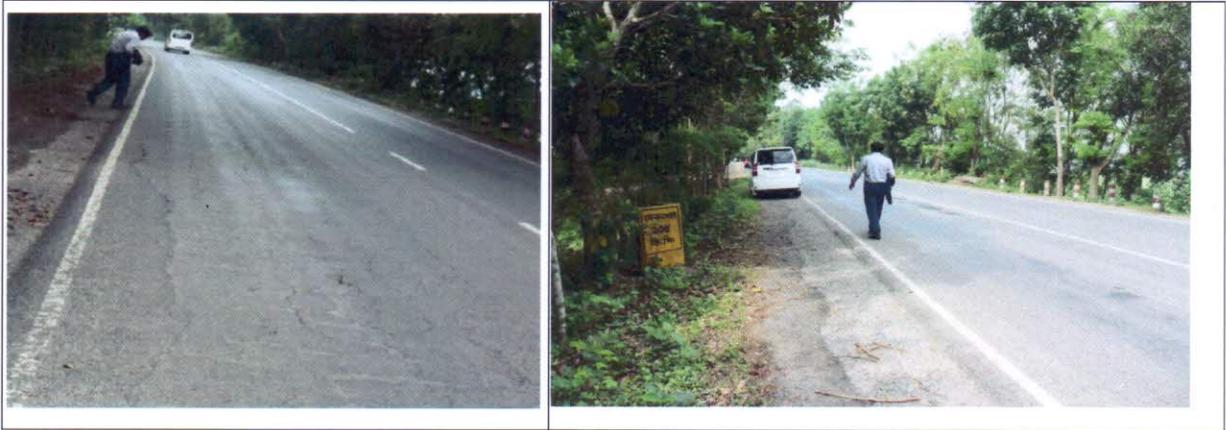
4. Settlement/Crack

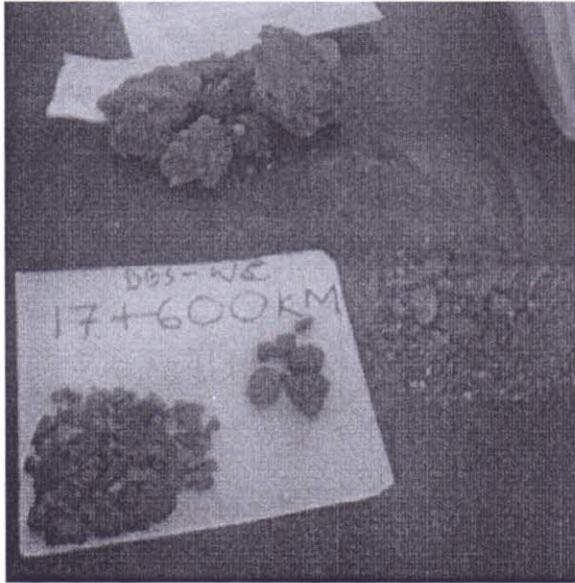
Photo 1(DBS-WC, retained on 5.00mm sieve)

Materials are of broken shingles (River born)

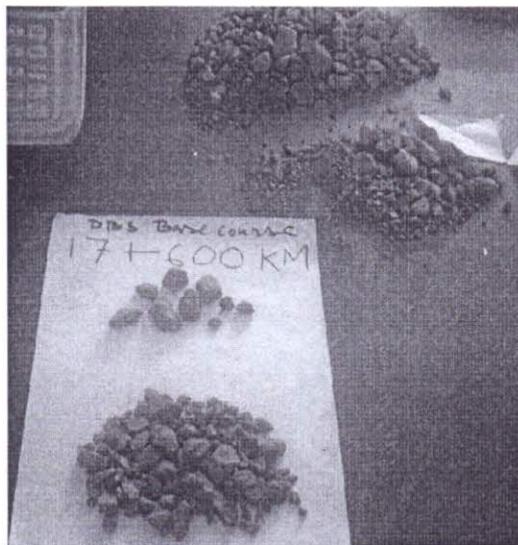
Photo 2(DBS base, retained on 5mm sieve)

Materials are of broken shingles (River born)

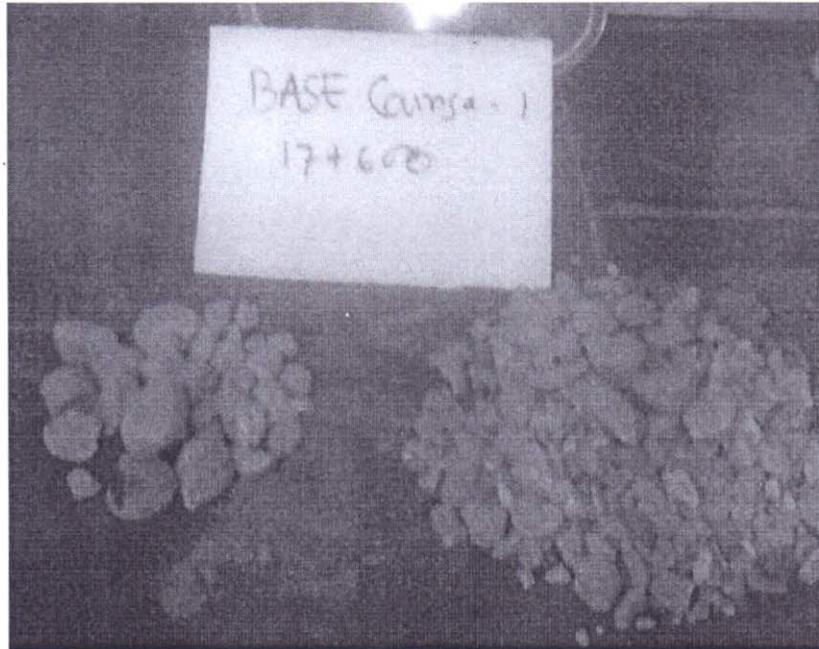
Photo 3(Base course Type-1, Retained on 5mm sieve)

Materials are of broken shingles (River born)

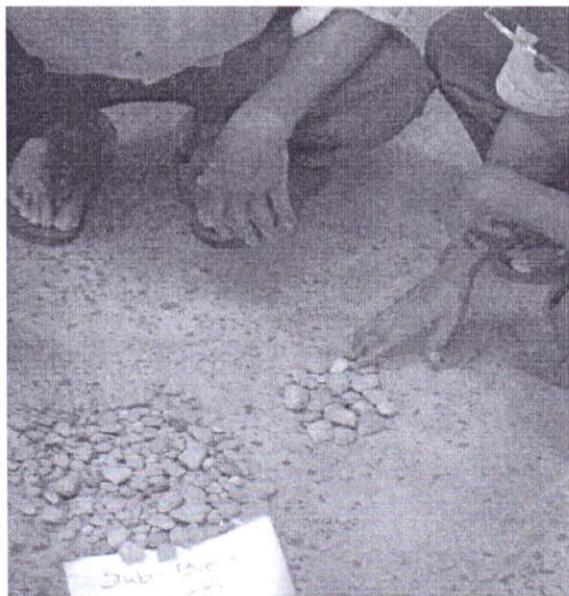
Photo 4(Sub Base, retained on 5mm sieve)

Materials are of broken shingles (River born)

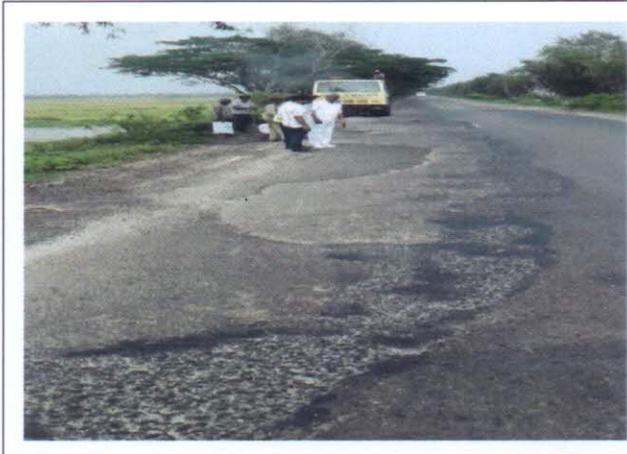
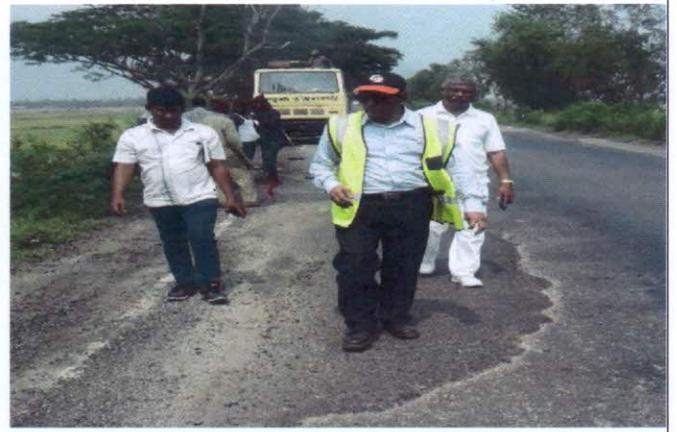
1. Damaged Pavement

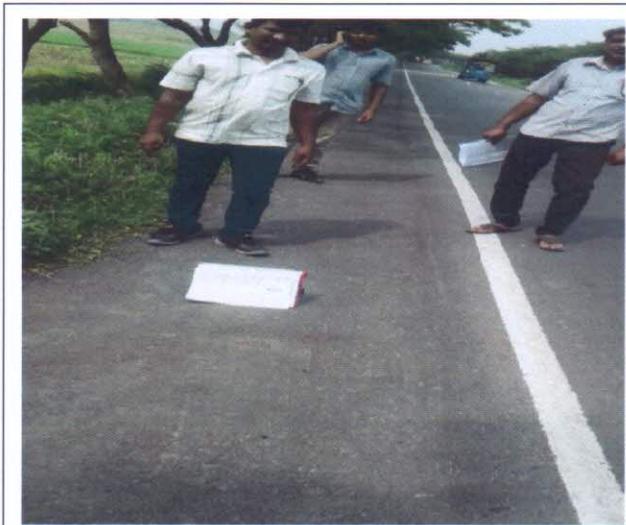
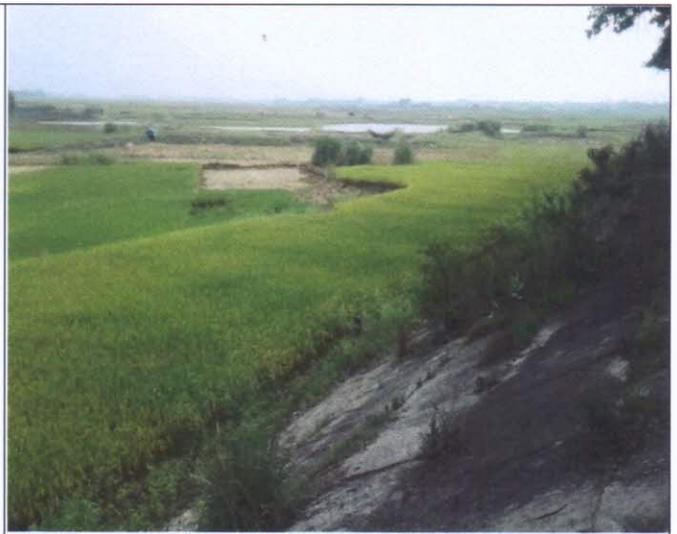
6. Marsh area

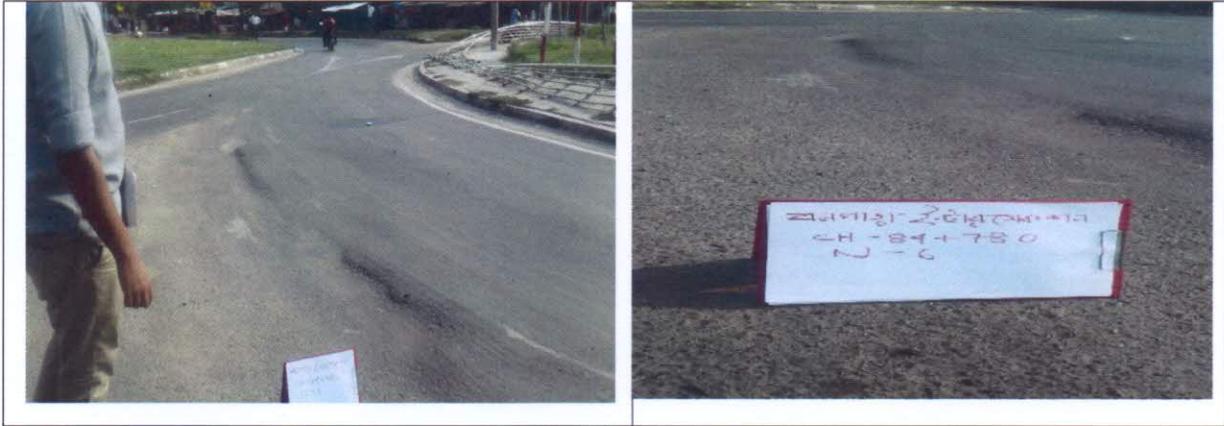
1. Heaving of asphalt material

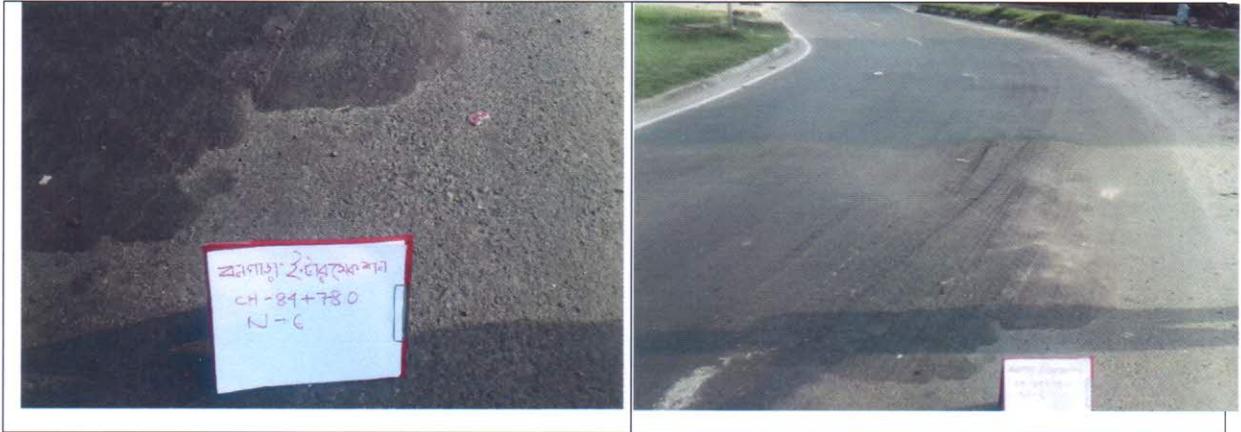
4. Bleeding

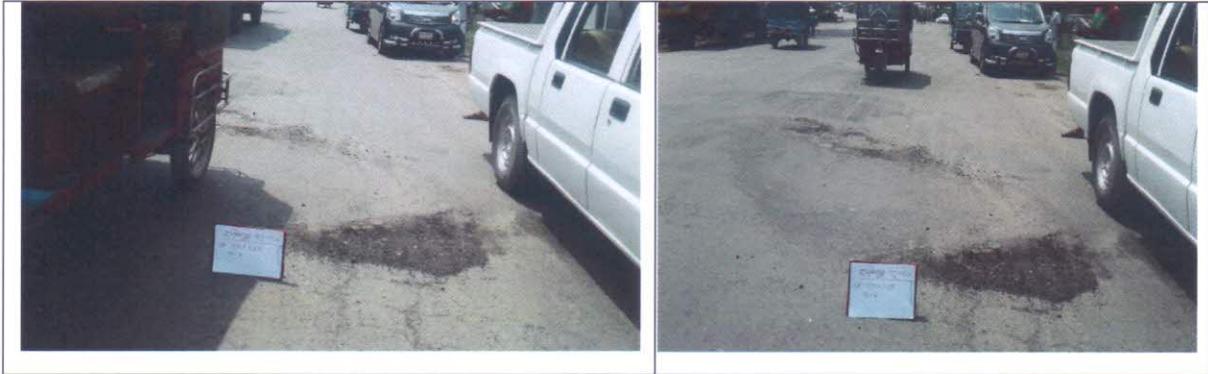
1. Damaged pavement

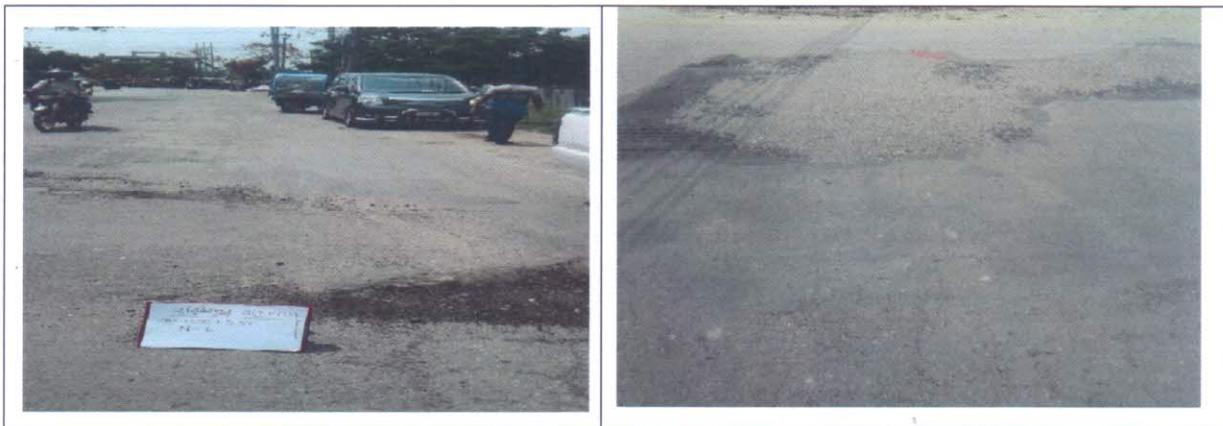
2. Damaged pavement

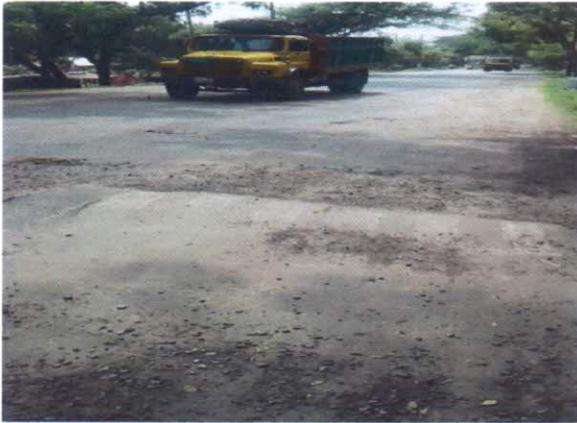
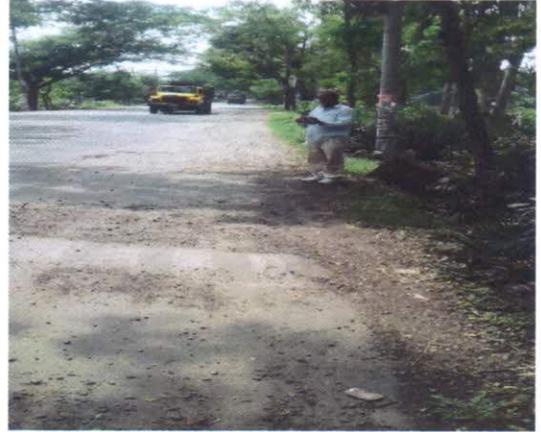
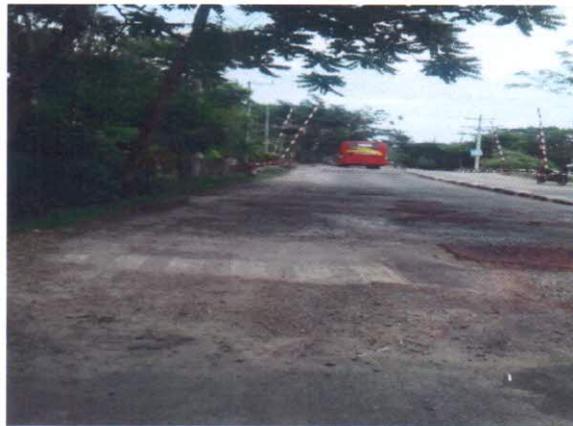
1. Damaged Pavement

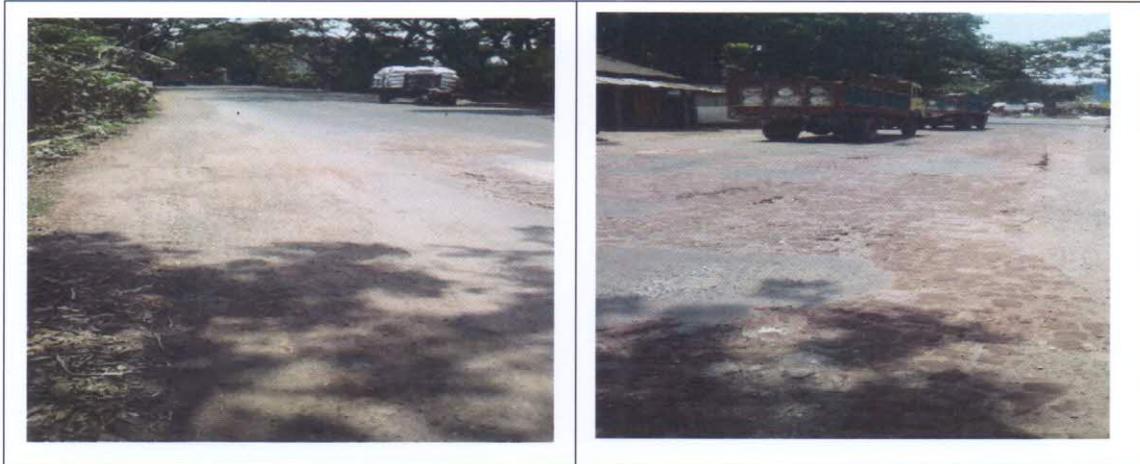
1. Damaged Pavement

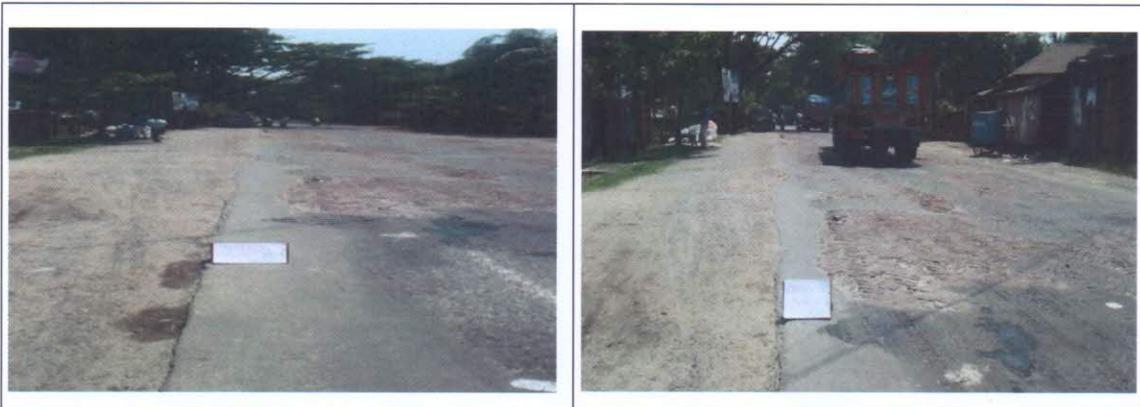
3. Damaged Pavement

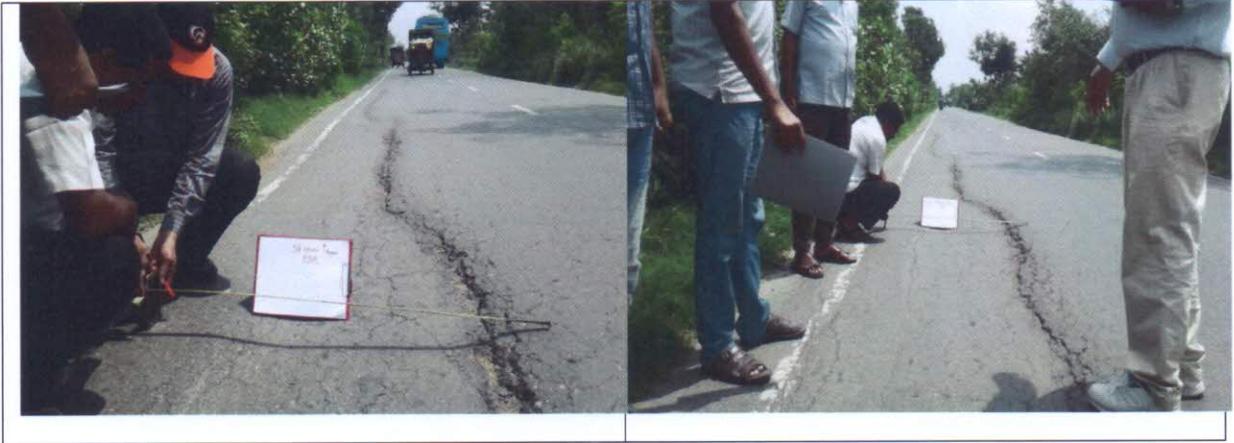
1. At chainage 38+000 , Settlement by 150mm

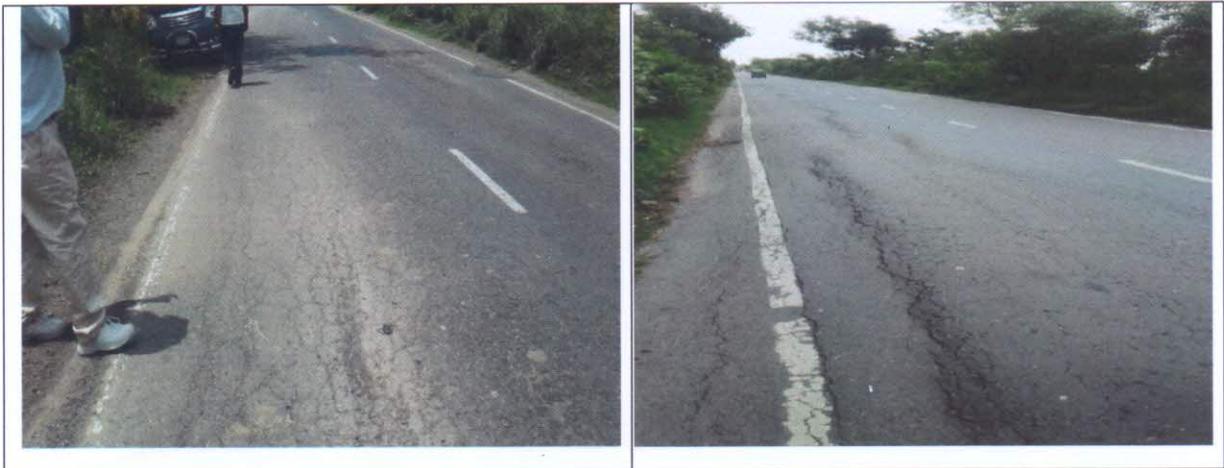
2. Crack on surface

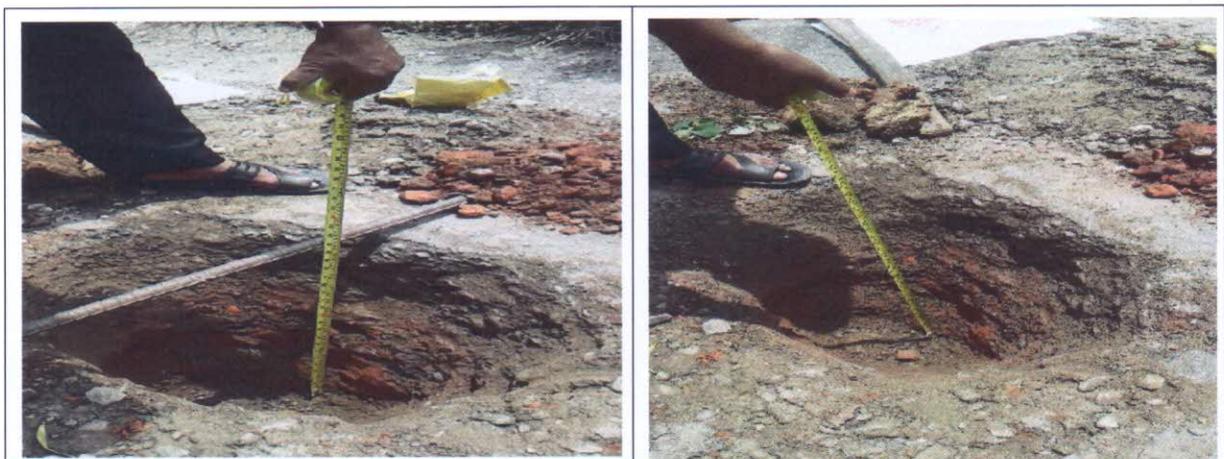
3. BC=50mm, Base-1=150mm, Macadam=275mm, Subgrade=Soil

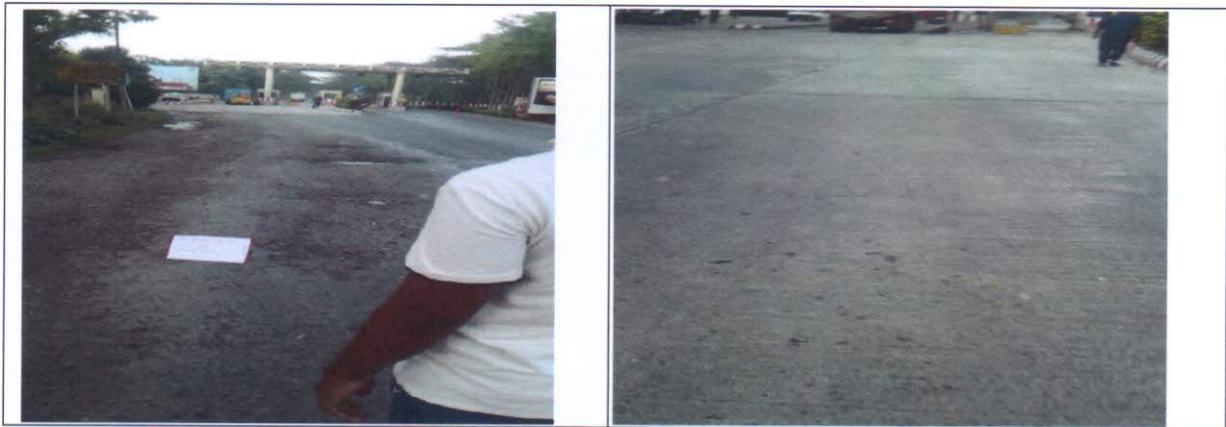
2. Damaged area and partially rigid pavement

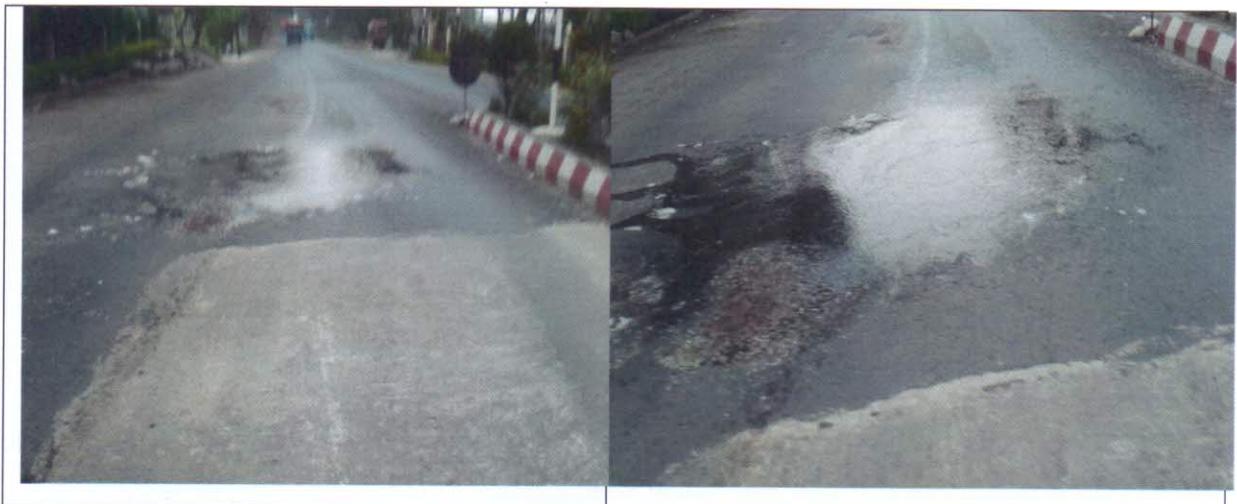
3. Water dripping from fish carrying vehicle

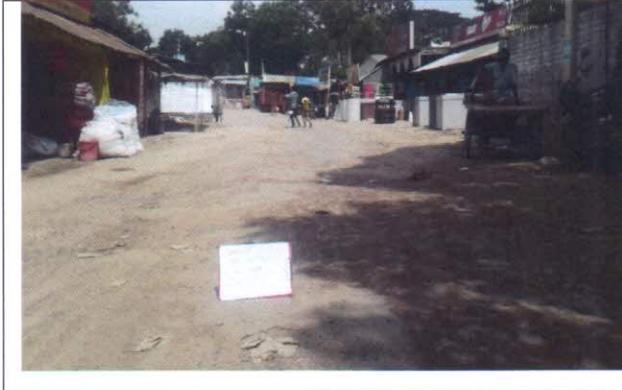
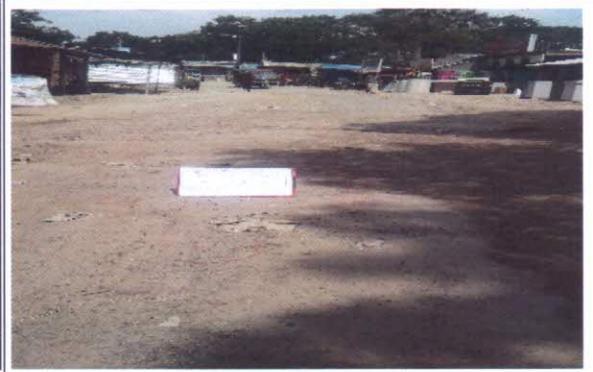
1. Low lying road

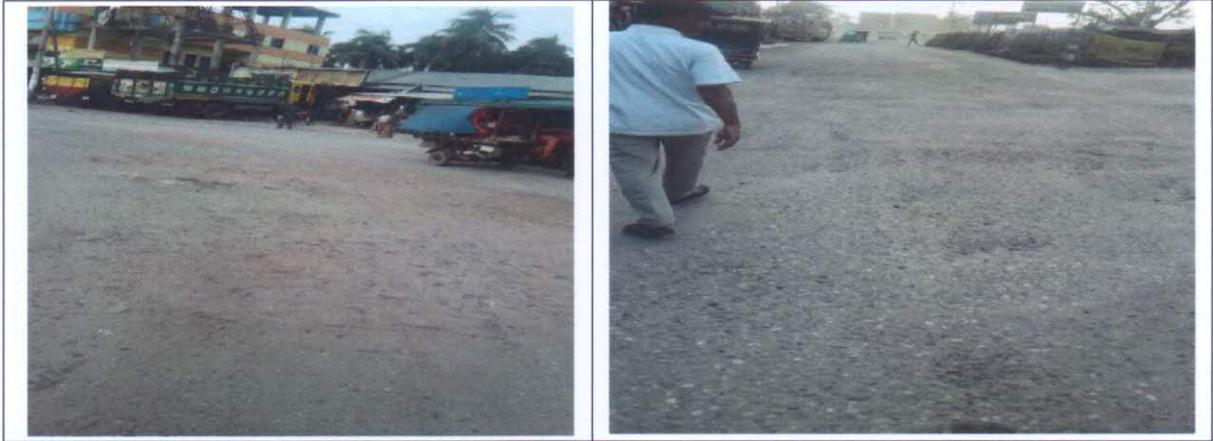
1. Damaged Pavement at ch 62+000
