**Roads and Highways Department (RHD)
Bangladesh Road Research Laboratory (BRRL)**

**Final Report
on
Failure investigation, Design correction, Data collection,
Research resource collection etc under BRRL during the
year 2016-2017**

June, 2017

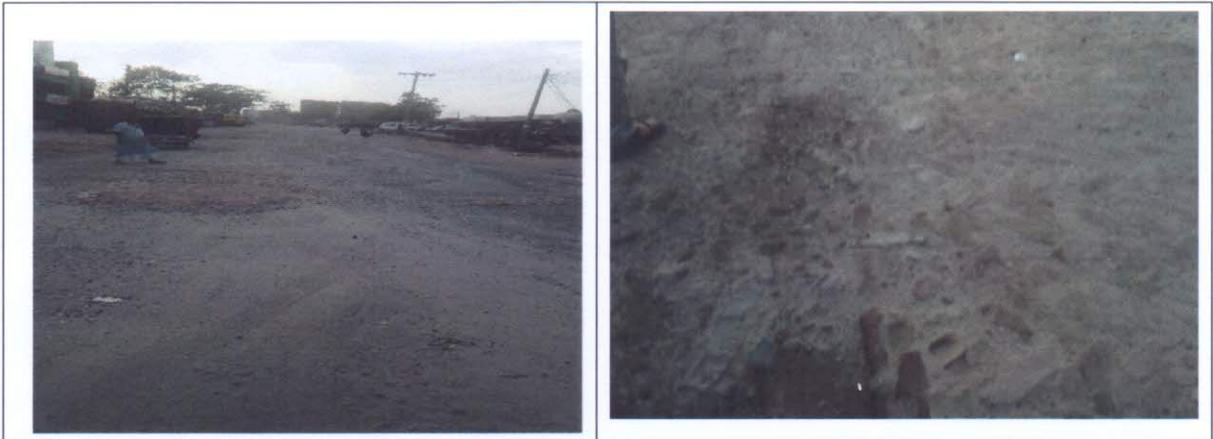
2. Damage repaired by HBB

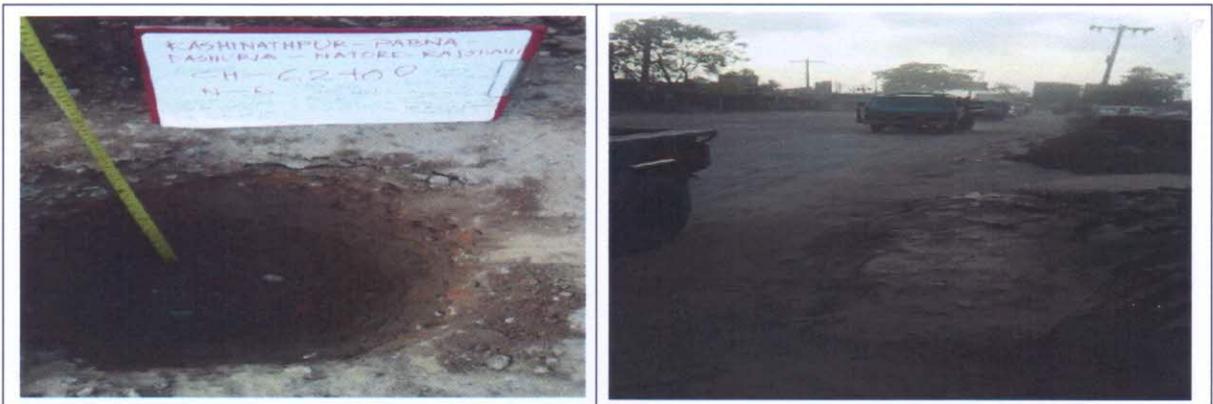
3. Damaged Pavement
