Road Safety Audit Report

Road Name: Bhanga-Bhatiapara-Mollahhat-
Fakirhat- Noapara National Highway (N805)
Audited Length: 111 Km

**Road Safety Division
Road Design and Safety Circle
Elenbari, Tejgaon , Dhaka**

May, 2019

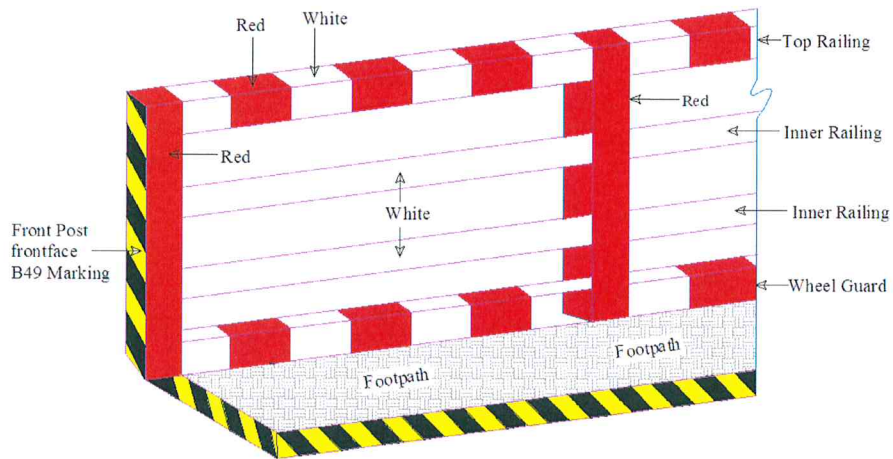
Figure 04d: Typical Safety Measures at Bridge Railing End

Problem: Almost all bridges on this Highway is found without any types of Road Marking. Some bridges seem freshly painted but none of them are reflective. Some of the bridge approaches are without proper delineation/ guide post and other safety barriers. At the chainage of 101+ 500 two consecutive bridges were found to be more hazourdous due to lack of proper safety measures.

Recommendation: Bridge approaches should have adequate safety measures though installation of guide post and/or crush barrier, especially in high embankment. Moreover, the entry post of the bridge railing should have appropriate hazard marking to improve conspicuity of railing at night. *No Overtaking Sign* along with marking is mandatory of such bridges and approaches.

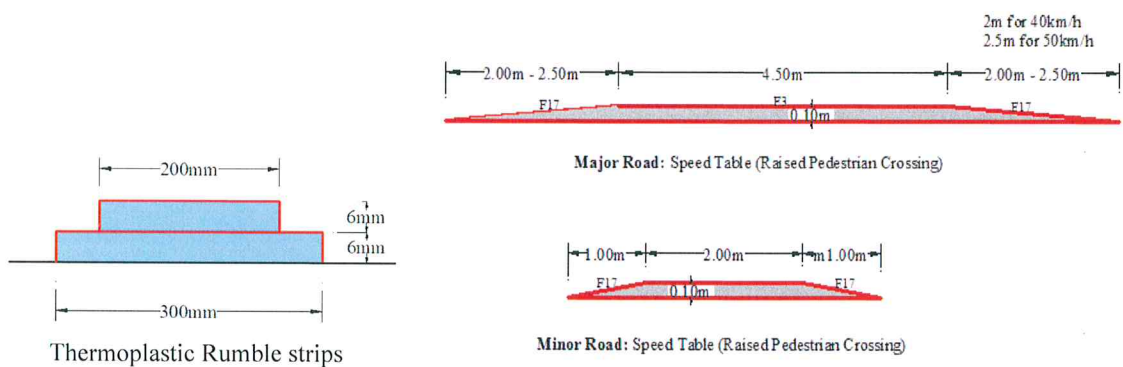
Figure 05b: Typical Design for Speed Table and Thermoplastic Rumble strips

Problem: Numerous speed breakers are found in different locations throughout the N805 which are unspecified and are creating stress to the drivers.

Recommendation: Any unauthorized speed breaker should be dismantled. Speed hump or table can be installed, depending on speed limit. Speed table can be installed with raised pedestrian crossing (if pedestrian crossing needed) with sets of rumble strips ahead of such speed reducer with appropriate traffic sign and marking.

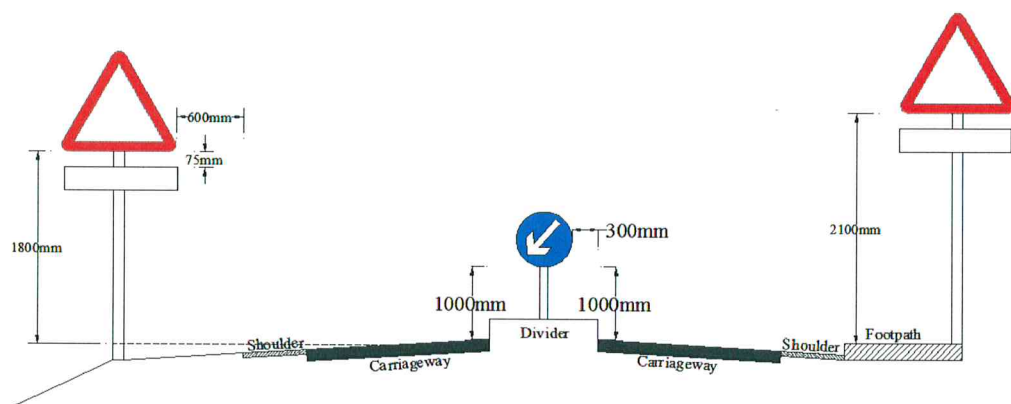
Figure 06d: Typical Road Section with proper Sign

Problem: At some chainage the road Markings and traffic signs are found to be unspecified in their dimensions and at some chainage they are found to be incorrect. Adequate *chevron sign* is not given on sharp bend. *No Overtaking Sign* is used in the road, but a *Broken White Center Line* is given instead of *Continuous White Line* which is improper and dangerous. Some identical unspecified speed limit is provided but speed restriction end signs are totally absent. Shoulder and the carriage way are not at the same level which makes the road more susceptible to road crush.

Recommendation: Road sign size shape and placing should conform the traffic sign manual. To fix the speed limit of any road segment, it should be appropriate as per traffic sign manual, shown in Paragraph E2.3. After imposing appropriate speed limit of any area, speed restriction end sign also needs to be placed at the end. To have better visibility at night, Signs should be retroreflective, therefore it should be diamond grade as per traffic sign manual. Road marking, particularly at sharp bend, it should have continuous center line with chevron marking on the outer side of the road at certain intervals. Any obstructed vegetation needs to be cleared at inner side of the curve. Shoulder drop is dangerous and therefore needs to be same level with the main carriageway.

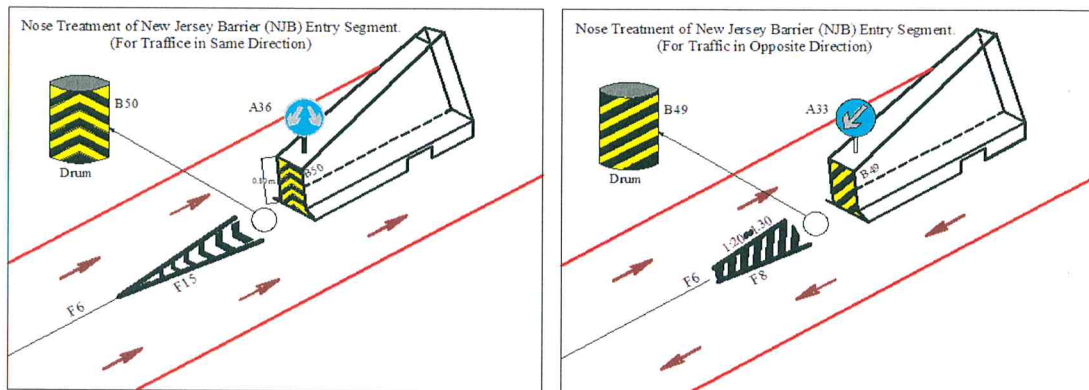
Figure 09b: Typical design of well Treated Nose

Problem: Almost every nose of road divider is quite tough to get noticeable to the driver. The absence of delineator, road marking with reflective paint is almost common scenario at various divider noses, which had been damaged due to vehicle collision, as perceived.

Recommendation: Proper end protection of concrete median is needed to protect the barrier from impact. Moreover it is very important to aware the drivers of such hazard well ahead by providing appropriate Traffic Sign and Rumble Strips. By providing the appropriate *Hazard Marking* with Sand Cushion Drum is also needed to protect the Nose of such medians.
