REPORT ON
DETAILED
ROAD SAFETY AUDIT
OF FIVE ROAD SECTIONS
(500 KM)

ROAD SAFETY AUDIT REPORT FY 2017-2018

Road Design & Safety Circle
Roads & Highways Department
Government of the People's Republic of Bangladesh
SARM Associates and HeptaTech Limited JV

Detailed Road Safety Audit of Road Sections of Joydebpur – Mymensingh (N3), Kanchpur- Daudkandi (N1) and Chattogram – Cox's Bazar (N1), Kashinathpur – Rajshahi (N6) and Dhaka – Aricha (N5) (Total 500 km) National Highway During FY 2017 -2018

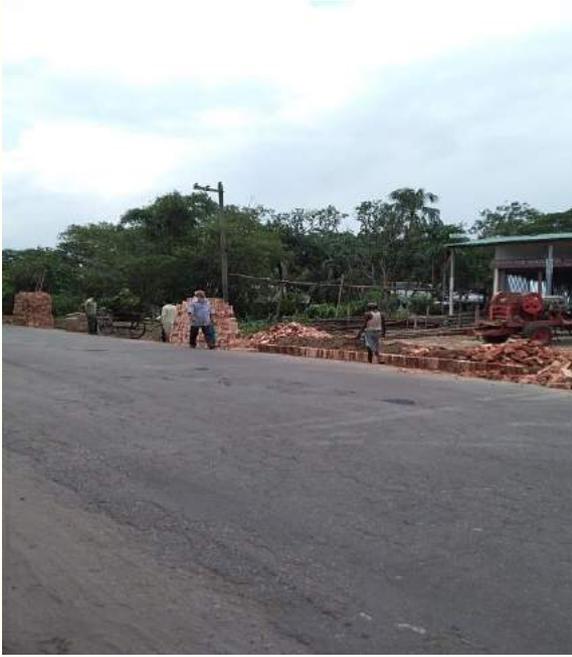
Illegal roadside activity within Ch.+ 252.5 to Ch.+255

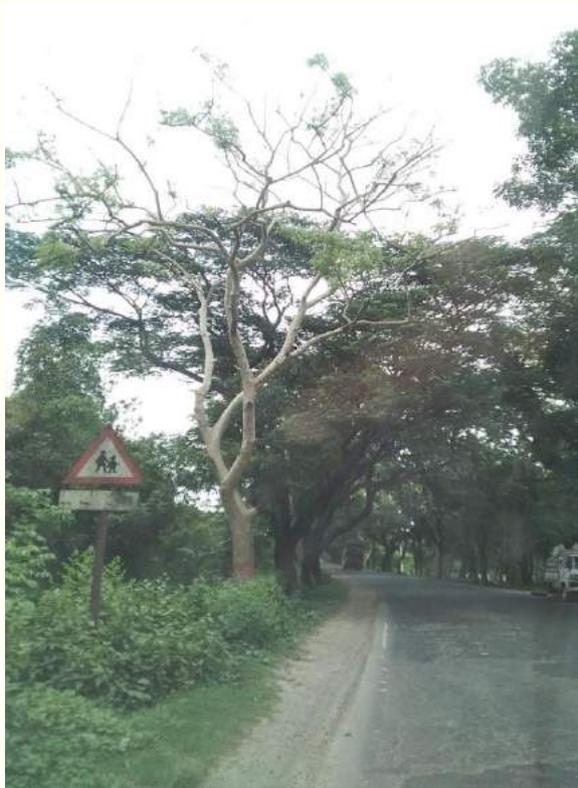
Road sign within Ch.+255 to Ch.+257 is not clear

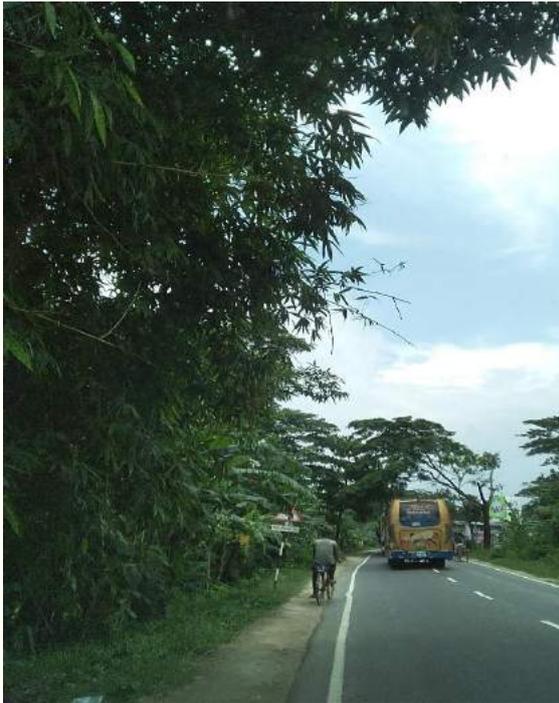
Poor visibility of road sign within Ch.+257 to Ch.+259

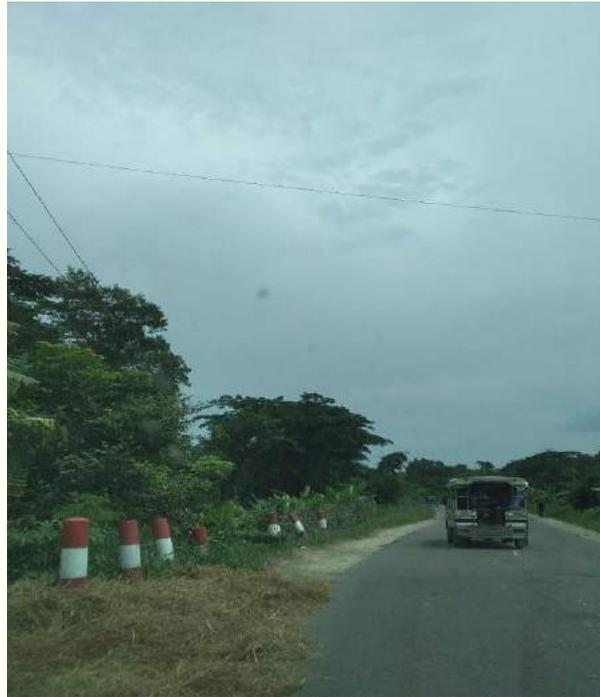
Unauthorized roadside activity within Ch.+ 259 to Ch.+261

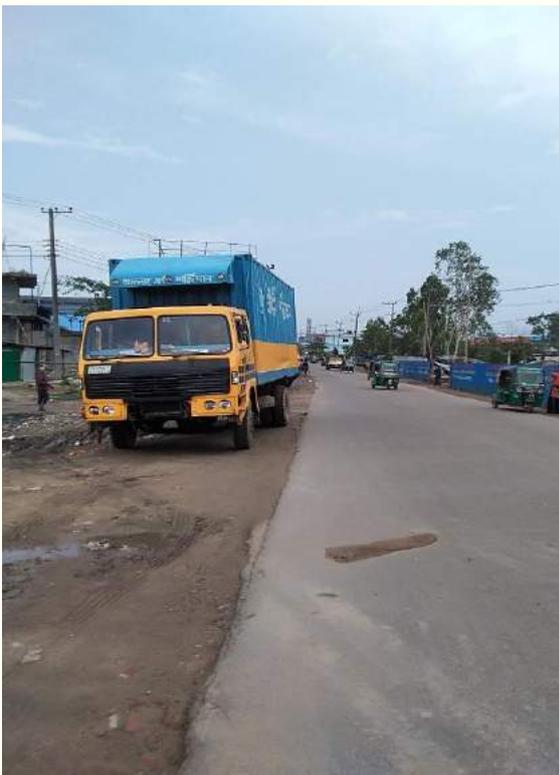
Unauthorized risky parking and shoulder drop within Ch.+ 261 to Ch.+263

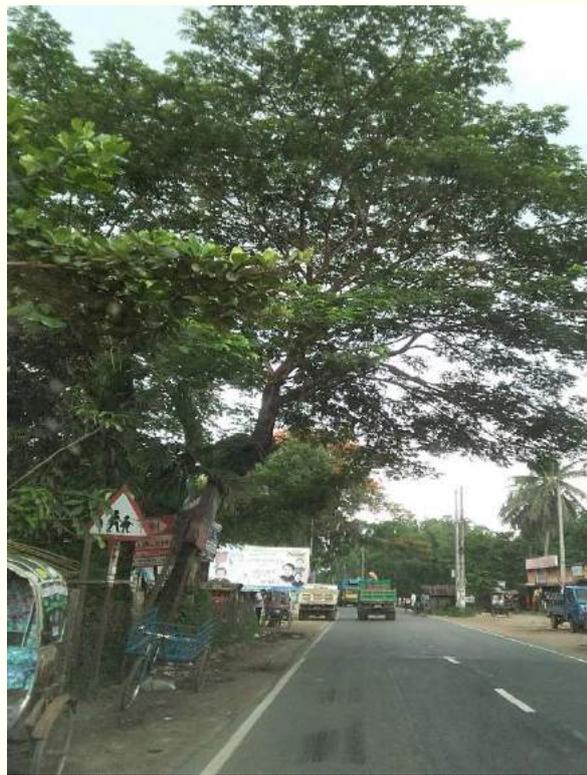
Disturbed road sign at Ch.+ 265 to Ch.+267

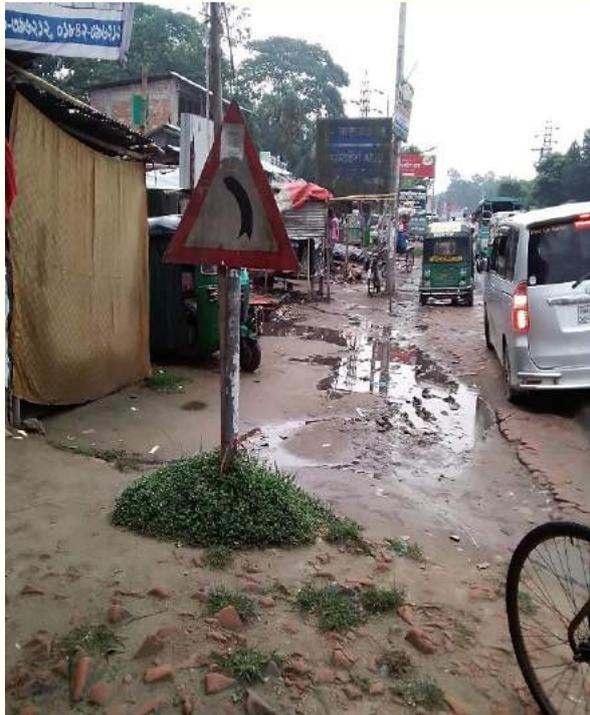
Unknown road sign at Ch.+274.5 to Ch.+276.5

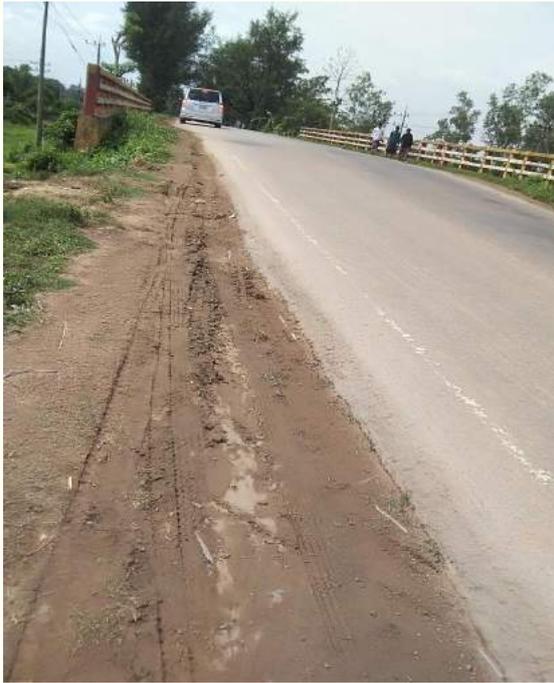
No warning sign and marking across the bridge within.Ch.+287 to Ch.+289

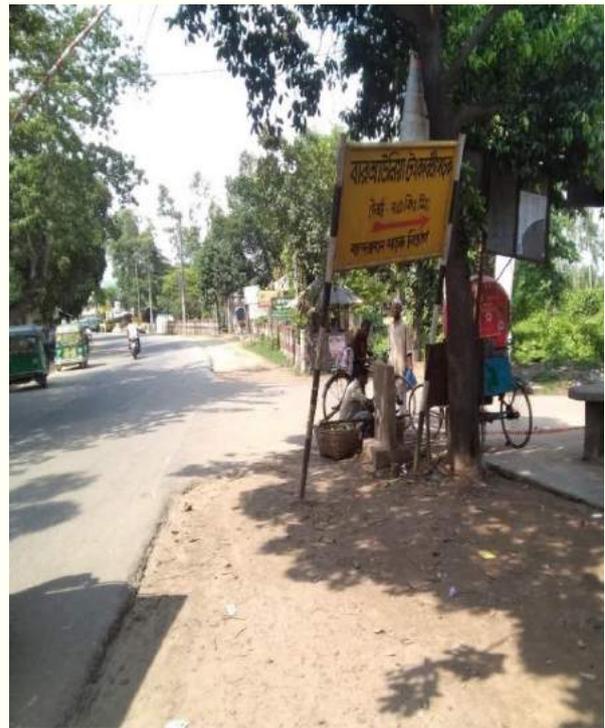
Unknown road sign within clear zone at Ch.+ 297 to Ch.+299

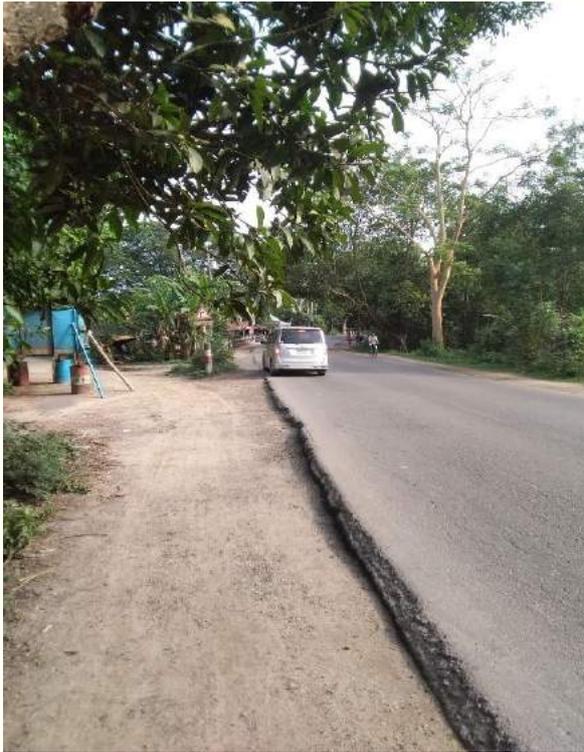
Risky shoulder drop at Ch.+299 to Ch.+301

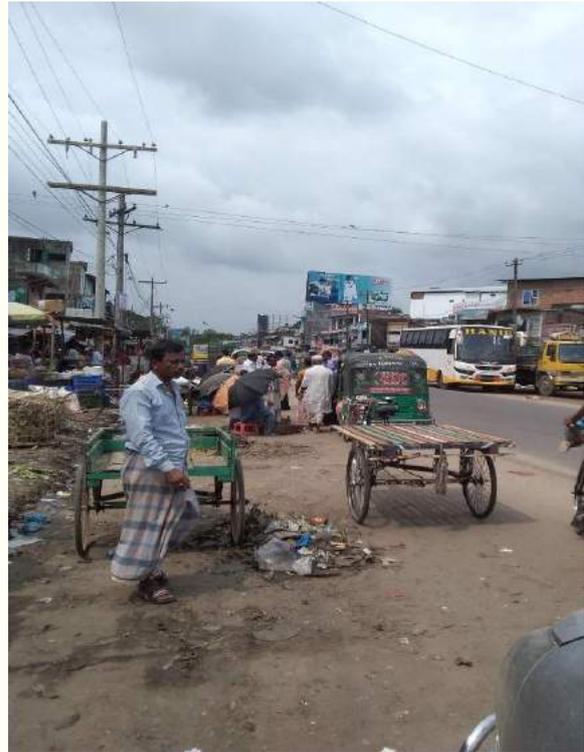
Unauthorized roadside business within Ch.+ 301 to Ch.+303

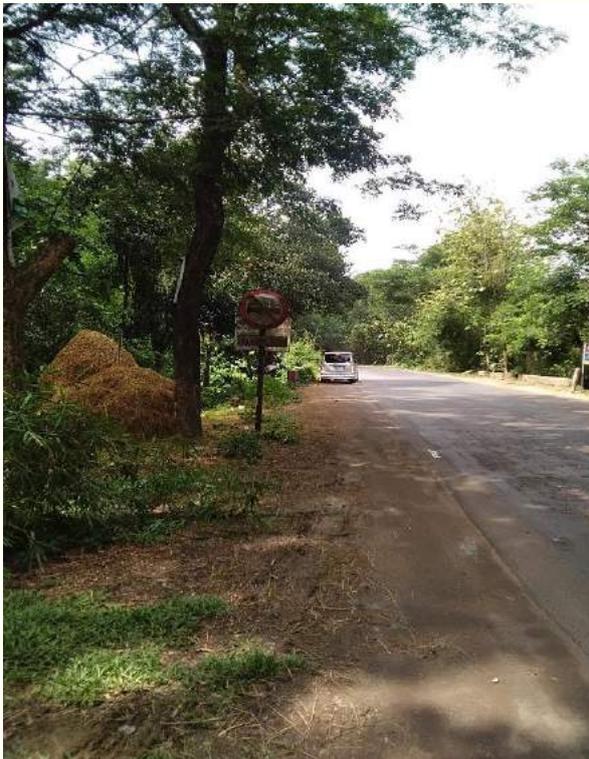
Less visible road sign at Ch.+311 to Ch.+313

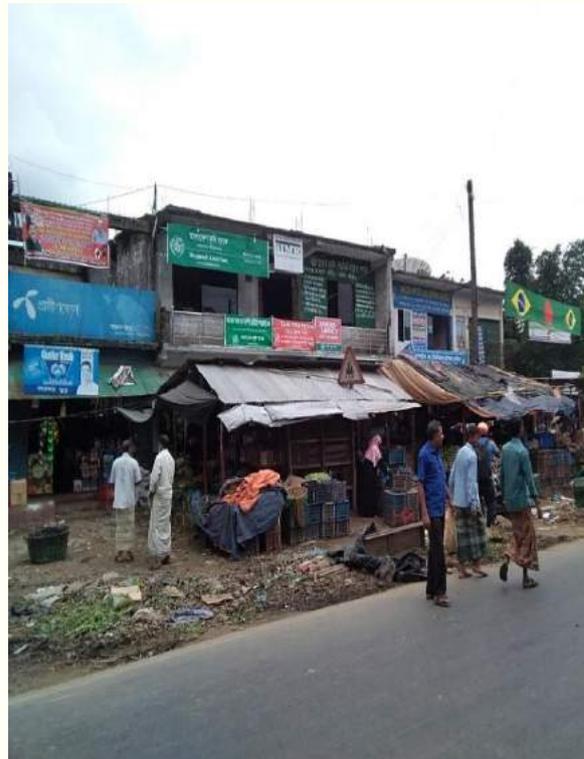
Roadside business in shoulder within Ch.+321 to Ch.+323

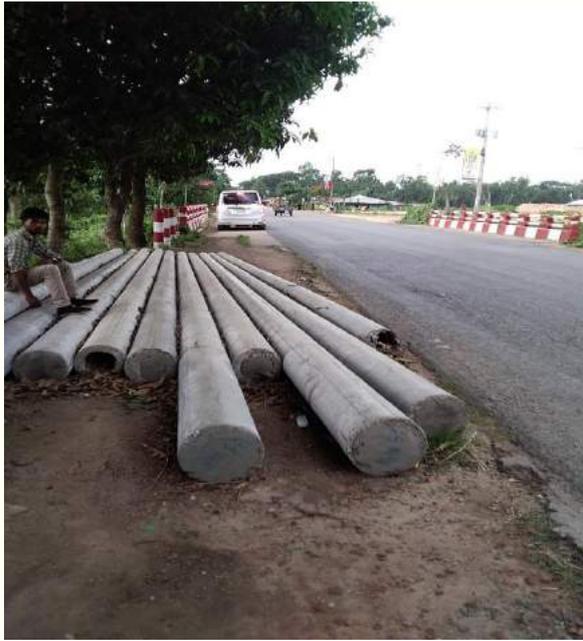
Risky concrete pole on shoulder within Ch.+323 to Ch.+325

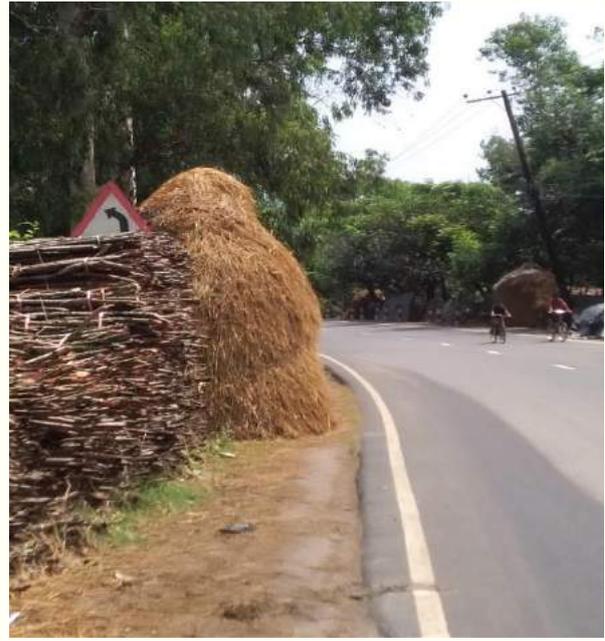
Sign covered by roadside business , creating serious obstruction within Ch.+329 to Ch.+331

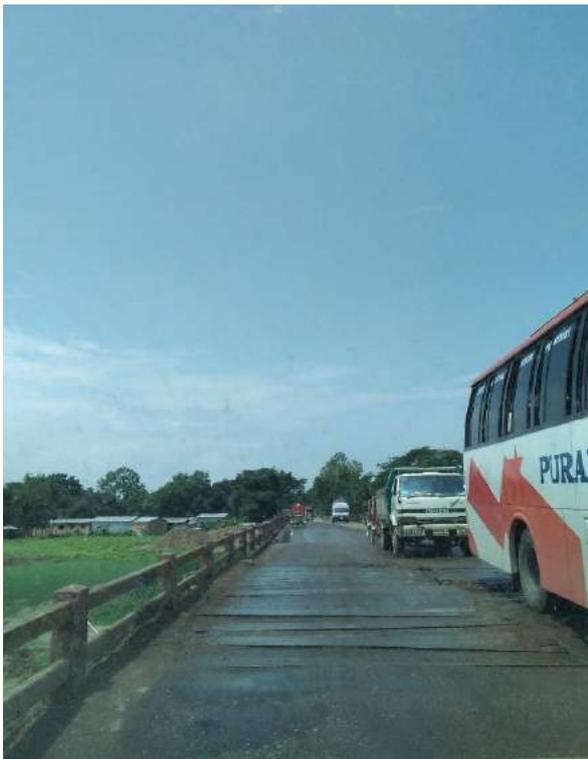
Bridge having no footpath and delineation at Ch.+ 331 to Ch.+333

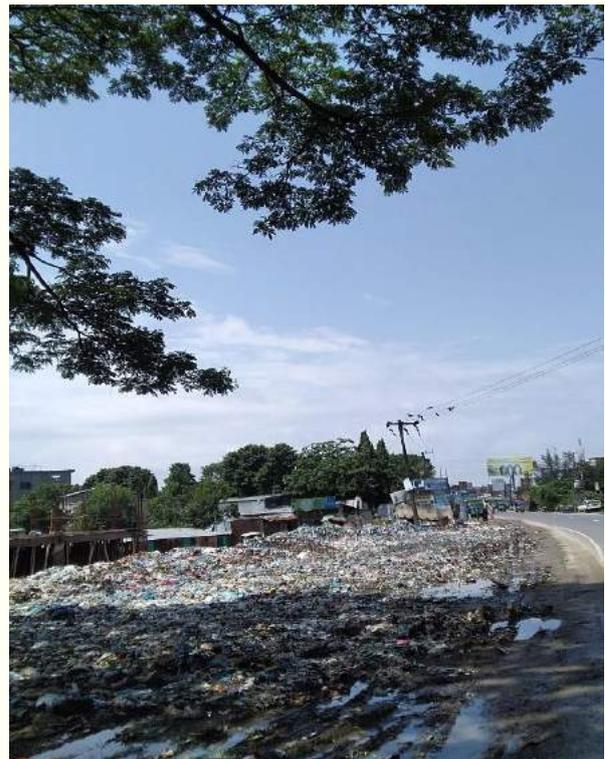
Unauthorized dumping within Ch.+331 to Ch.+333

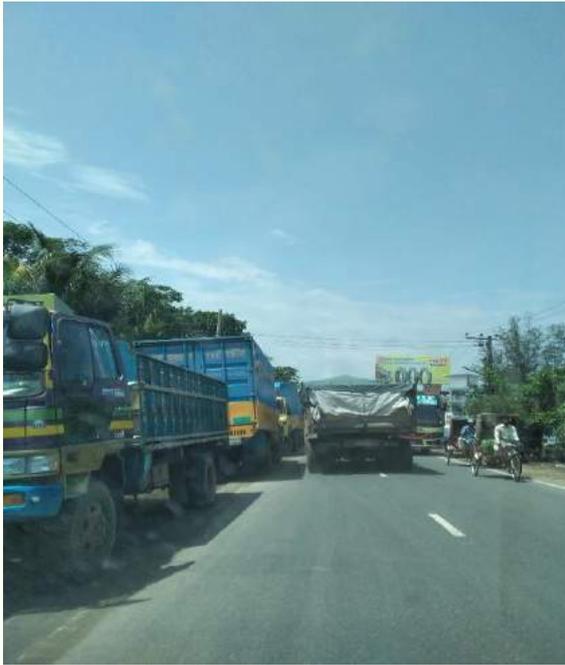
Illegal truck parking within Ch.+331 to Ch.+333

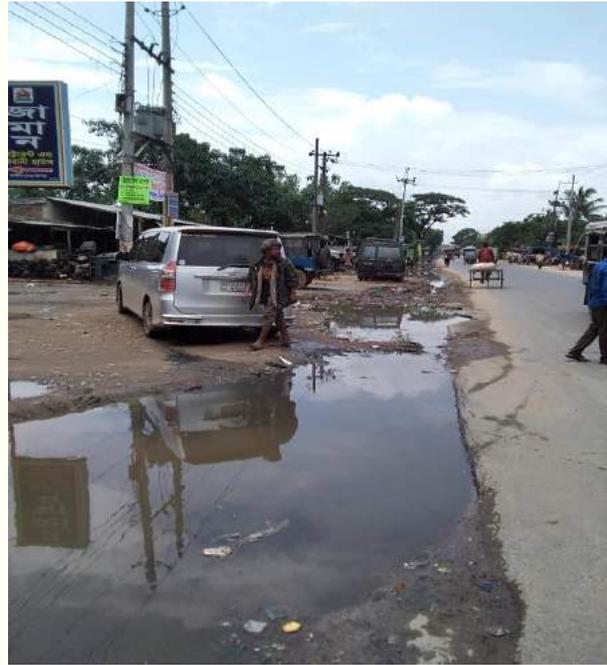
Water logging at Ch.+ 331 to Ch.+333

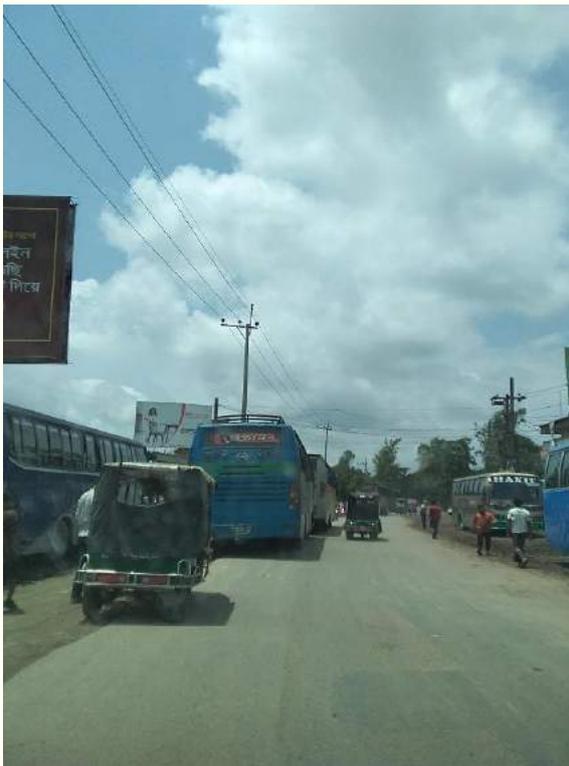
Bus parking within Ch.+333 to Ch.+335 in an illegal manner

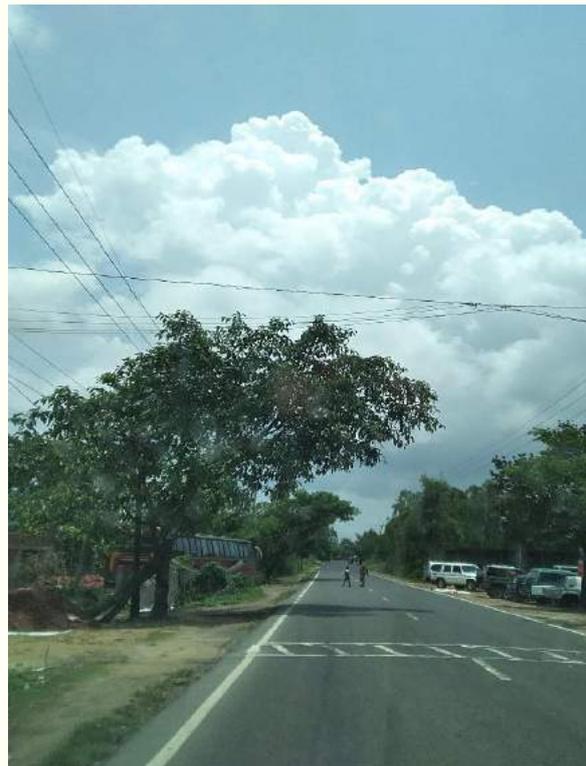
Below standard zebra crossing without speed calming arrangement within Ch.+ 335 to Ch.+337

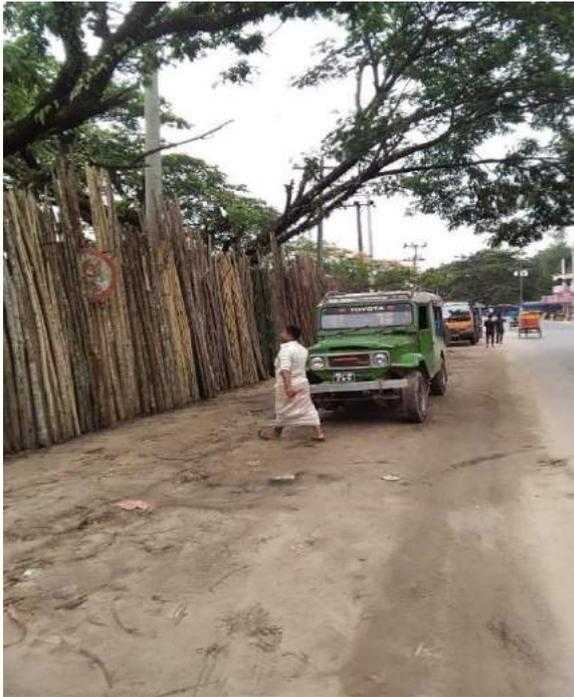
Blockage in the road side area by unauthorized business within Ch.+ 343 to Ch.+345

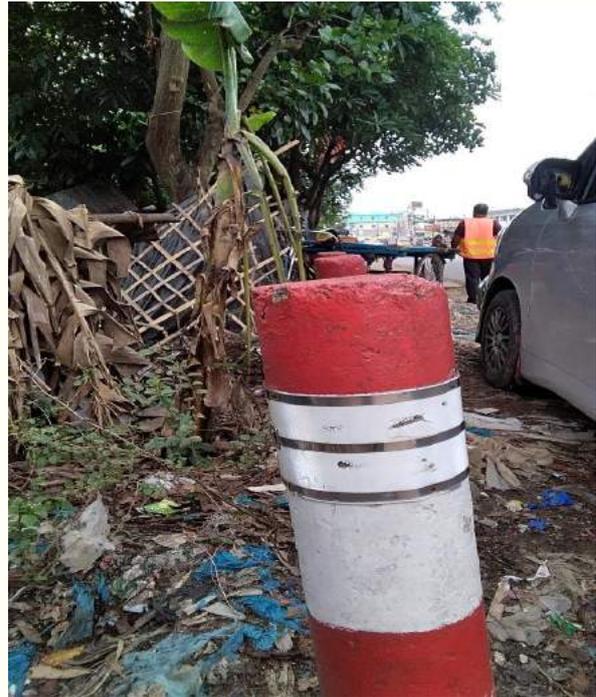
Disturbed concrete pole at Ch.+ 355 to Ch.+357

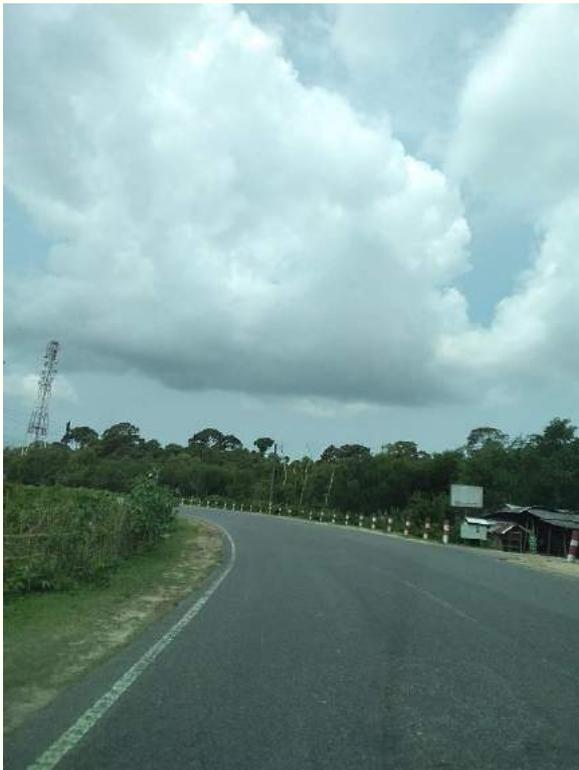
Curve section without chevron sign at Ch.+369 to Ch.+371

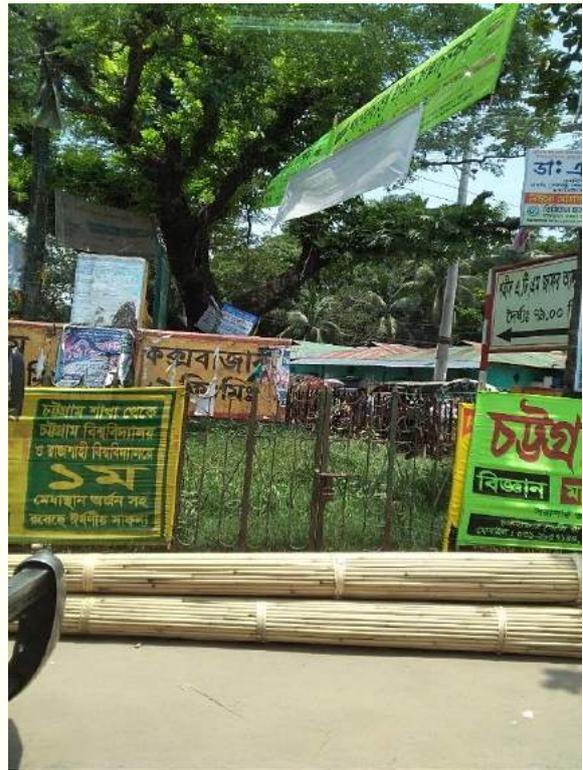
Number of banners in roadside area creating visibility obstruction within Ch.+ 381 to Ch.+383

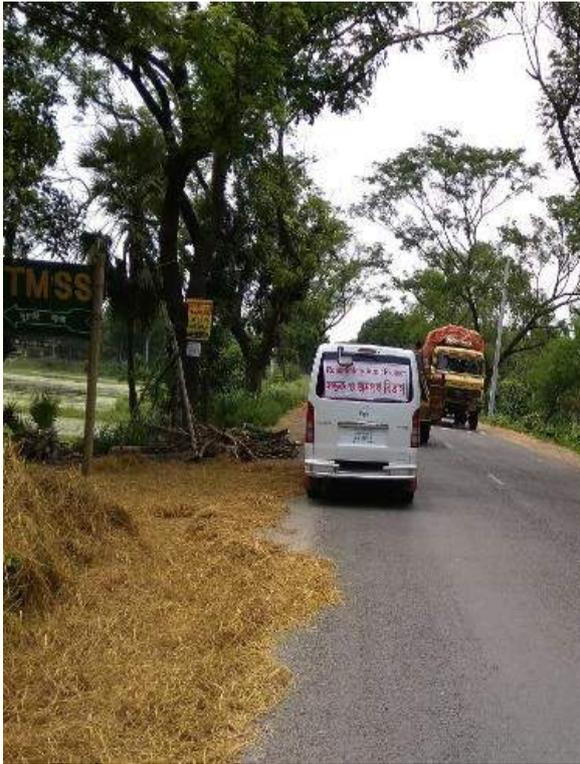
Unauthorized roadside activity within Ch.+8 to Ch.+10

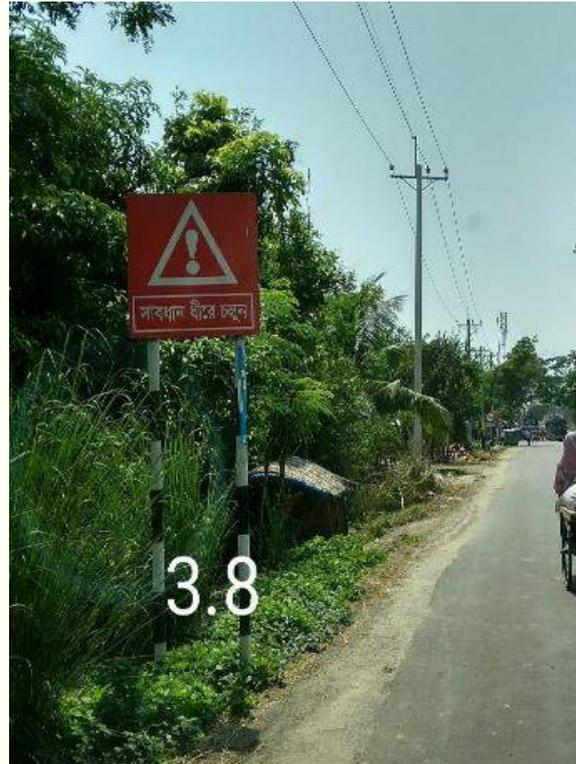
Warning sign post in shoulder within Ch.+10 to Ch.+12

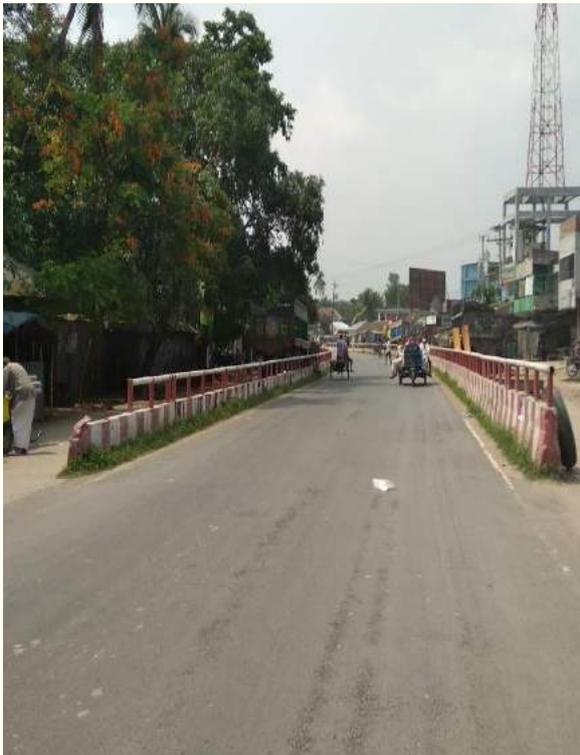
No marking and sign at barrier within Ch.16 to Ch.+18

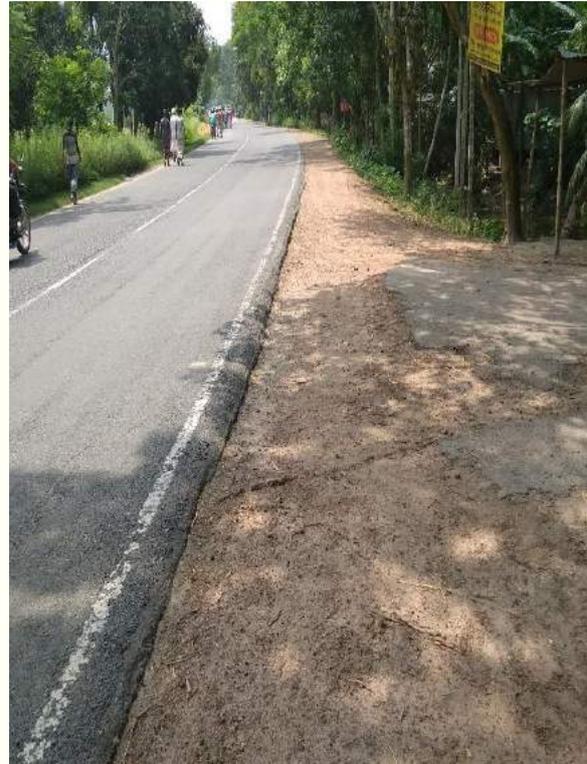
Lack of shoulder forcing pedestrian to walk on carriageway within Ch.+18 to Ch.+20

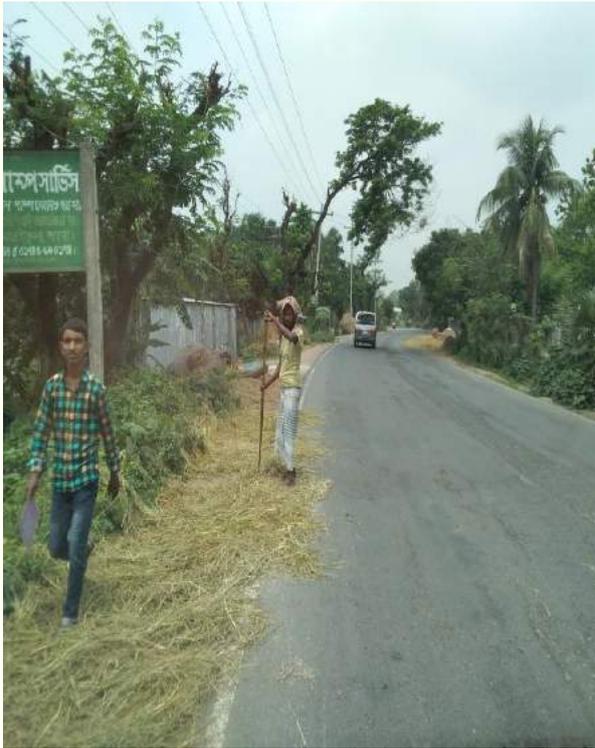
Illegal roadside activity within Ch.+ 22 to Ch.+24

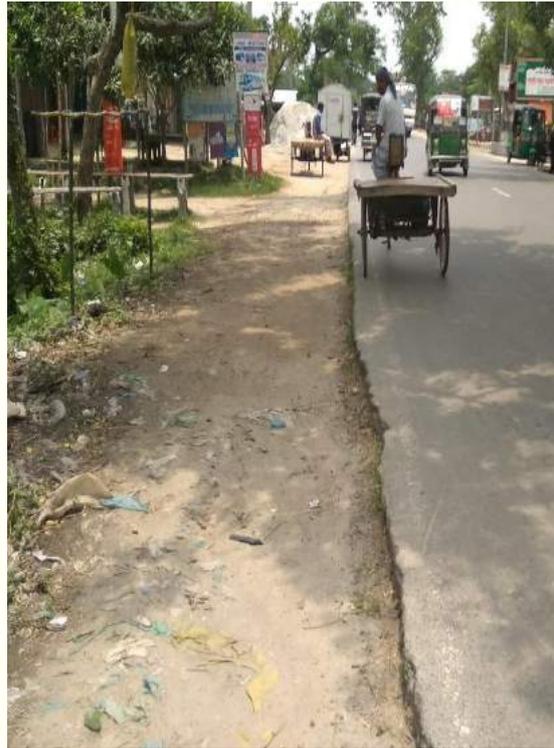
Risky shoulder drop within Ch.+26 to Ch.+28

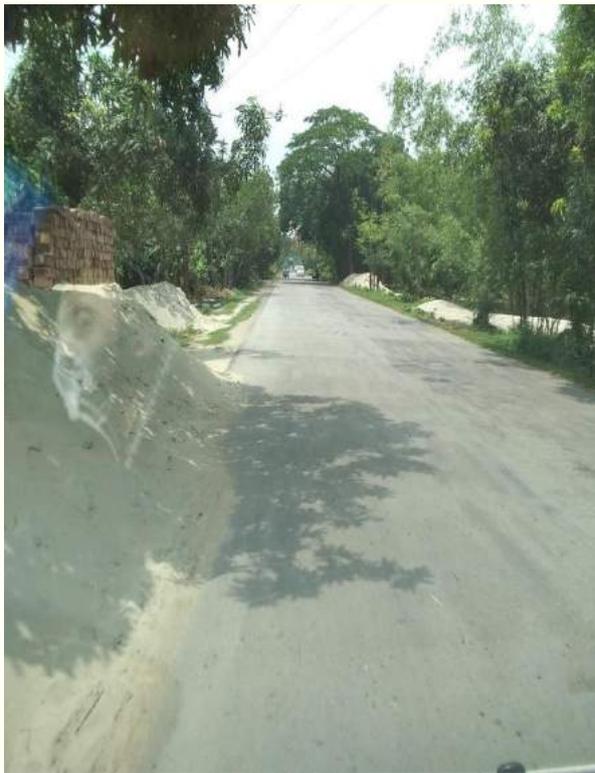
Construction materials over carriageway are kept illegally within within Ch.+28 to Ch.+30

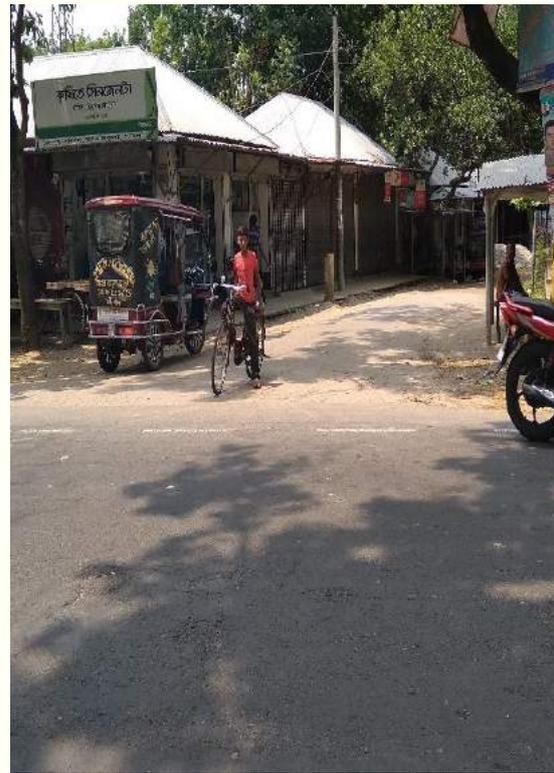
Side road without proper treatment within Ch.+ 30 to Ch.+32

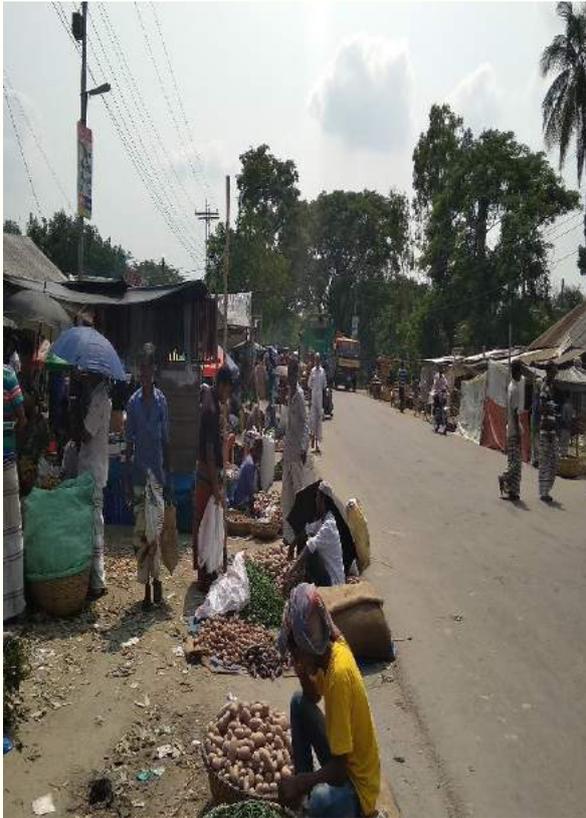
Unauthorized roadside business within Ch.+ 32 to Ch.+34

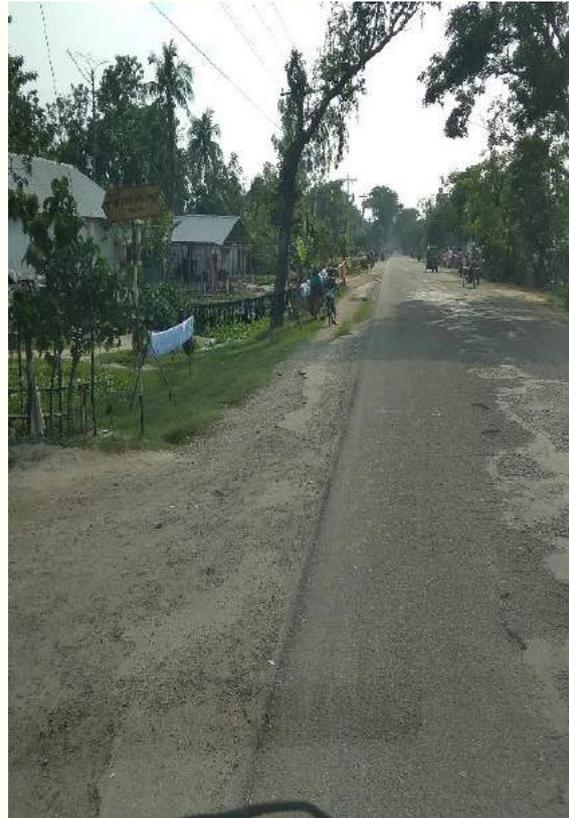
Poor pavement and shoulder within Ch.+36 to Ch.+38

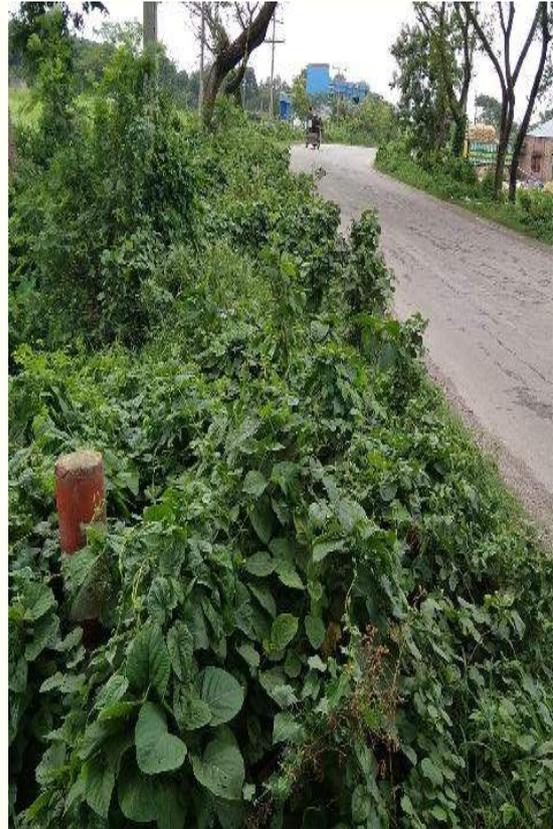
Roadside bushes within Ch.+58 to Ch.+60

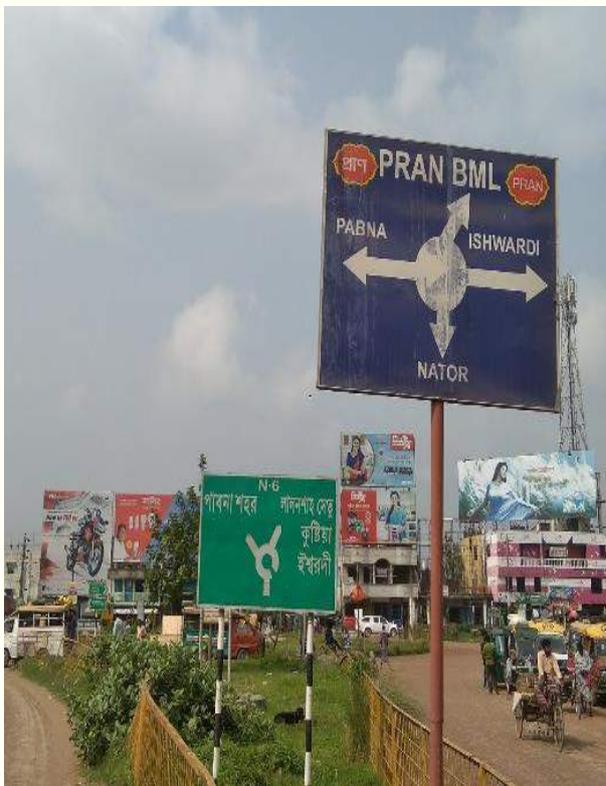
Confusing sign within Ch.+ 60 to Ch.+62

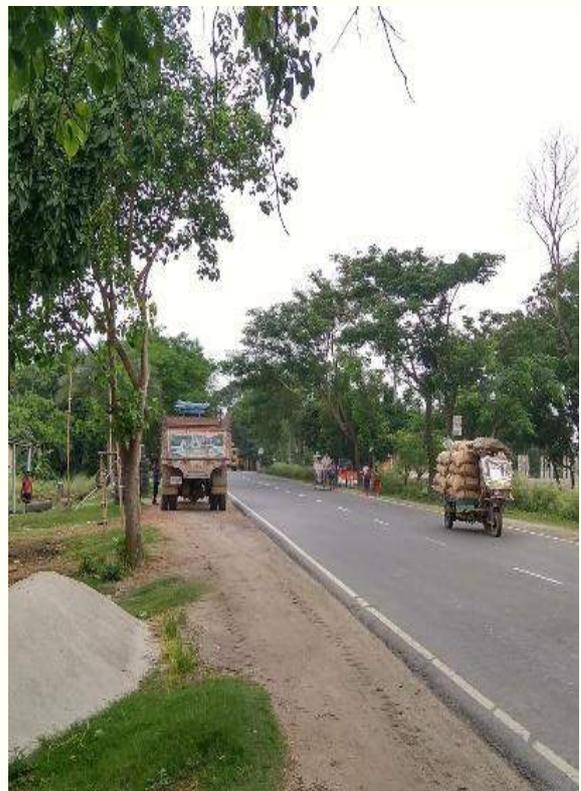
Unauthorized roadside parking within Ch.+72 to Ch.+74

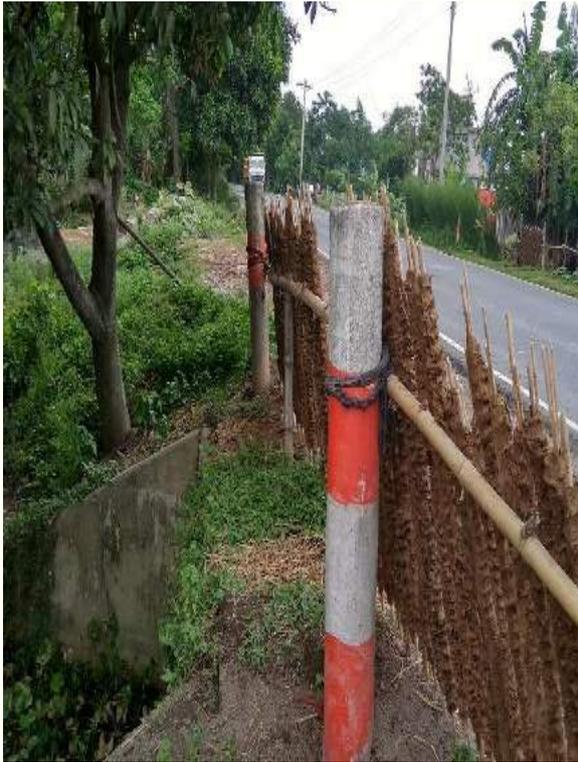
Unauthorized road side activities within Ch.+72 to Ch.+74

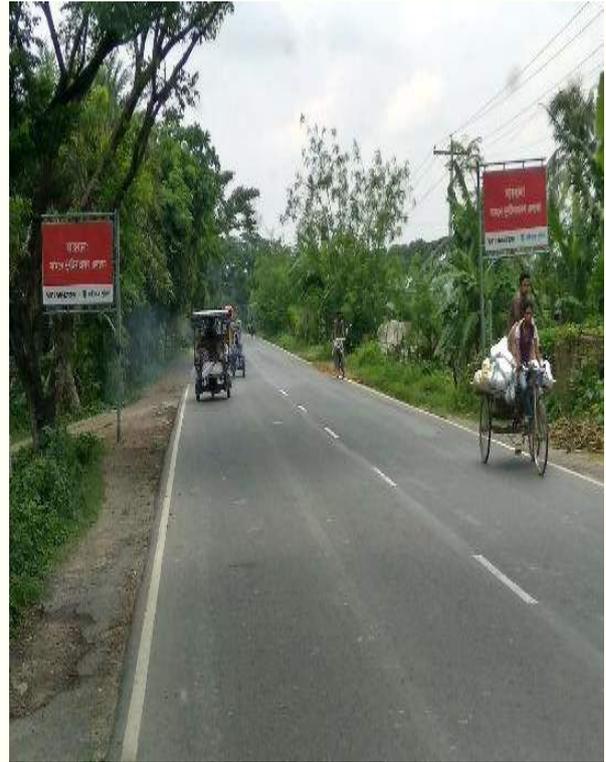
Risky, unknown sign post within clear zone within Ch.+ 72 to Ch.+74

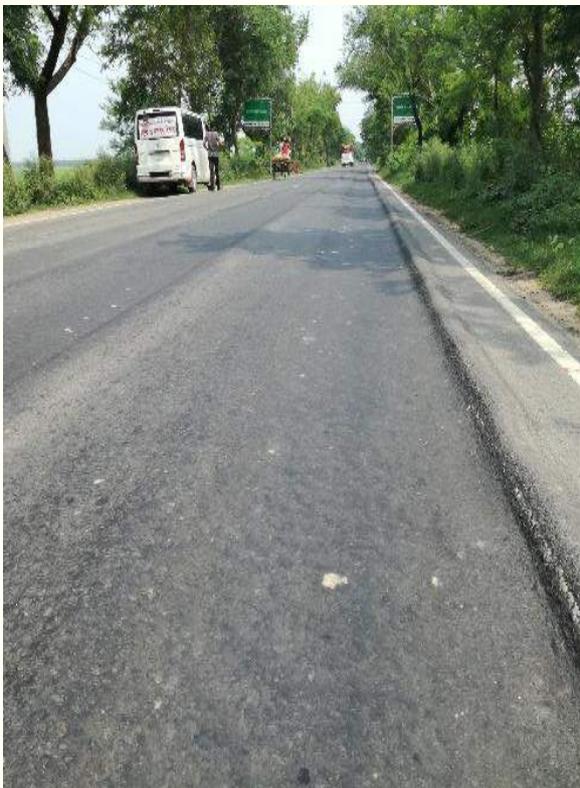
Distressed pavement within Ch.+74 to Ch.+76

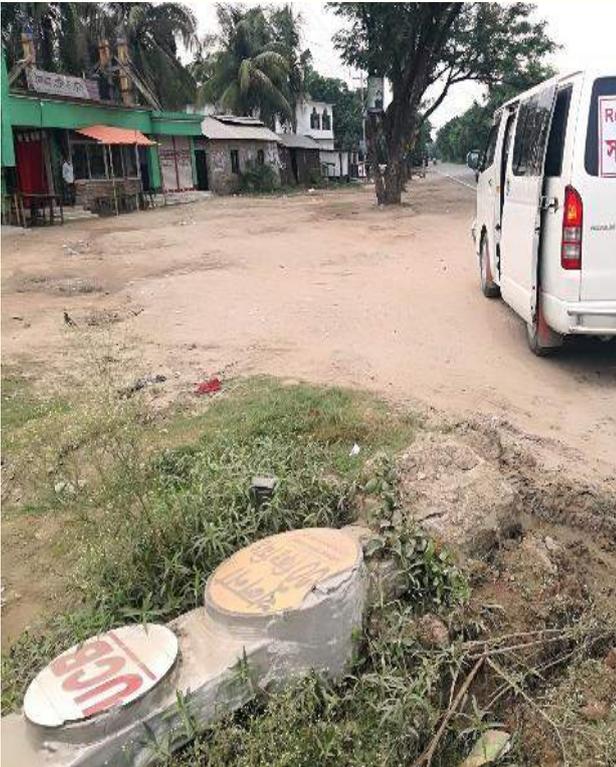
Unknown and disturbed km sign post within Ch.+84 to Ch.+86

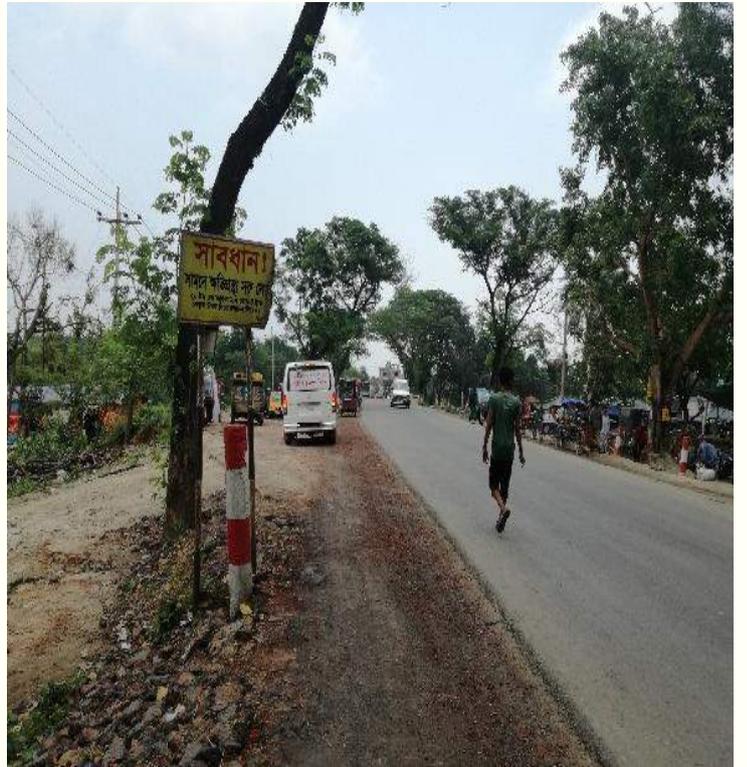
Disturbed sign within Ch.+96 to Ch.+98

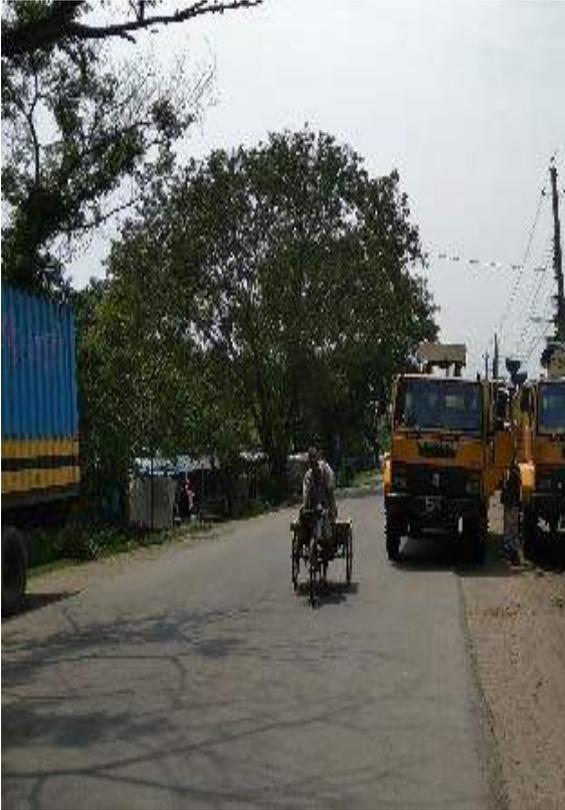
Unauthorized parking within Ch.+ 98 to Ch.+100

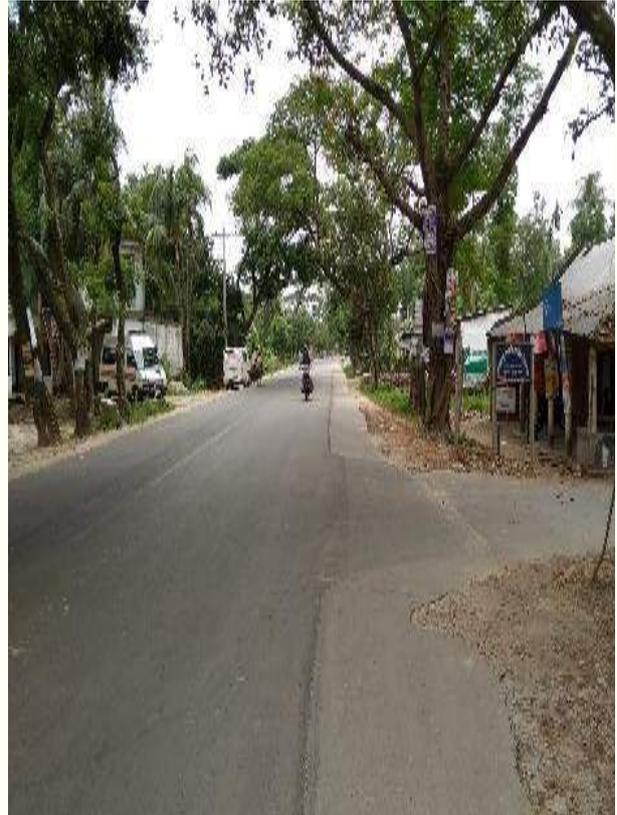
Side road without advanced warning sign within Ch.+106 to Ch.+108

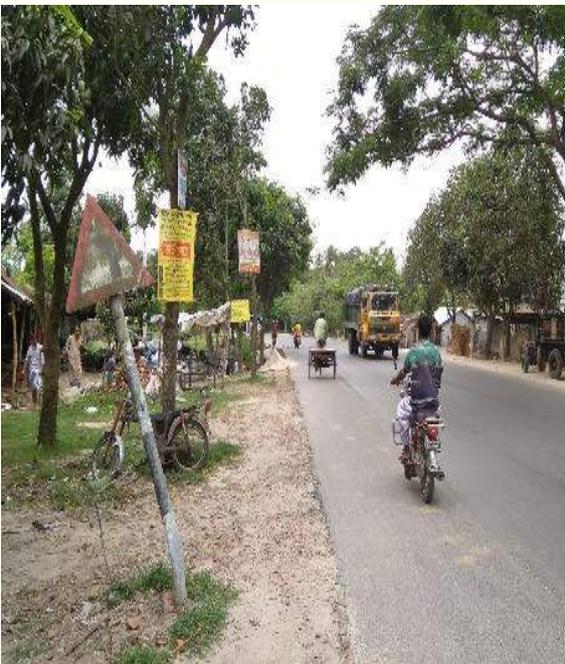
Disturbed road sign within Ch.+110 to Ch.+112

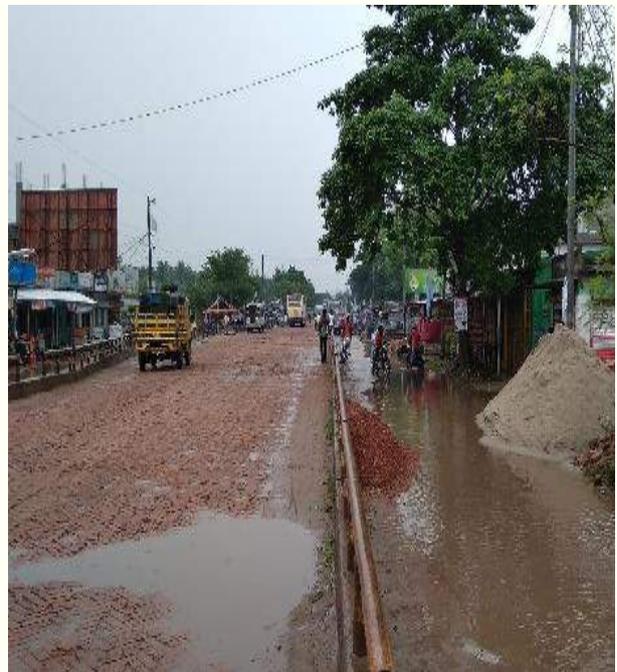
Pavement without DBS within Ch.+ 118 to Ch.+120

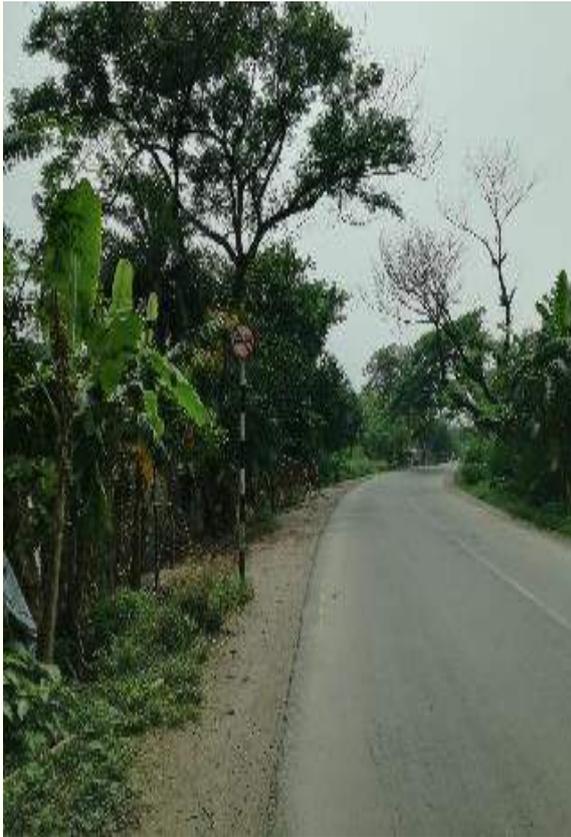
Wrong dimension of road sign within Ch.+124 to Ch.+126

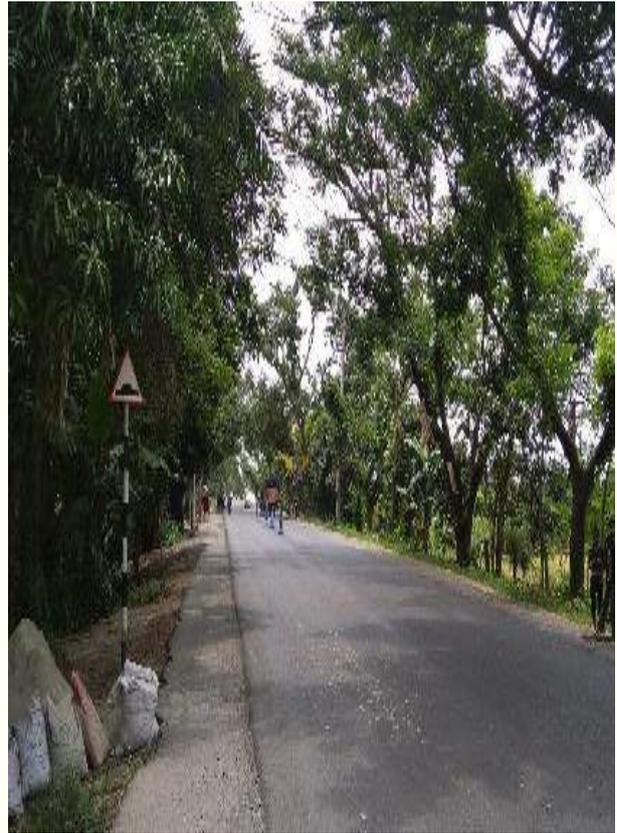
Wrong dimension of road sign within Ch.+130 to Ch.+132

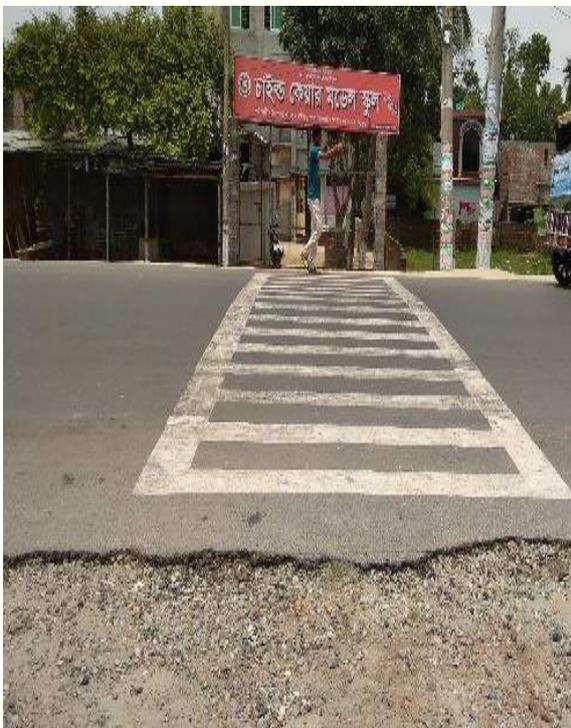
Unauthorized zebra crossing without traffic calming device within Ch.+ 138 to Ch.+140
