REPORT ON
DETAILED
ROAD SAFETY AUDIT
OF FIVE ROAD SECTIONS
(500 KM)

ROAD SAFETY AUDIT REPORT FY 2017-2018

Road Design & Safety Circle
Roads & Highways Department
Government of the People's Republic of Bangladesh
SARM Associates and HeptaTech Limited JV

Detailed Road Safety Audit of Road Sections of Joydebpur – Mymensingh (N3), Kanchpur- Daudkandi (N1) and Chattogram – Cox's Bazar (N1), Kashinathpur – Rajshahi (N6) and Dhaka – Aricha (N5) (Total 500 km) National Highway During FY 2017 -2018

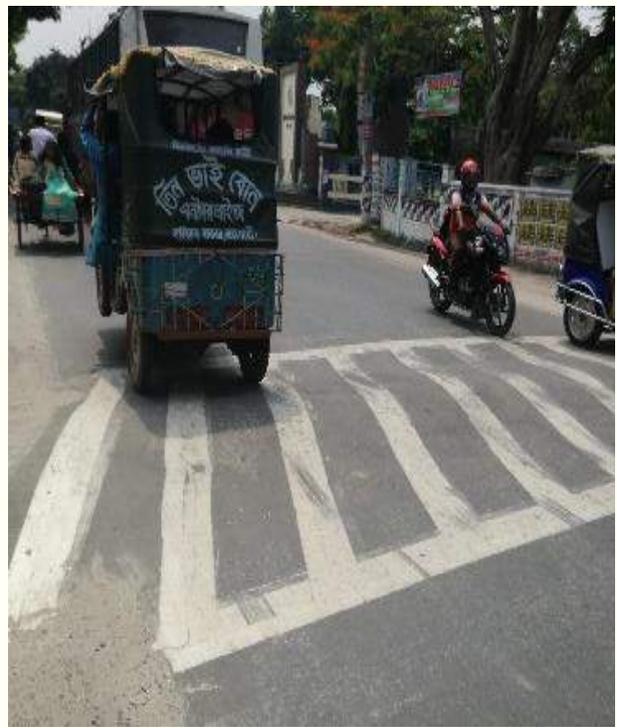
Wrong designed raised pedestrian crossing within Ch.+140 to Ch.+142

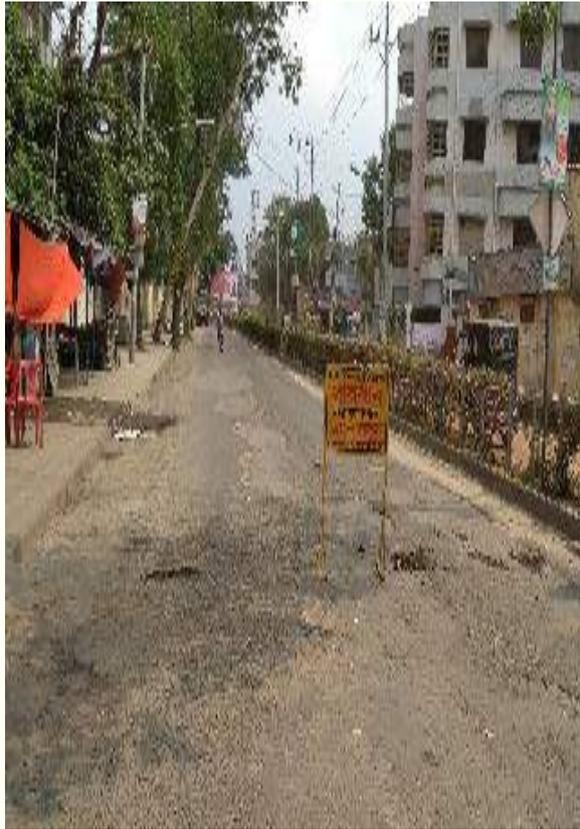
Wrong and risky construction practice within Ch.+142 to Ch.+144

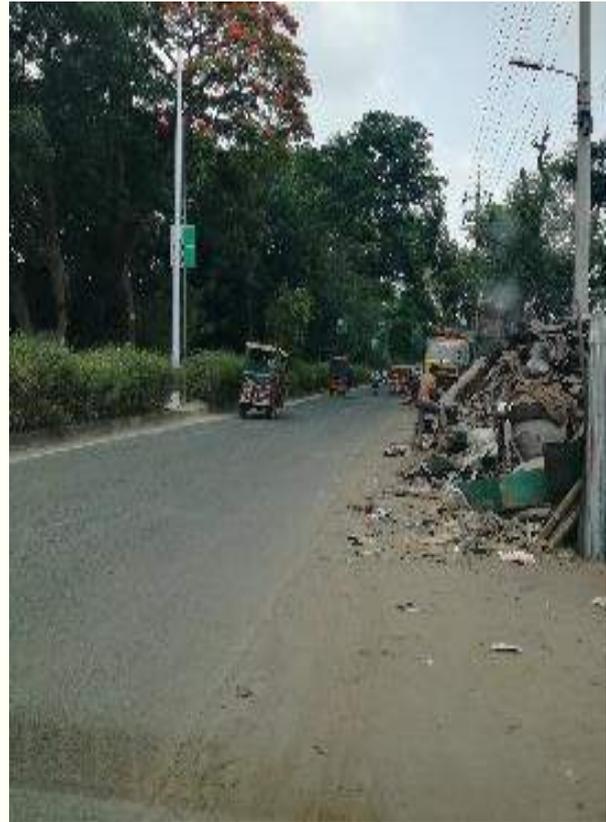
Illegal roadside activity within Ch.+144 to Ch.+146

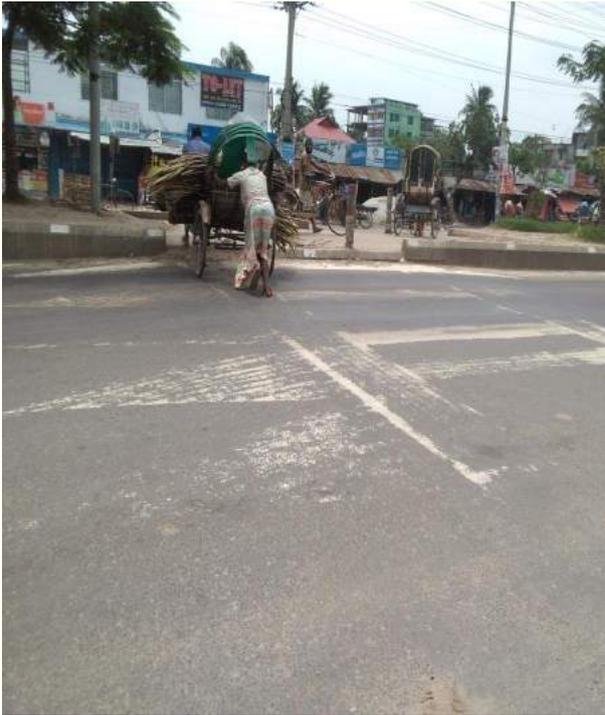
Faded pedestrian crossing within Ch.+21.8 to Ch.+23.8

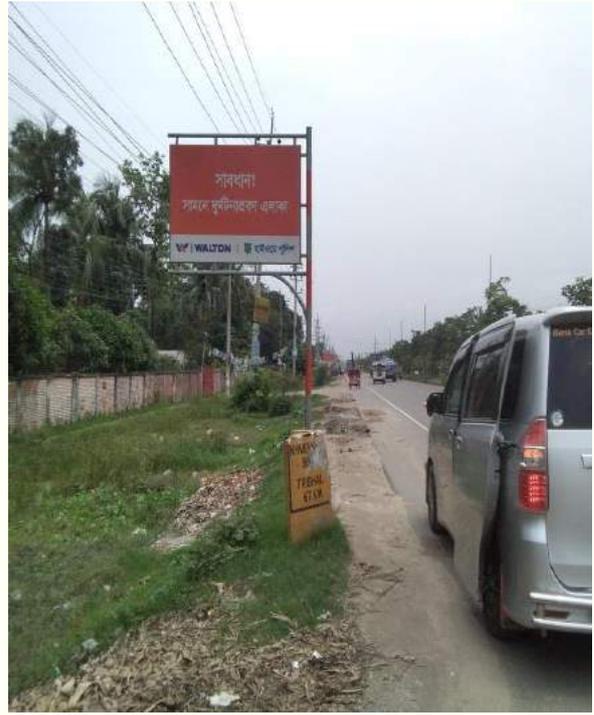
Risky km post and unknown sign post in earthen shoulder within Ch.+21.8 to Ch.+23.8

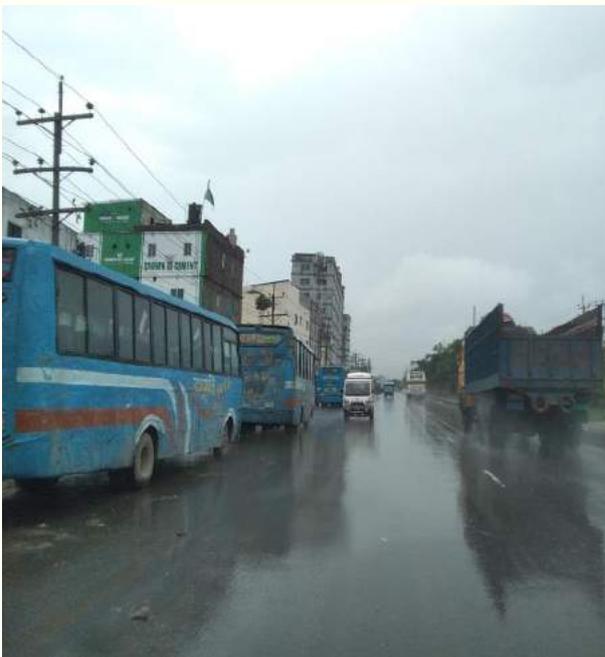
Unauthorized parking within Ch.+21.8 to Ch.+23.8

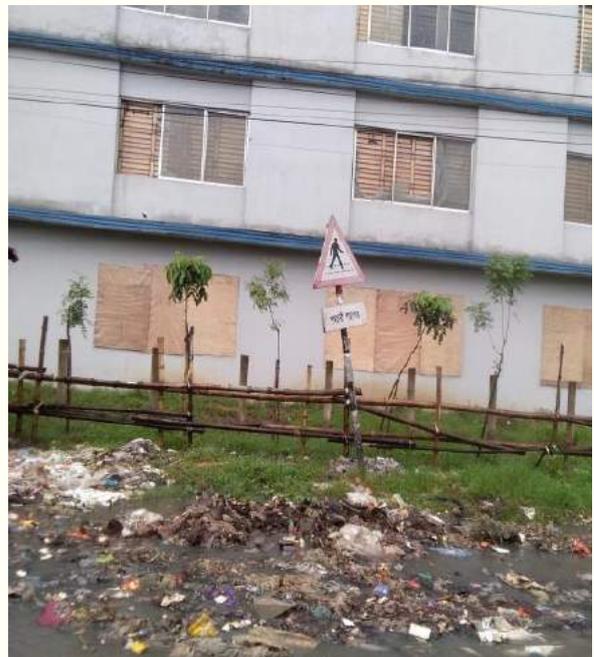
Disturbed and faded road sign within Ch.+21.8 to Ch.+23.8

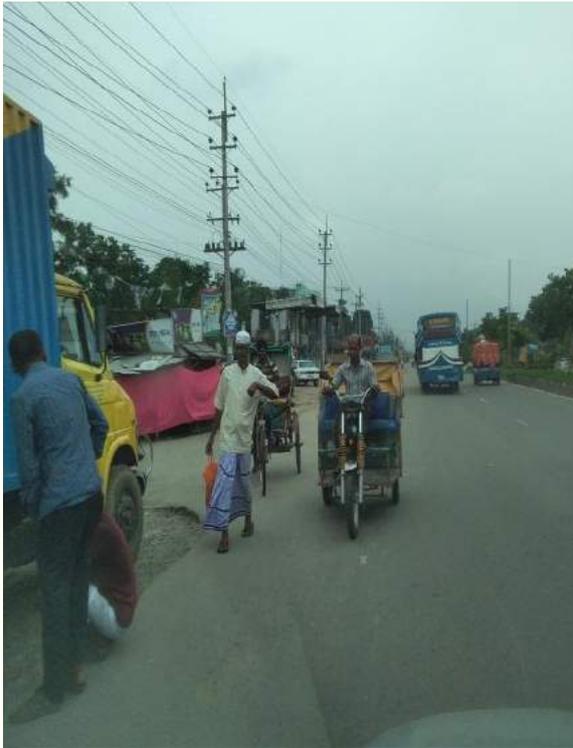
Unauthorized vehicle movement within Ch.+23.8 to Ch.+25.8

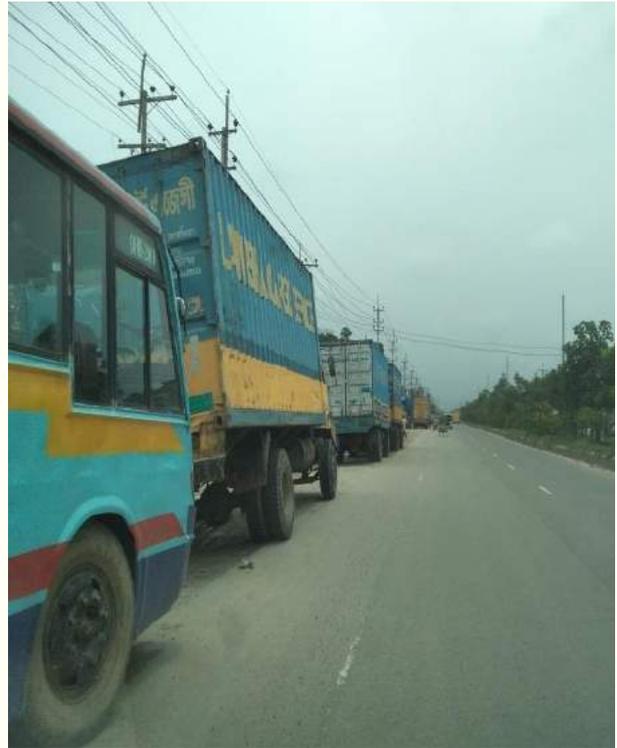
Illegal parking within Ch.+23.8 to Ch.+25.8

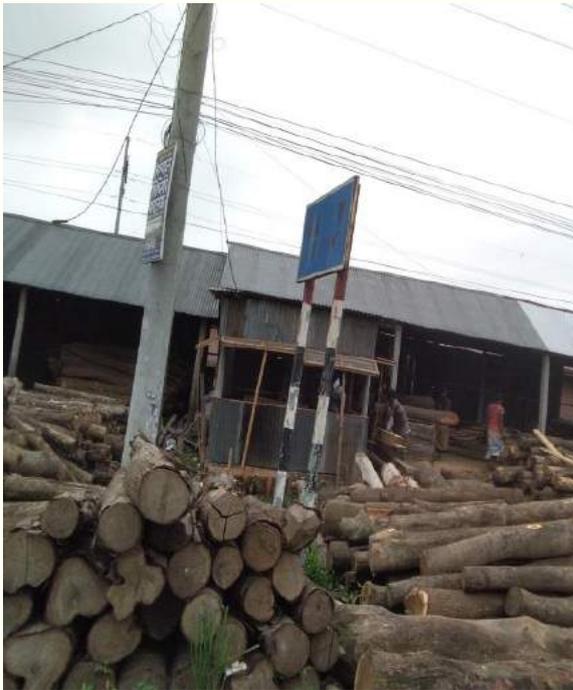
Unauthorized roadside business and non-reflective sign within Ch.+23.8 to Ch.+25.8

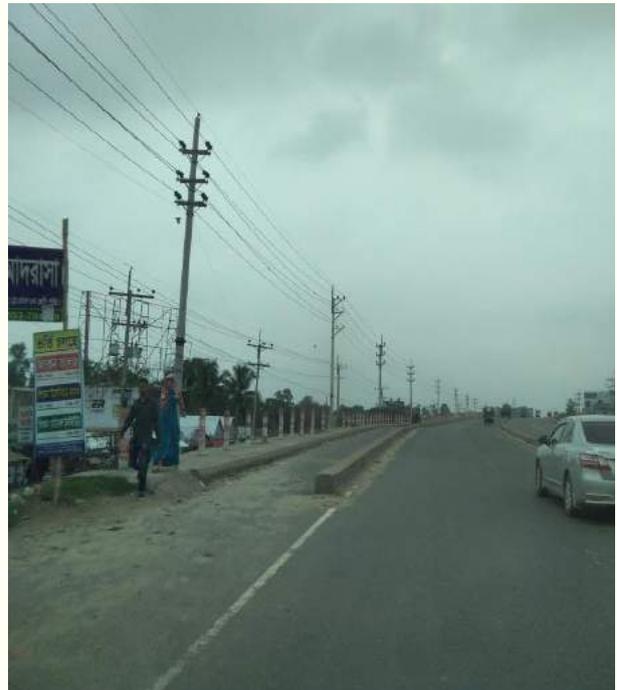
Divider without warning sign at Ch.+23.8 to Ch.+25.8

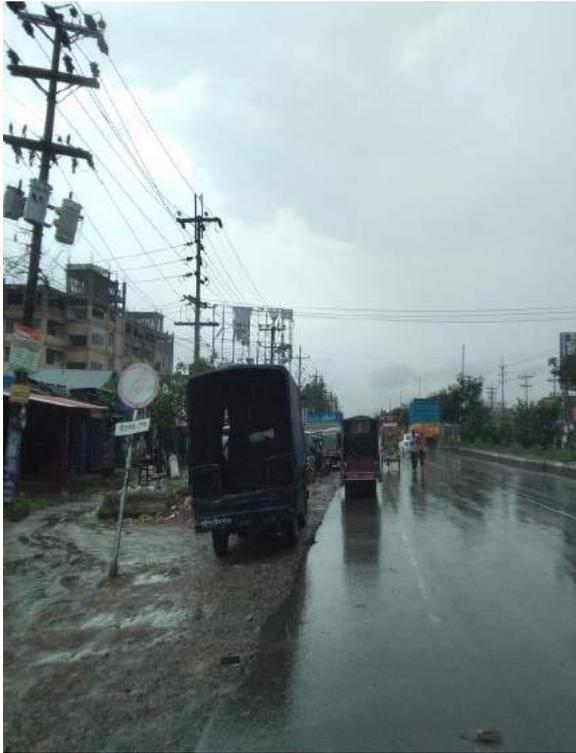
Disturbed road sign and risky shoulder drop within Ch.+23.8 to Ch.+25.8

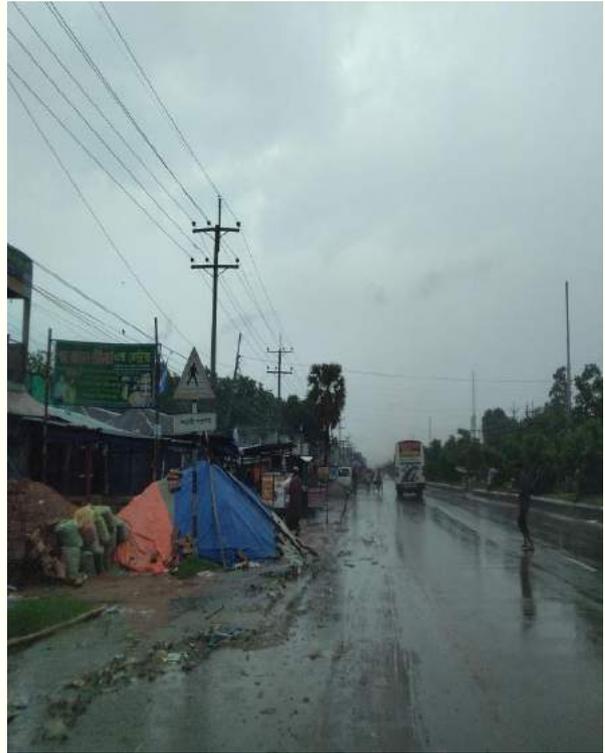
Unauthorized road side business within Ch.+23.8 to Ch.+25.8

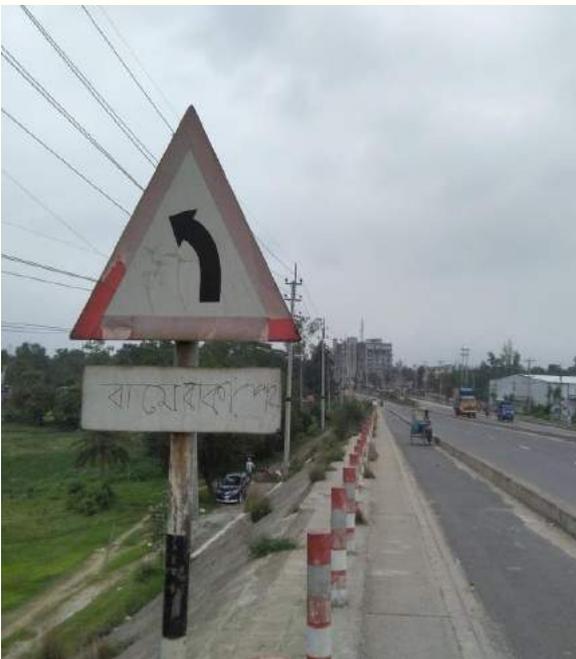
Faded and non-reflective sign within Ch.+25.8 to Ch.+27.8

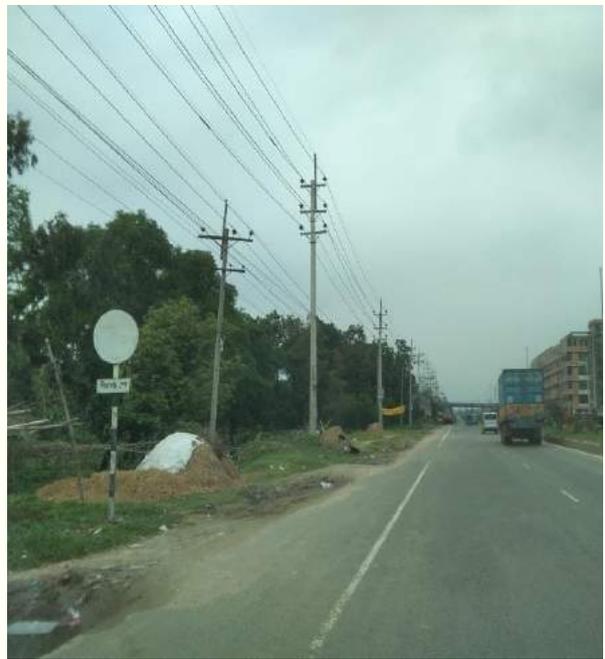
Faded road sign and marking within Ch.+25.8 to Ch.+27.8

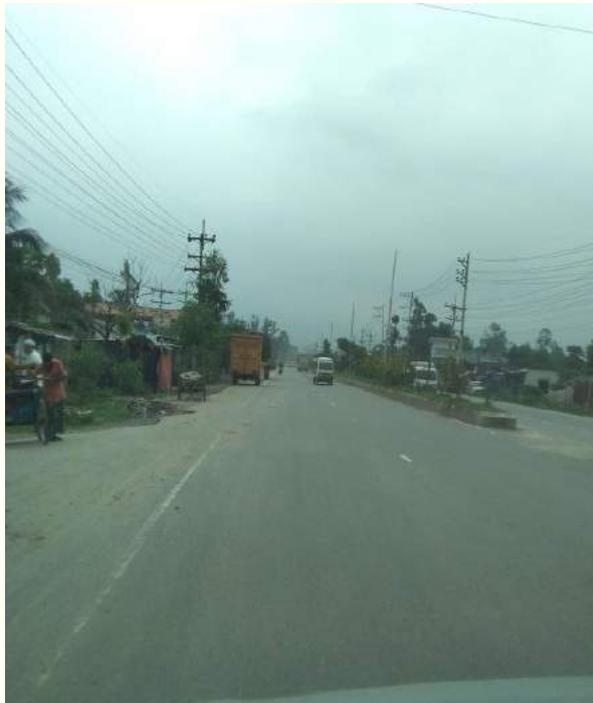
Unauthorized roadside business at Ch.+27.8 to Ch.+29.8

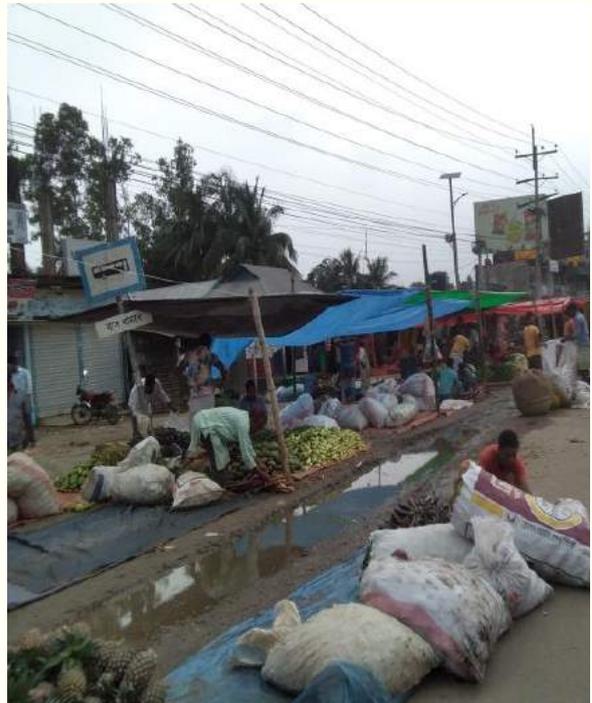
Faded zebra crossing within Ch.+27.8 to Ch.+29.8

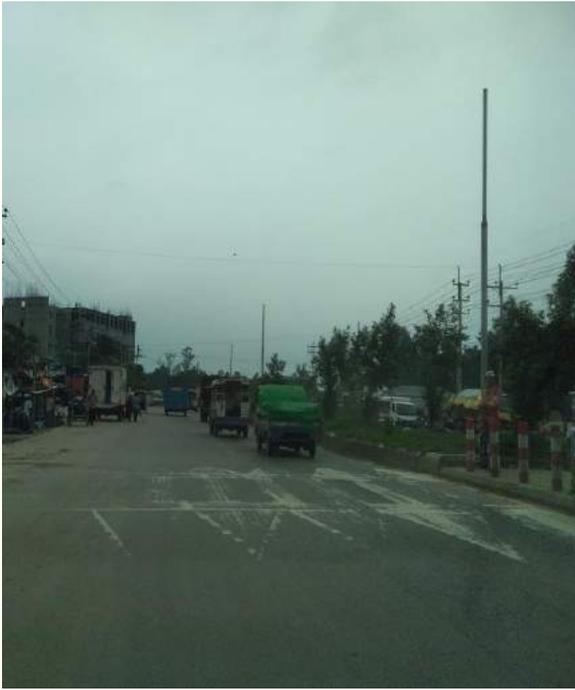
Unknown road sign within Ch.+27.8 to Ch.+29.8

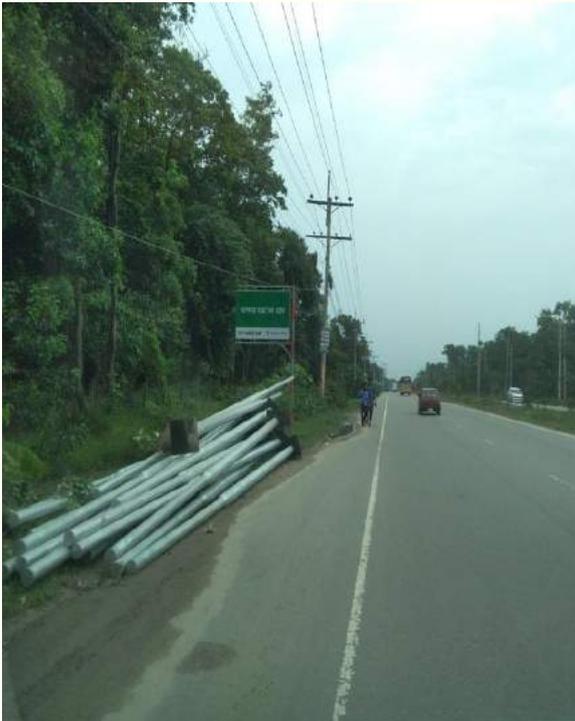
Unknown road sign at earthen shoulder at Ch.+31.8 to Ch.+33.8

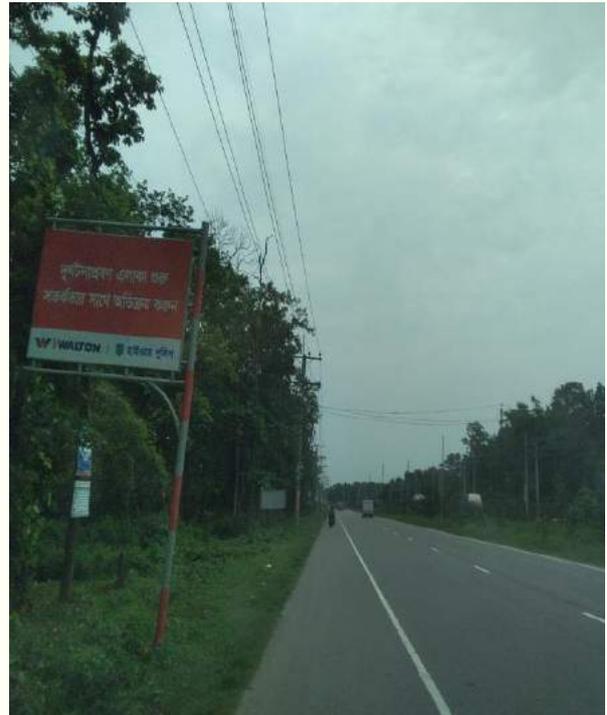
Risky edge drop and faded road sign within Ch.+35.8 to Ch.+37.8

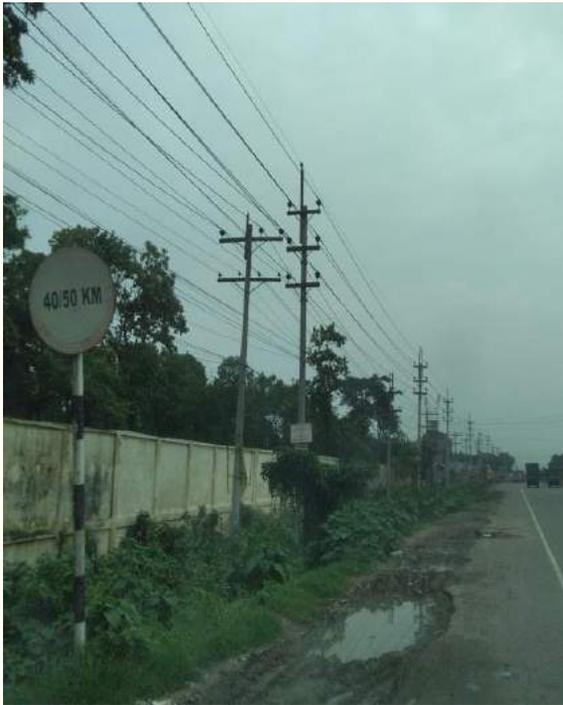
Faded sign and illegal parking within Ch.+35.8 to Ch.+37.8

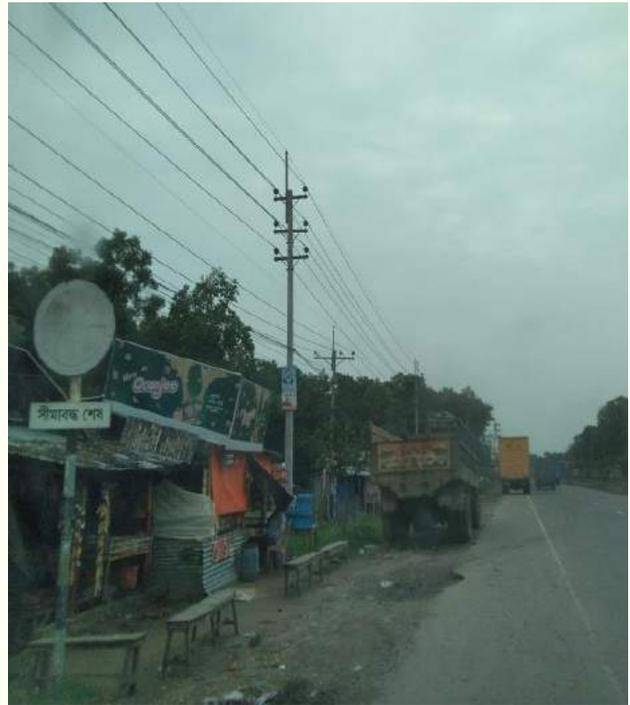
Illegal roadside parking within Ch.+35.8 to Ch.+37.8

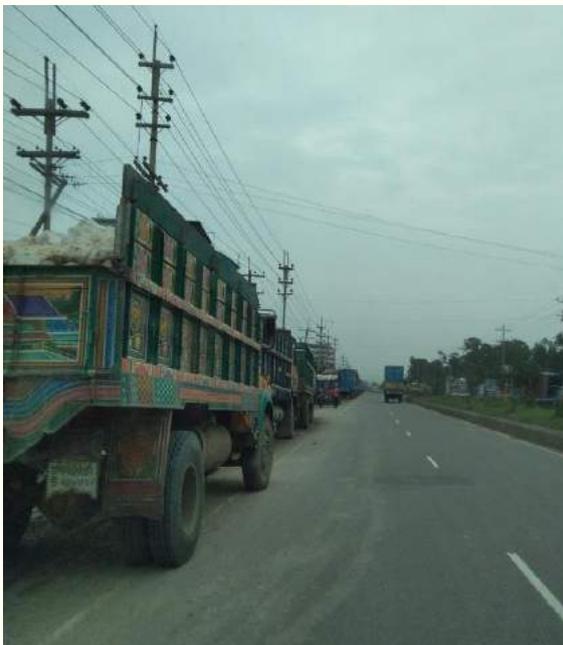
Invisible road sign within Ch.+37.8 to Ch.+39.8

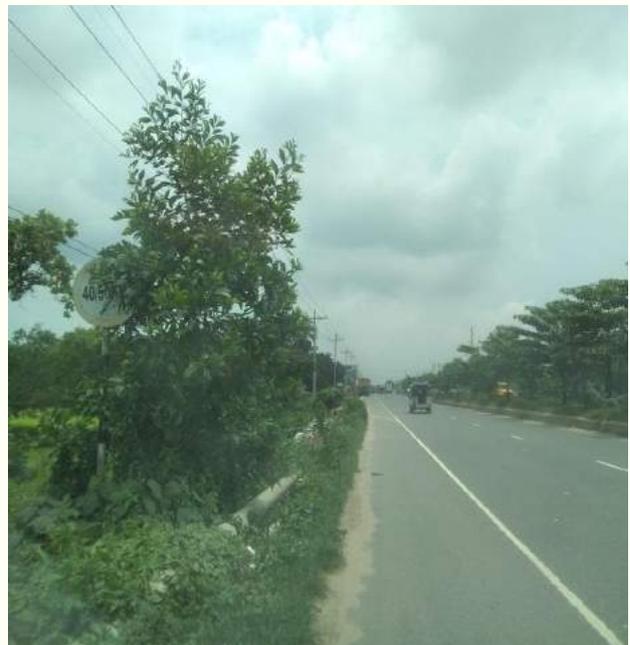
Faded road sign within Ch.+39.8to Ch.+41.8

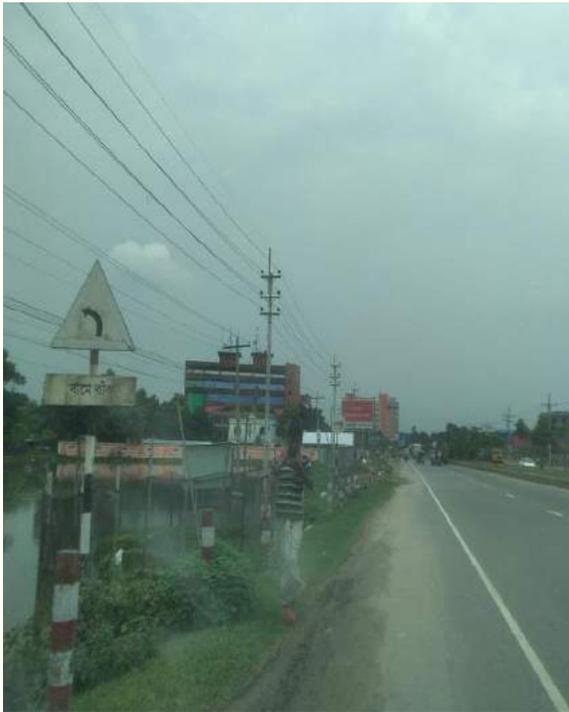
Faded road sign within Ch.+43.8 to Ch.+45.8

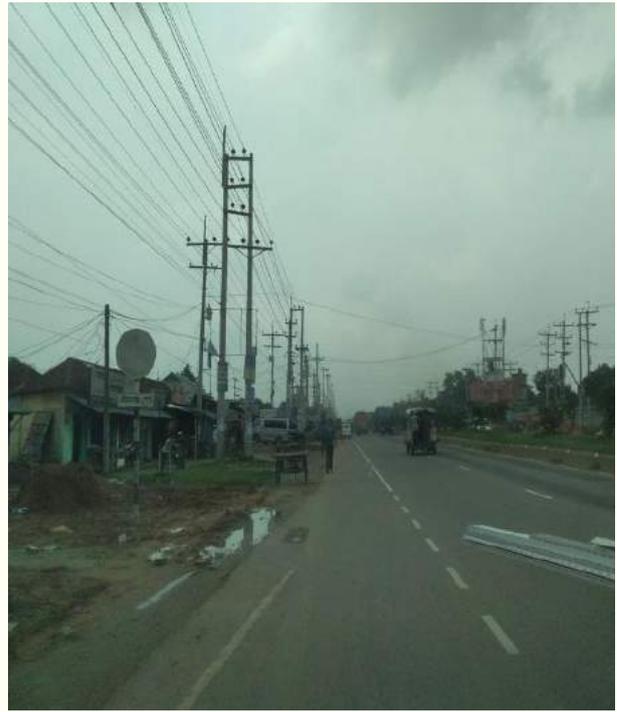
Disturbed road sign within Ch.+43.8 to Ch.+45.8

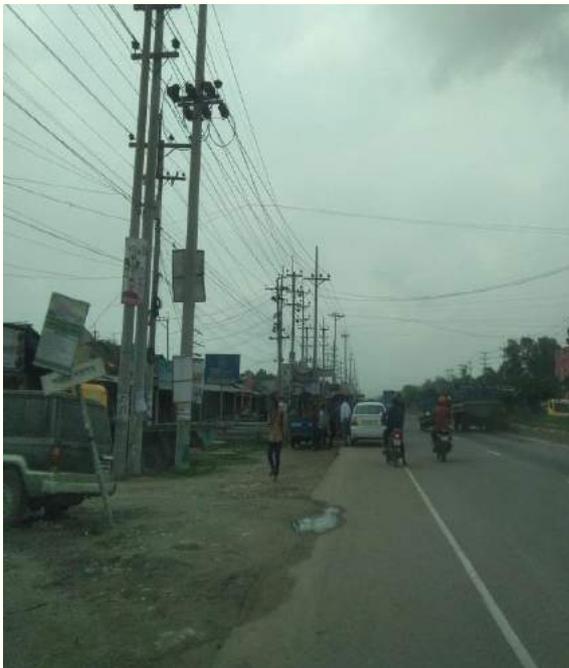
Unknown road sign within Ch.+45.8 to Ch.+47.8

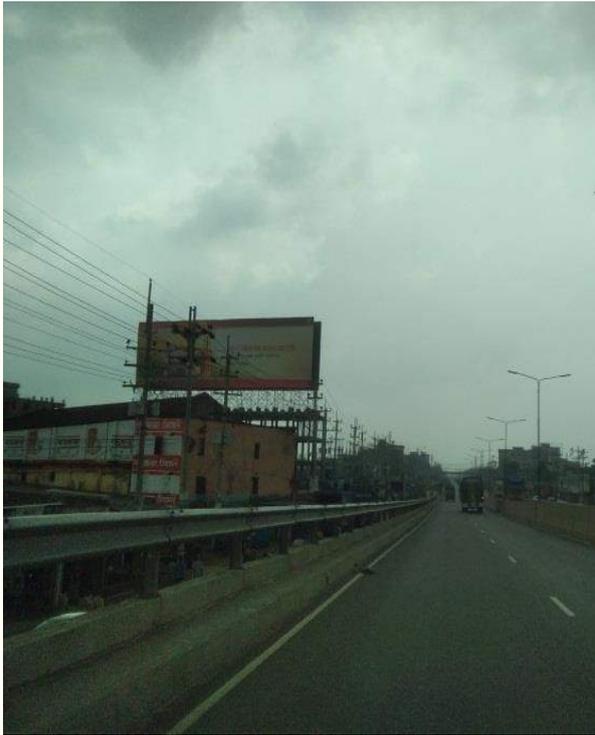
**Illegal roadside activity within
Ch.+49.8 to Ch.+51.6**

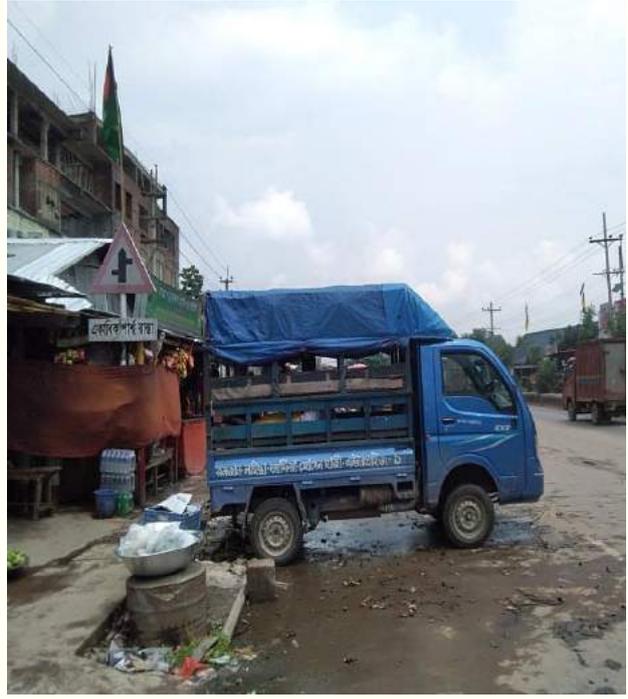
Disturbed & broken sign within Ch.+57.6to Ch.+59.6

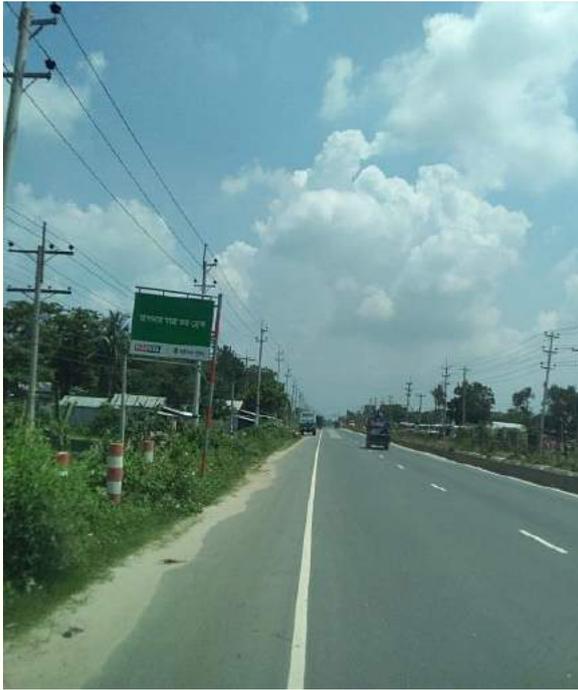
Road construction work along roadside area within Ch.+63.6 to Ch.+65.6 causing high risk

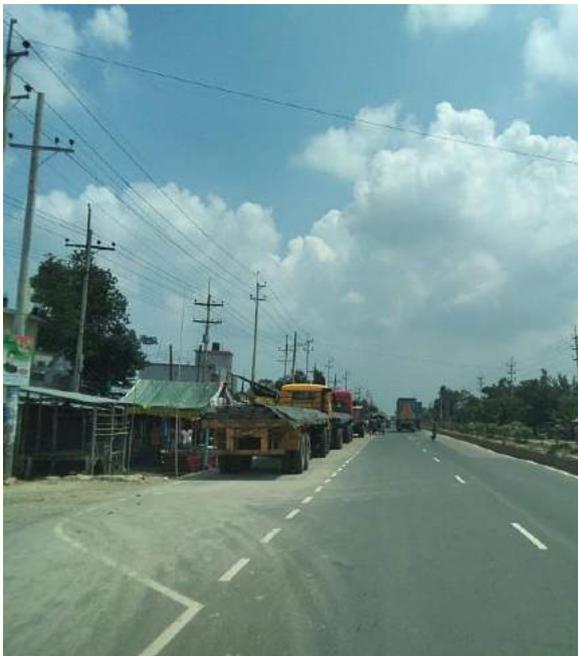
Unauthorized parking at Ch.+65.6 to Ch.+67.5

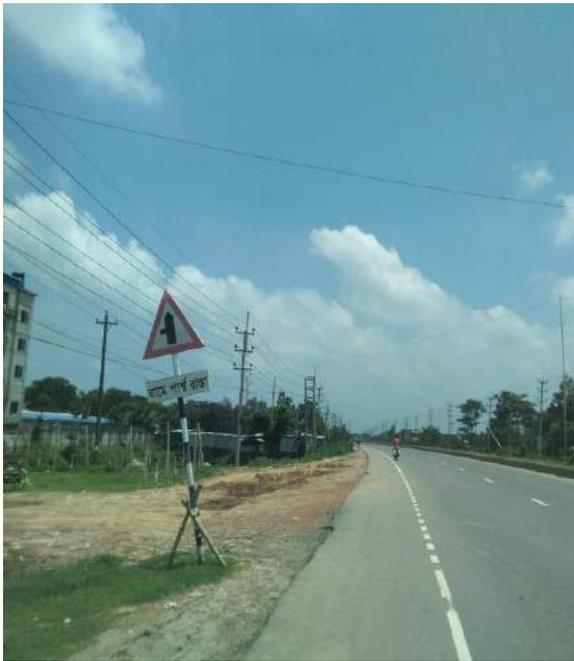
Disturbed sign post within Ch.+71.5 to Ch.+73.5

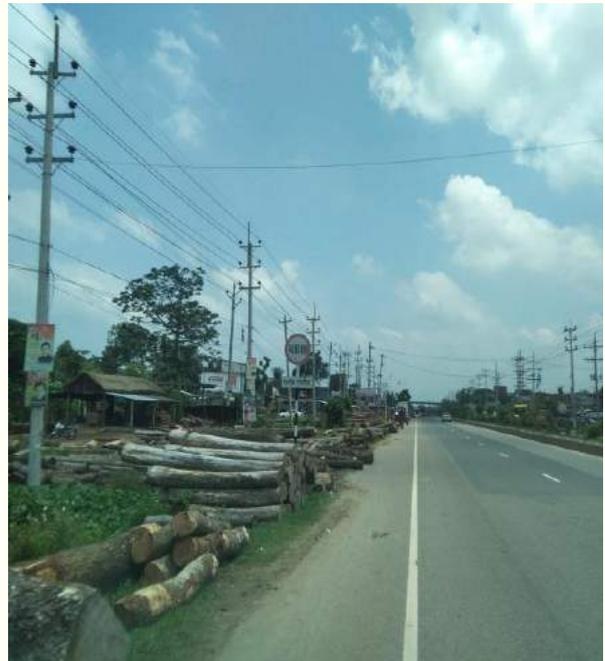
Unauthorized occupancy & unknown sign post within Ch.+73.5 to Ch.+75.5

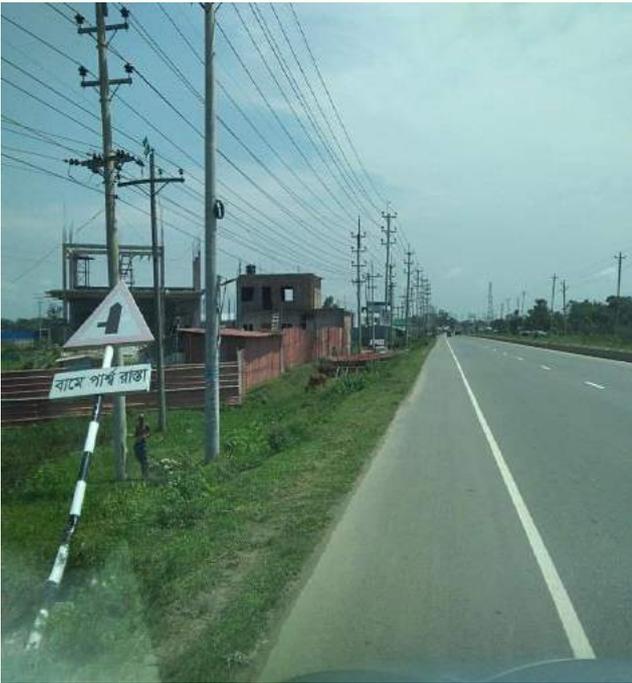
Disturbed sign post within Ch.+75.5 to Ch.+77.5

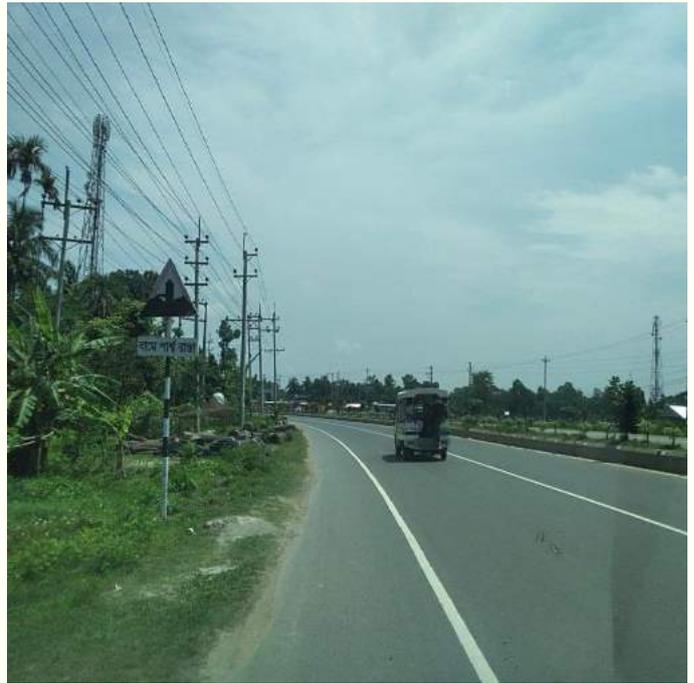
Disturbed sign post within Ch.+77.5 to Ch.+79.5

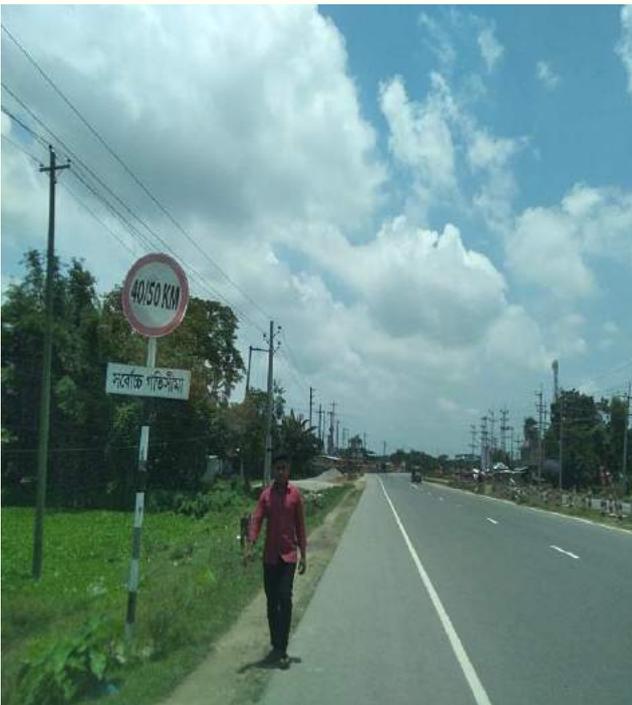
Unknown sign within Ch.+77.5 to Ch.+79.5

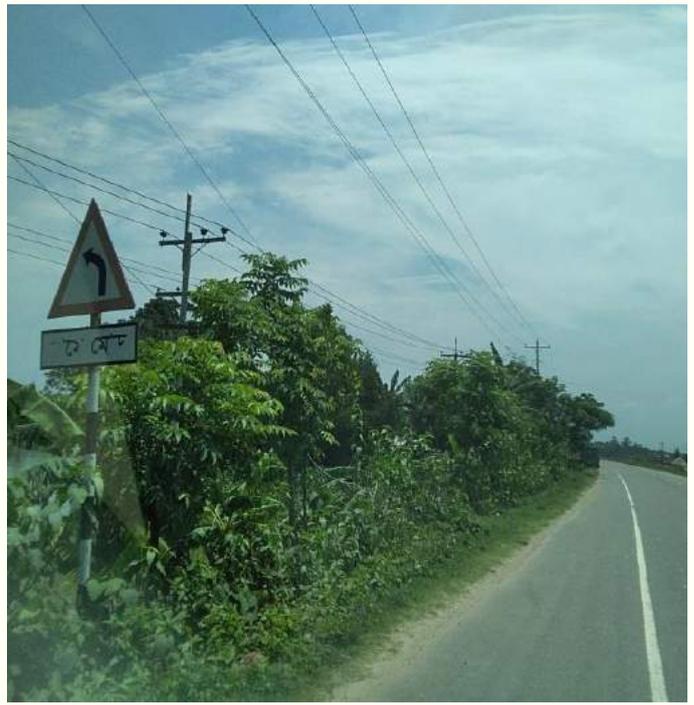
Faded & invisible sign within Ch.+81.5 to Ch.+83.5

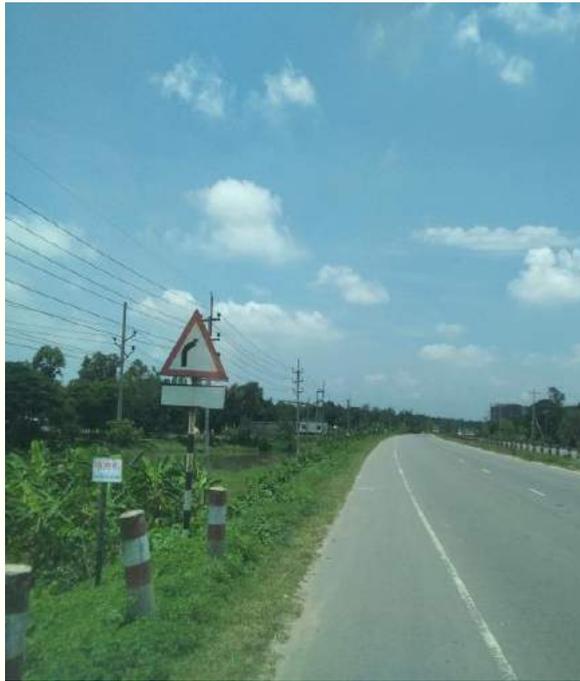
Faded sign and name plate within
Ch.+81.5 to Ch.+83.5

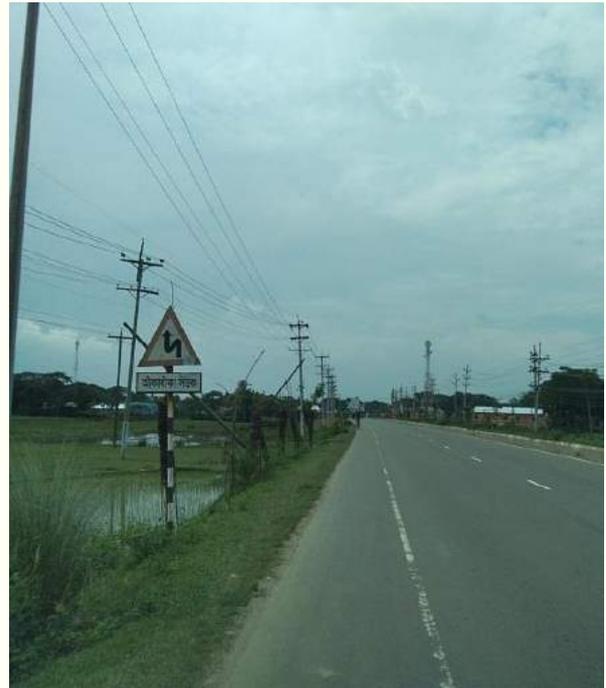
Faded road marking within
Ch.+83.5 to Ch.+85.5

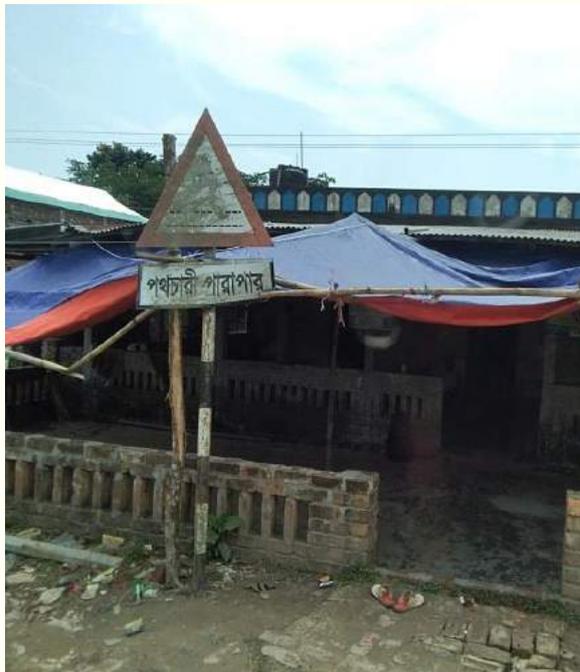
Unauthorized occupancy & faded sign within
Ch.+85.5 to Ch.+87.5

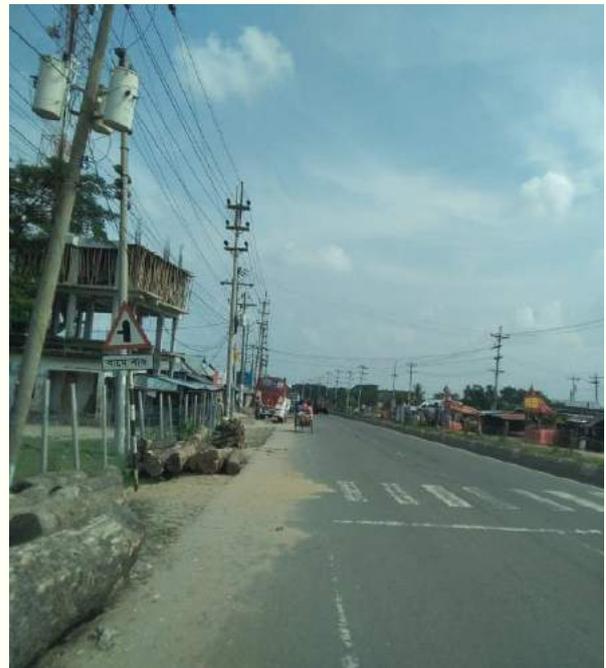
Faded road marking & unauthorized occupancy
within Ch.+85.5 to Ch.+87.5

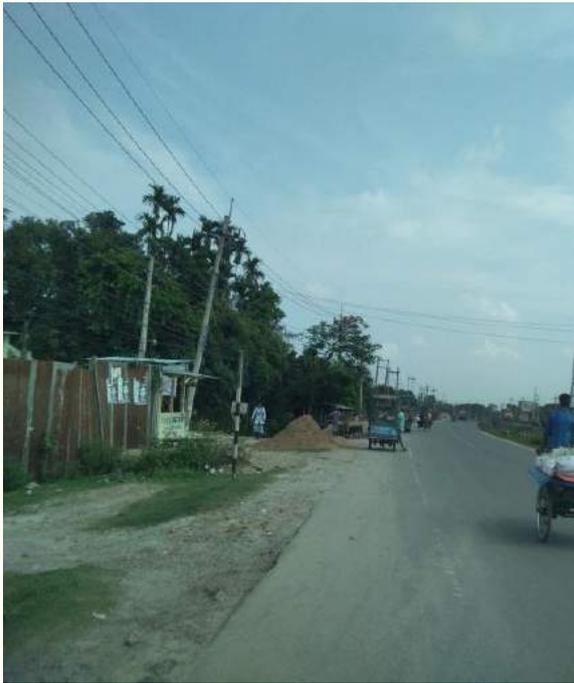
Faded road marking within Ch.+87.5 to Ch.+89.5

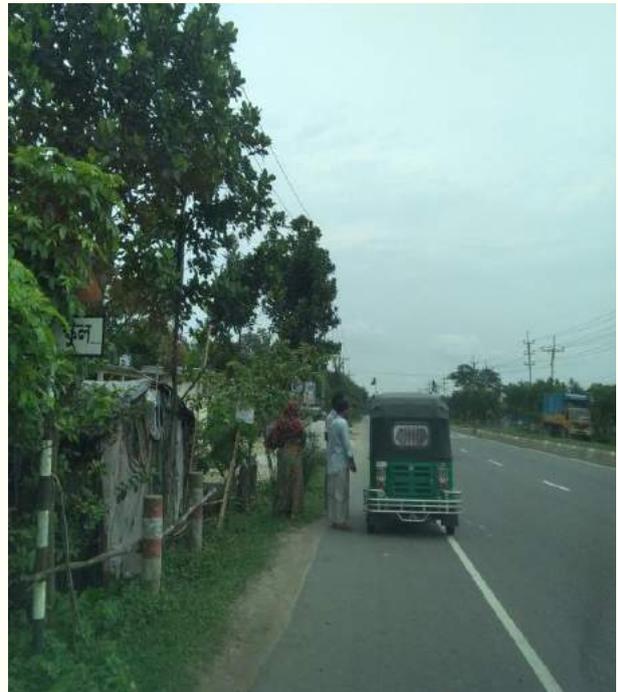
Invisible sign post & insufficient earthen shoulder within Ch.+93.5 to Ch.+95.5

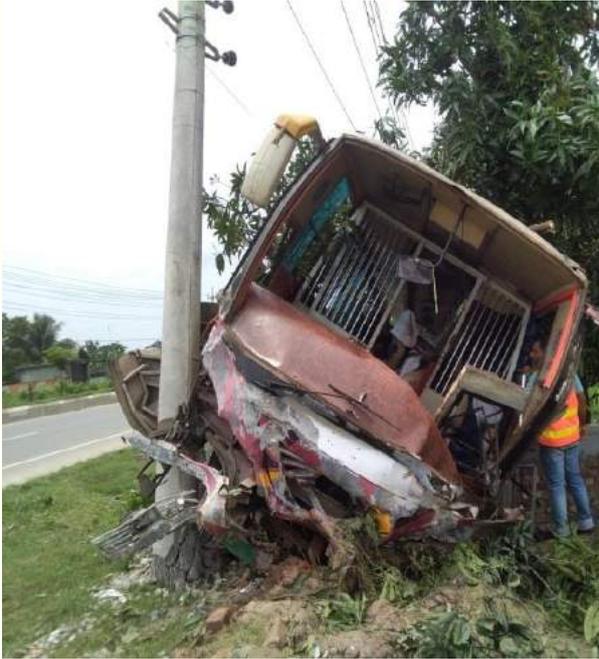
**Crash with electric pole within
Ch.+97.5 to Ch.+99.5**

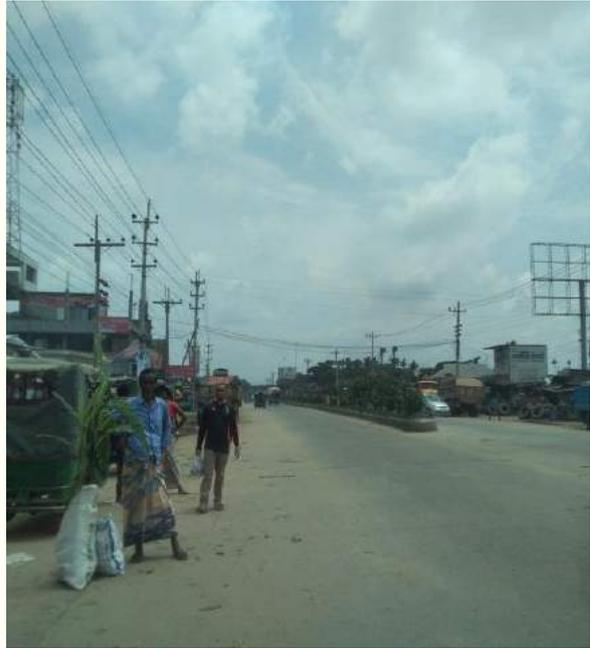
**No road marking & unauthorized parking
within Ch.+99.5to Ch.+101.5**

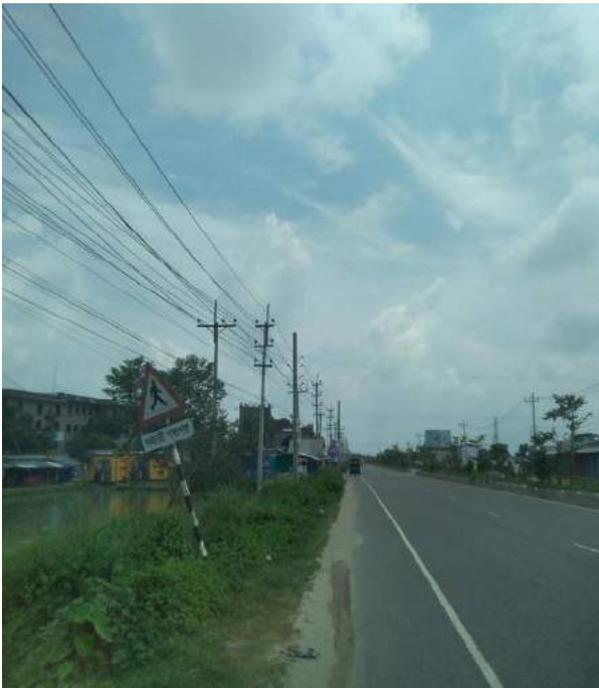
Disturbed sign post within Ch.+99.5to Ch.+101.5

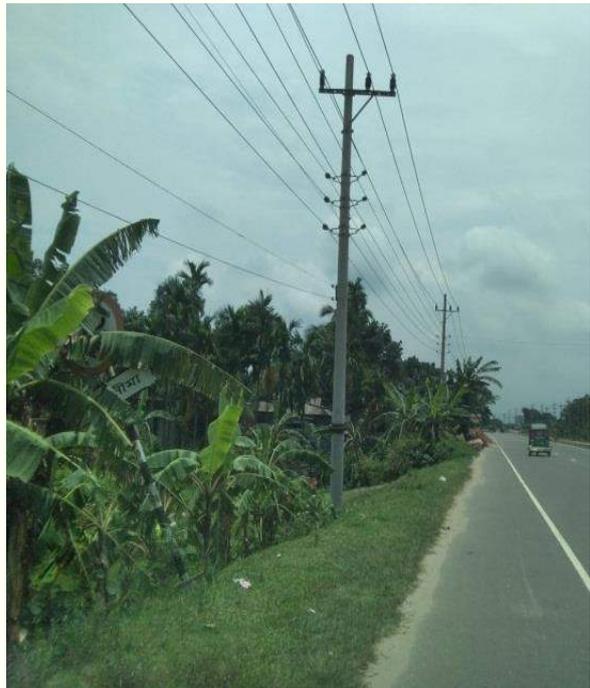
**Disturbed & not visible sign post within
Ch.+101.5 to Ch.+103.5**

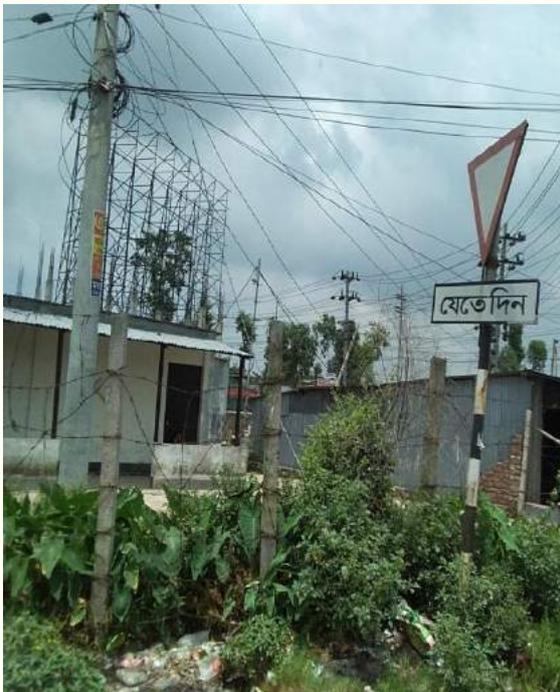
Disturbed sign within Ch.+103.5 to Ch.+105.5

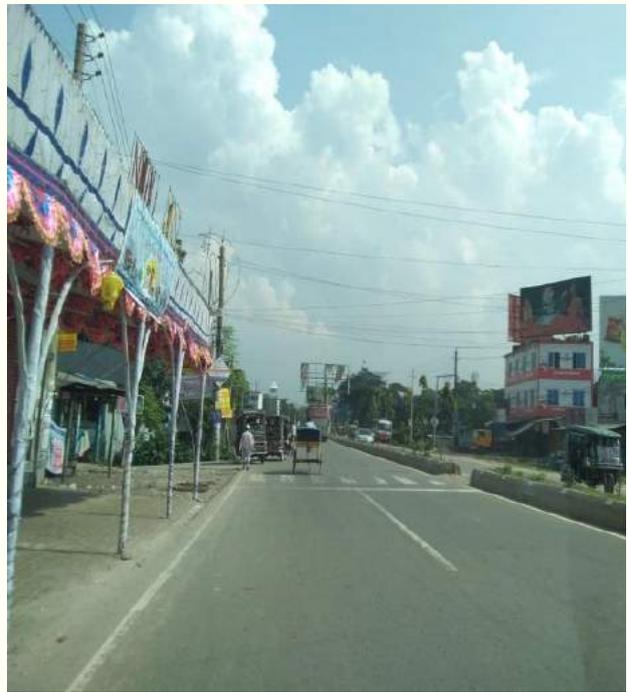
Illegal structure & faded road marking at Ch.+105.5 to Ch.+107.5

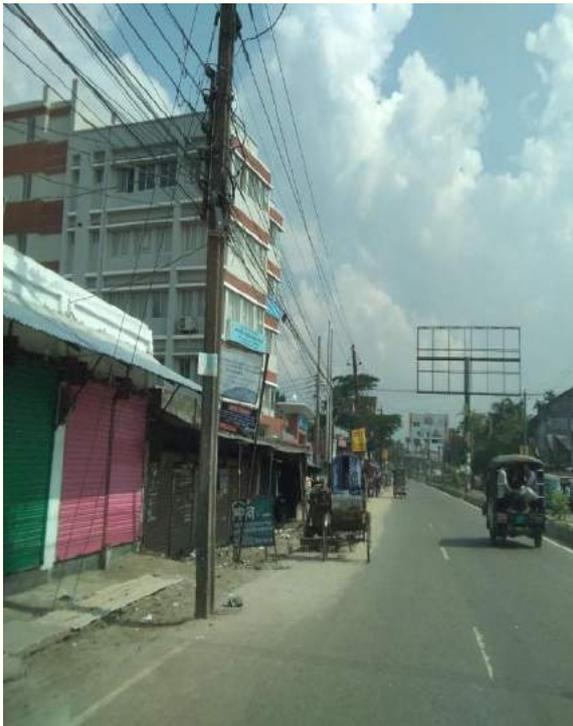
Electric pole on road at Ch.+105.5 to Ch.+107.5

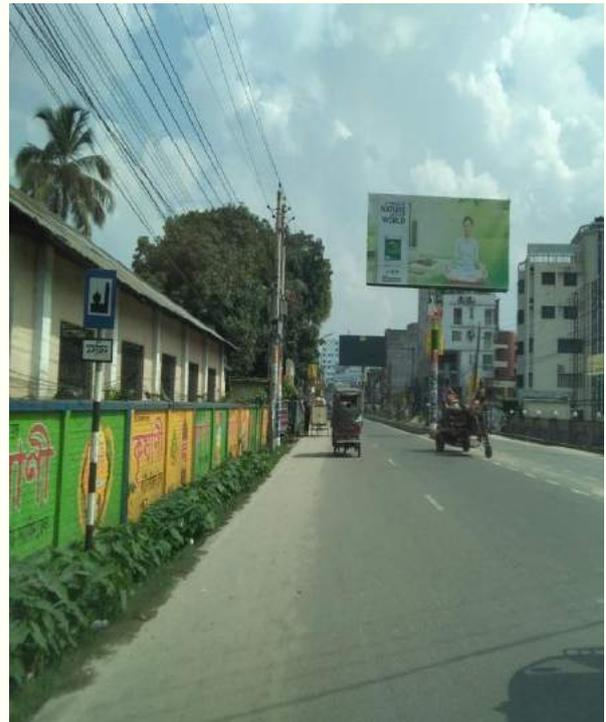
Roadside electric pole & faded road marking within Ch.+107.5 to Ch.+109.5

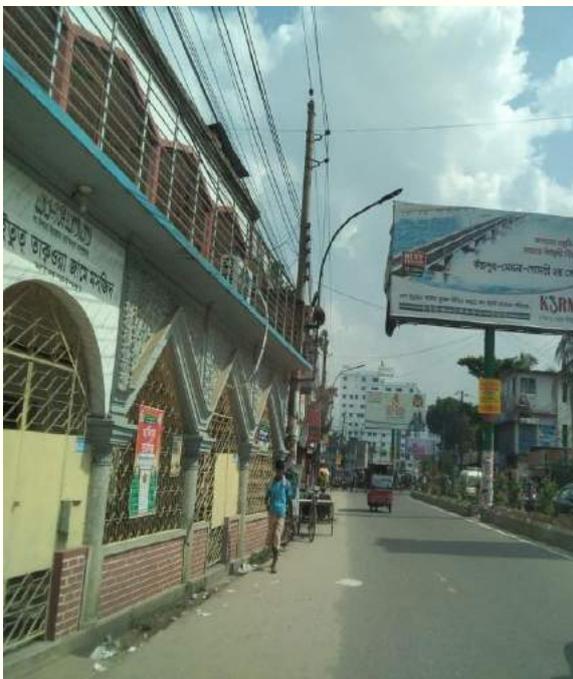
Permanent structure established on roadside area within Ch.+107.5 to Ch.+109.5

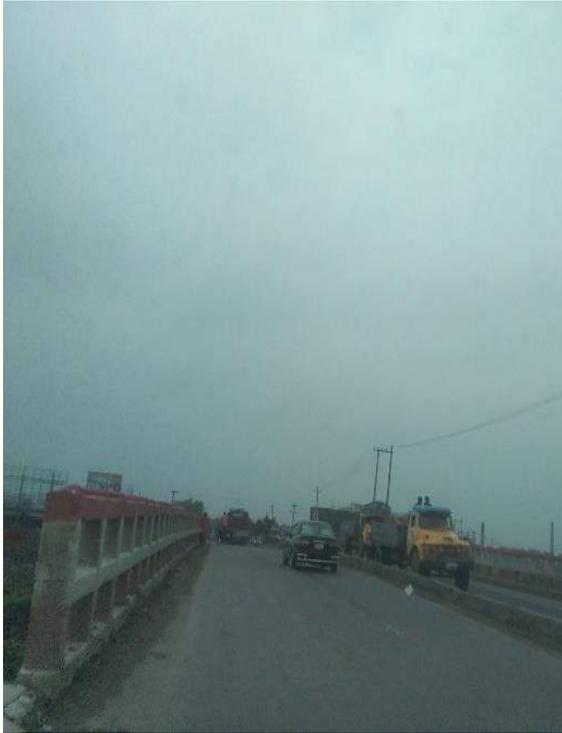
No pedestrian crossing facility on the bridge at Ch.+0 to Ch.+2
