REPORT ON
DETAILED
ROAD SAFETY AUDIT
OF FIVE ROAD SECTIONS
(500 KM)

ROAD SAFETY AUDIT REPORT FY 2017-2018

Road Design & Safety Circle
Roads & Highways Department
Government of the People's Republic of Bangladesh
SARM Associates and HeptaTech Limited JV

Detailed Road Safety Audit of Road Sections of Joydebpur – Mymensingh (N3), Kanchpur- Daudkandi (N1) and Chattogram – Cox's Bazar (N1), Kashinathpur – Rajshahi (N6) and Dhaka – Aricha (N5) (Total 500 km) National Highway During FY 2017 -2018

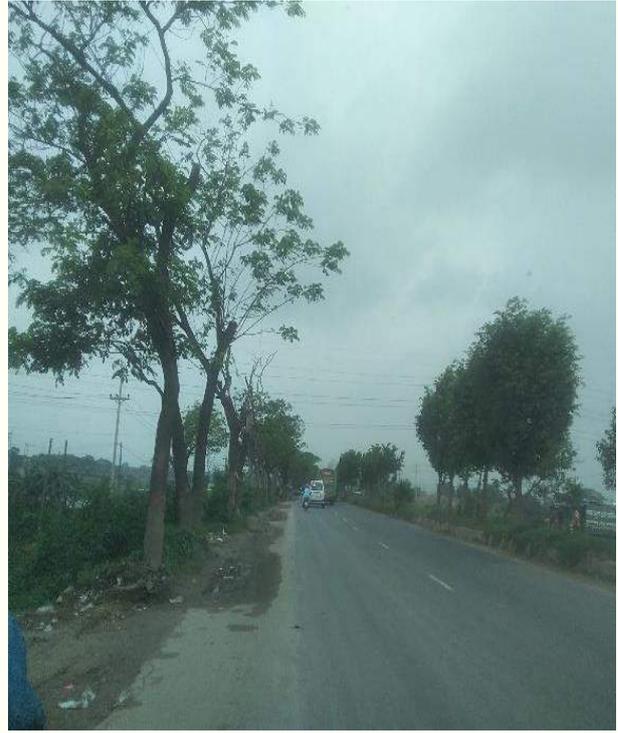
Earthen shoulder within Ch.+2 to Ch.+4 is at risk due to roadside tree

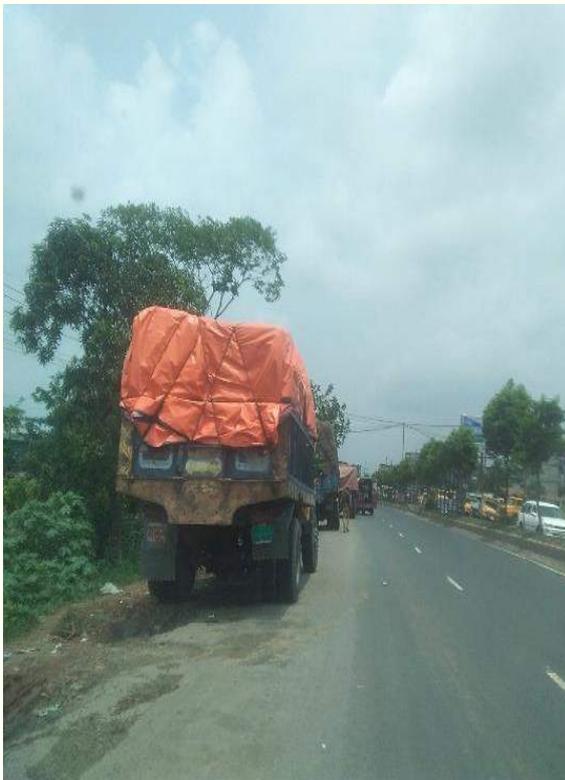
Unauthorized roadside parking within Ch.+4 to Ch.+6

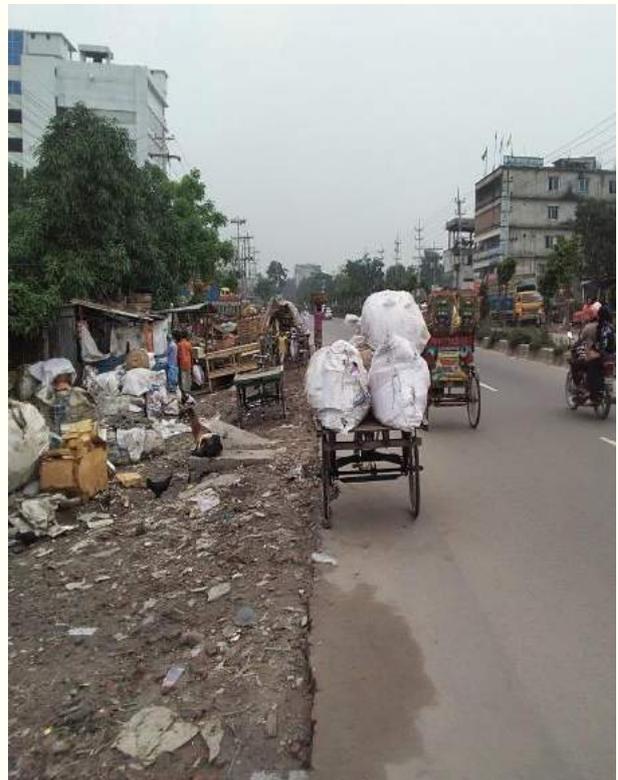
Risky shoulder within Ch.+12 to Ch.+14

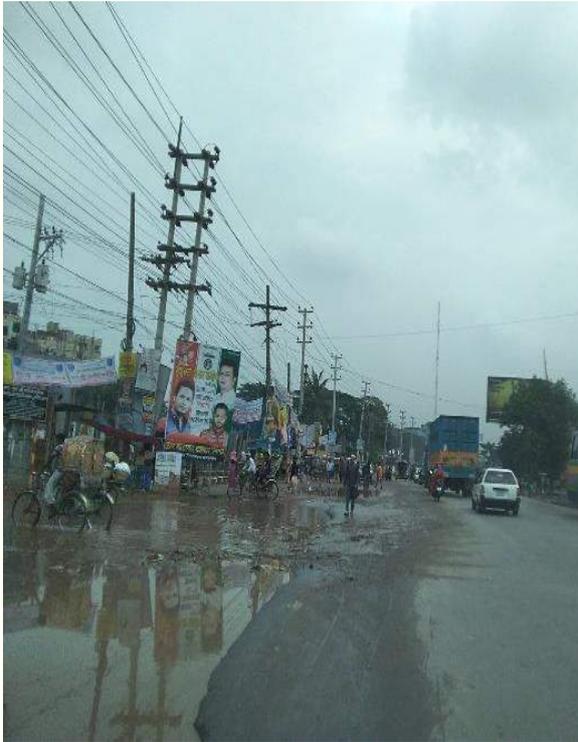
Water logging within Ch.+14 to Ch.+16

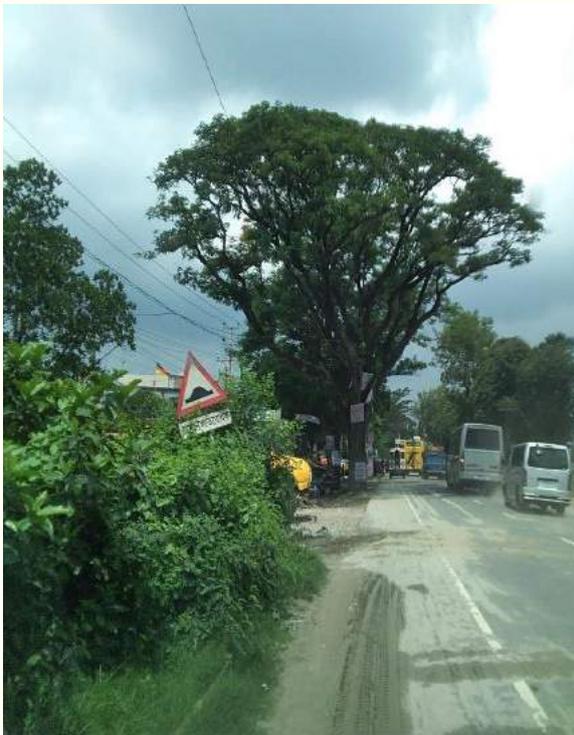
Disturbed road sign within Ch.+26 to Ch.+28 is misplaced and less visible

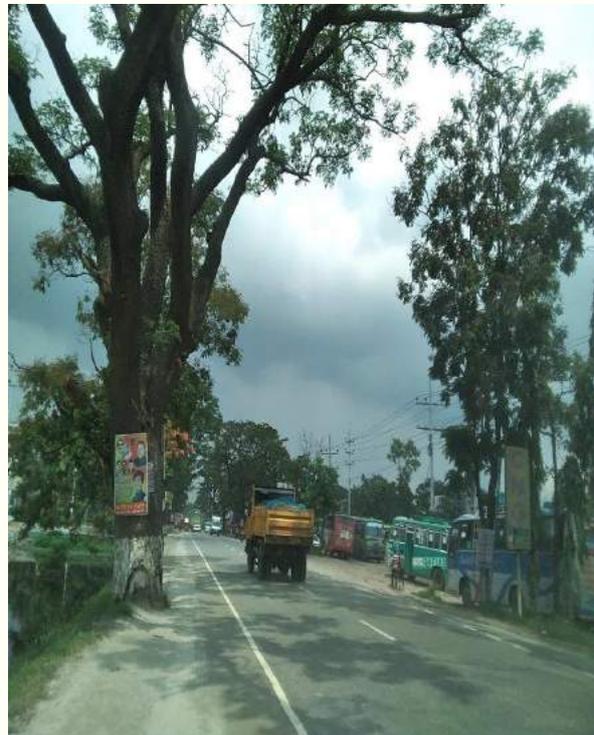
Earthen shoulder within Ch.+26 to Ch.+28 gets blocked by roadside large tree

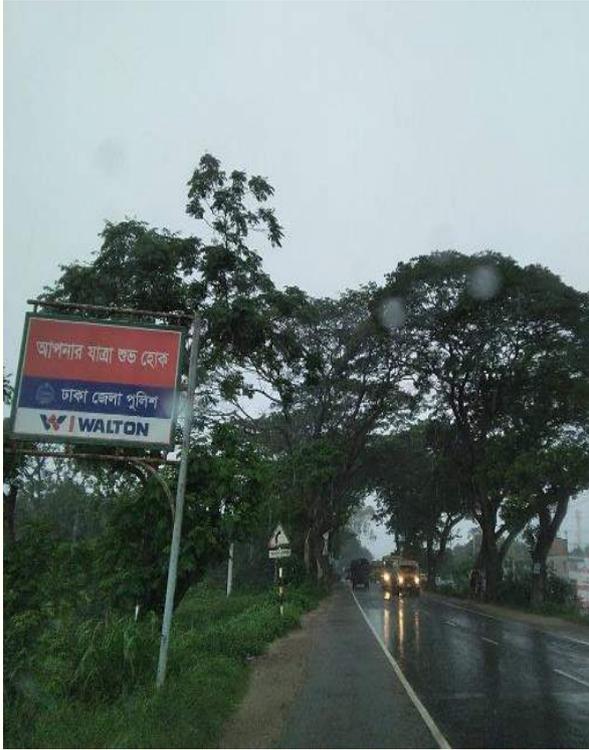
Risky concrete pole in earthen shoulder within Ch.+26 to Ch.+28

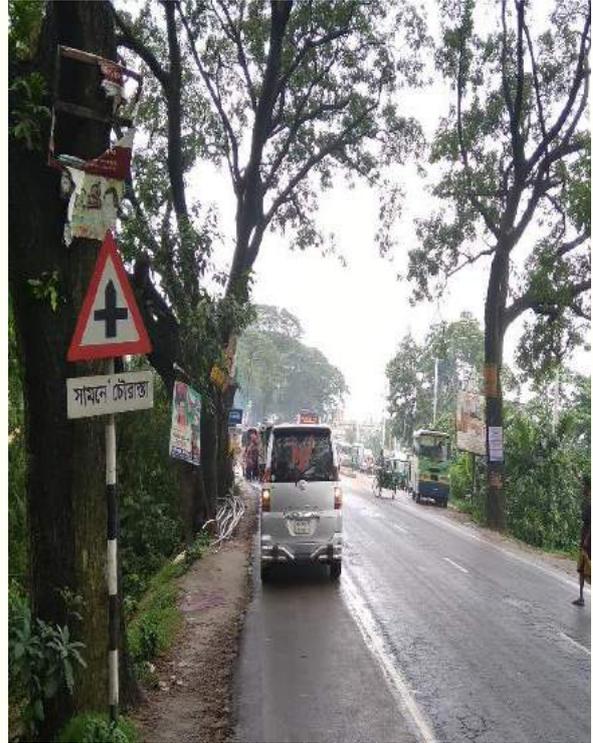
Road Sign in earthen shoulder within Ch.+28 to Ch.+30

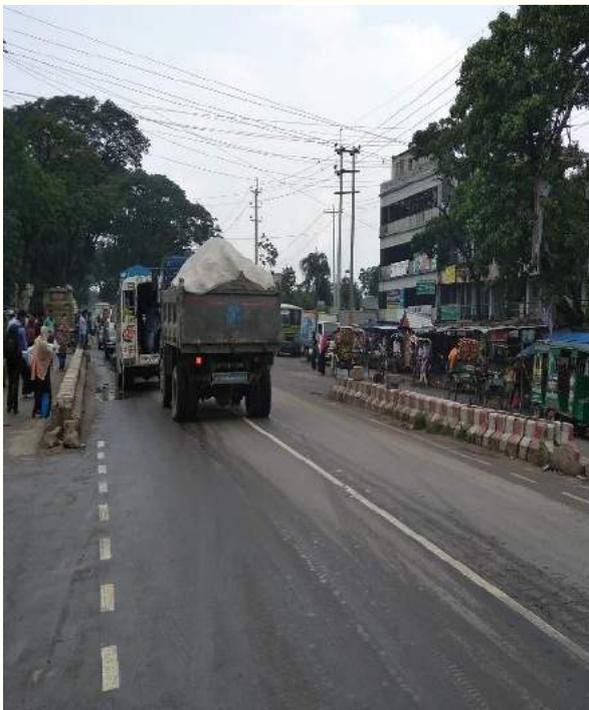
Absence of warning sign at median within Ch.+28 to Ch.+30

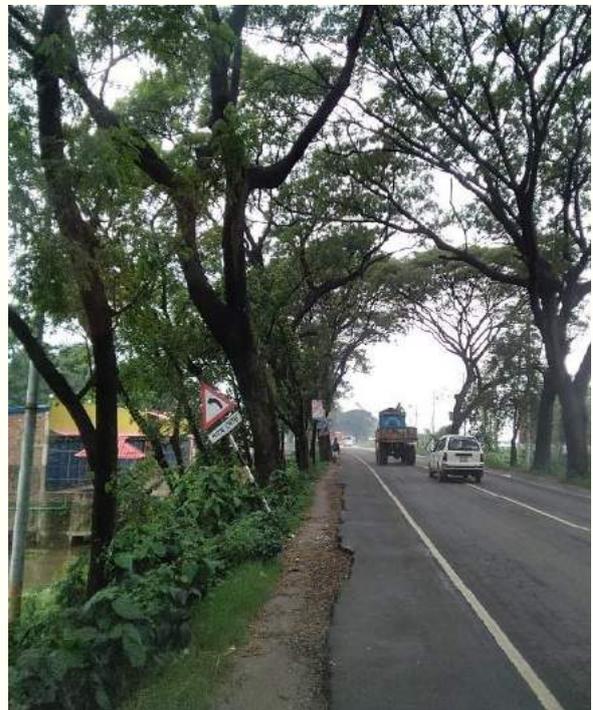
Risky edge drop within Ch.+30 to Ch.+32

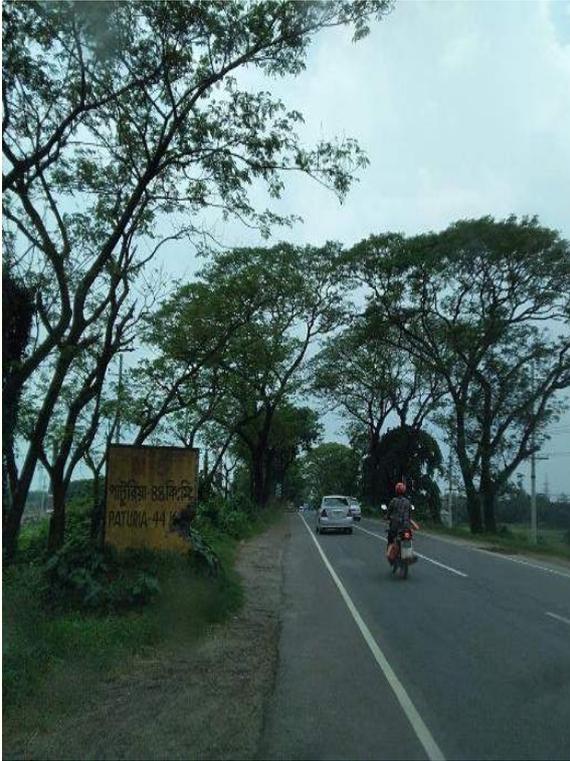
Unknown km post at earthen shoulder within Ch.+32 to Ch.+34

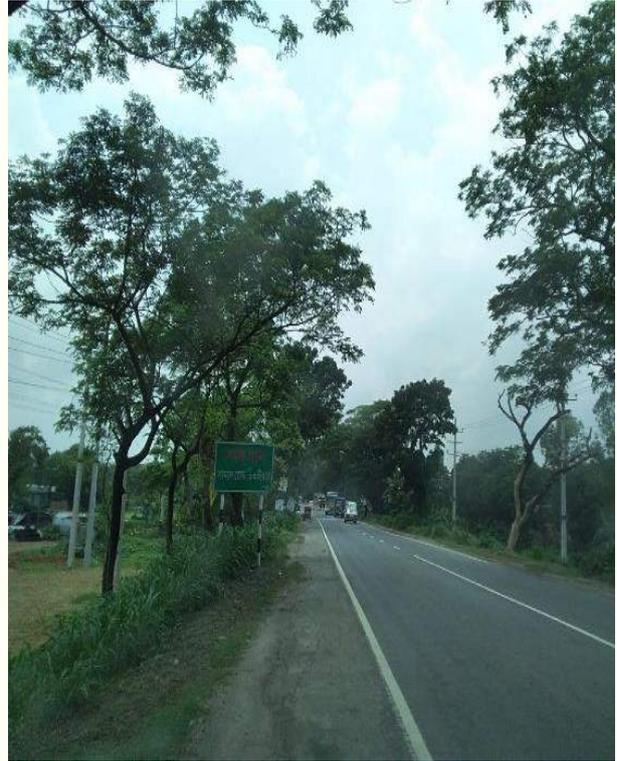
Sign post on earthen shoulder within Ch.+34 to Ch.+36 causing risk

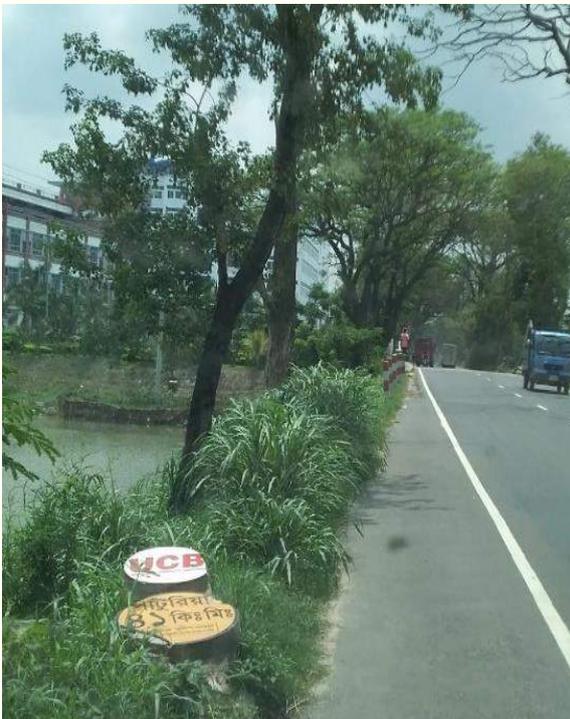
Disturbed, unknown km post within Ch.+36 to Ch.+38

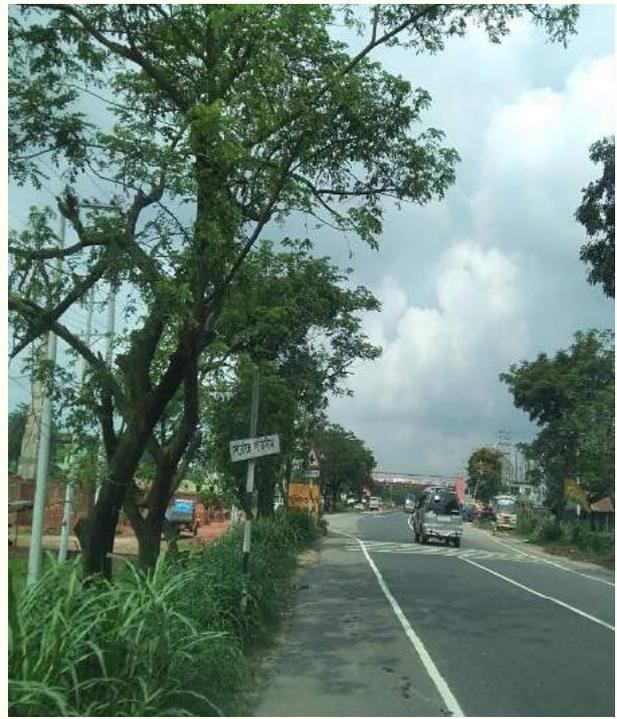
Disturbed road sign within Ch.+38 to Ch.+40

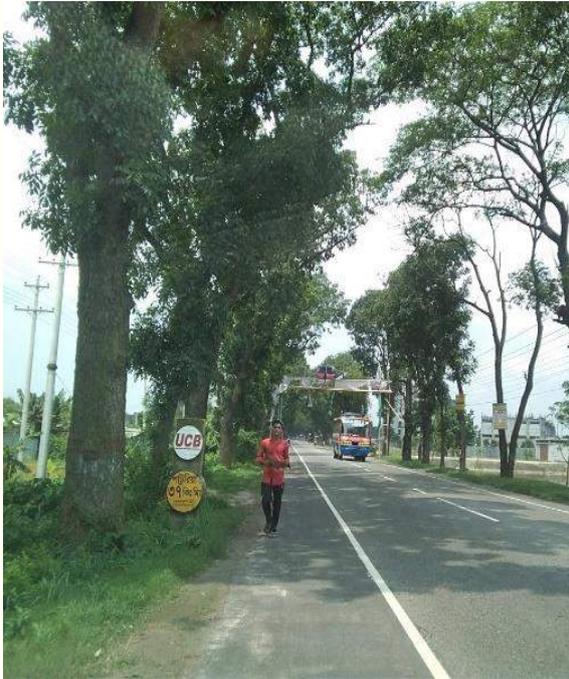
Unknown km post in earthen shoulder within Ch.+40 to Ch.+42

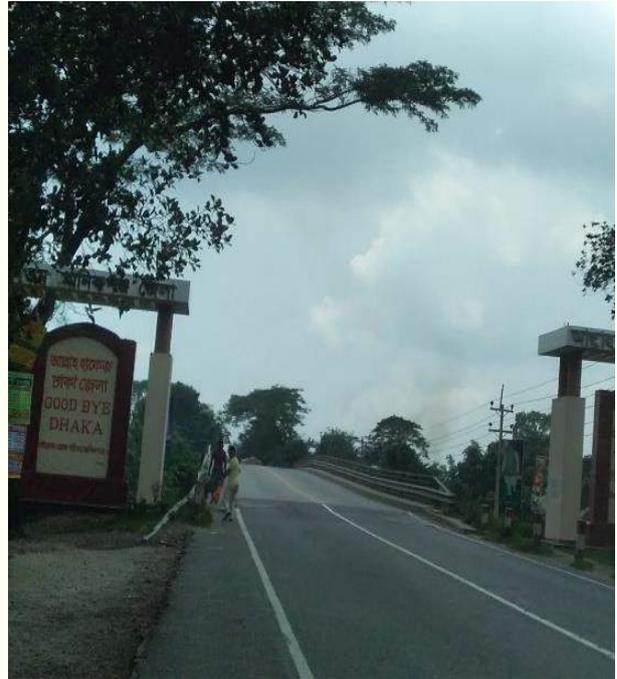
Risky structure at earthen shoulder within Ch.+42 to Ch.+44

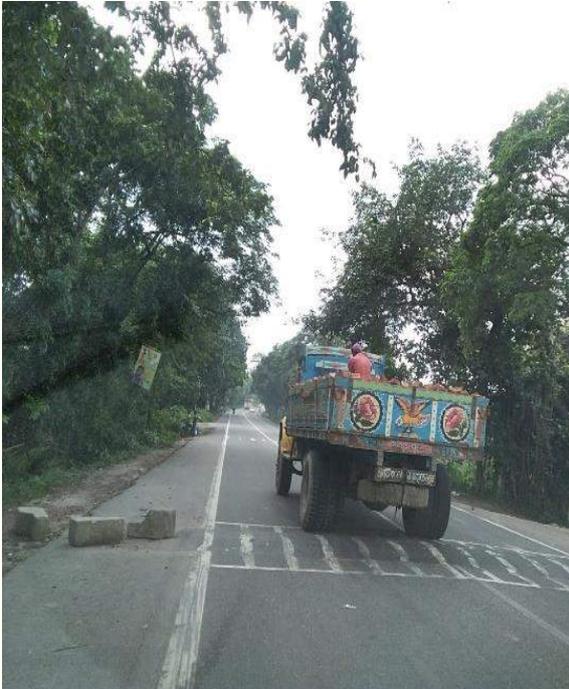
Risky concrete block placed within Ch.+42 to Ch.+44

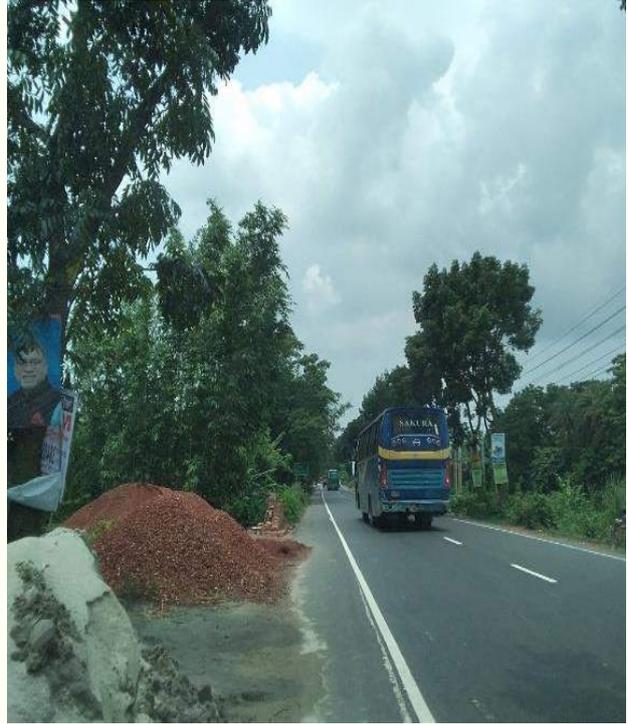
Unauthorized roadside business within Ch.+44 to Ch.+46

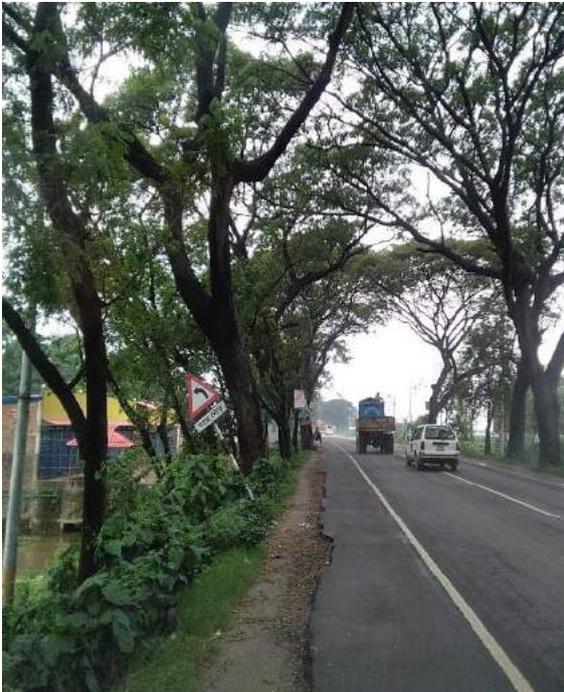
Risky shoulder drop within Ch.+46 to Ch.+48

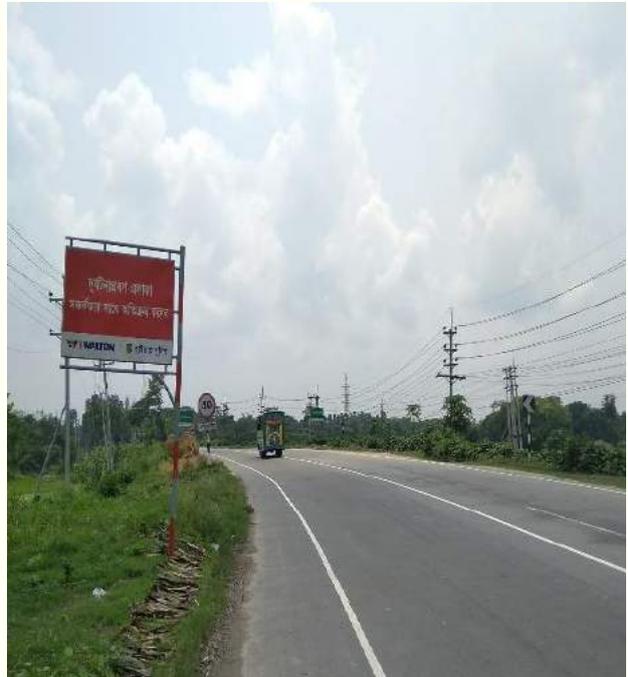
Risky, unknown road sign within Ch.+48 to Ch.+50

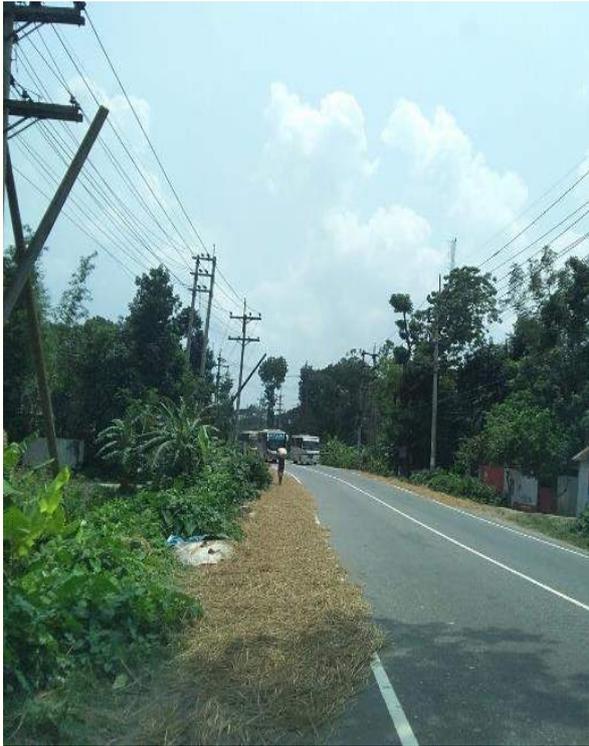
Unauthorized roadside business within Ch.+48 to Ch.+50

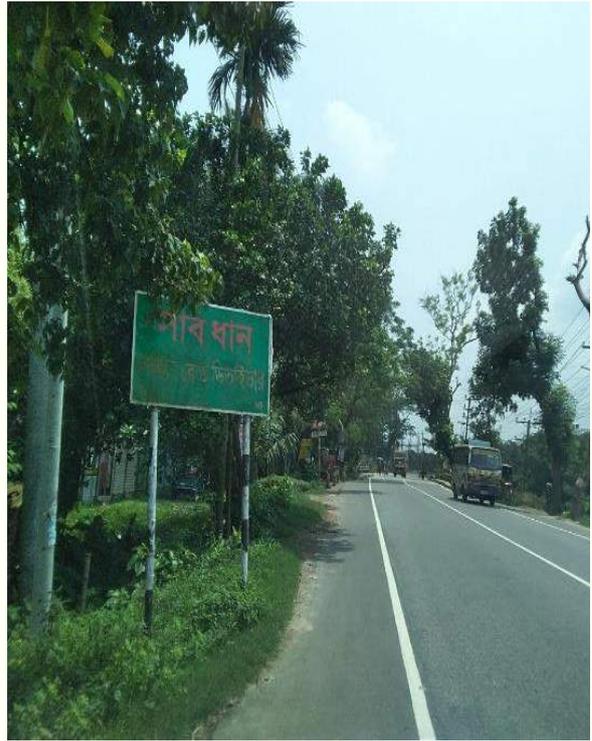
Risky sign post on shoulder within Ch.+48 to Ch.+50

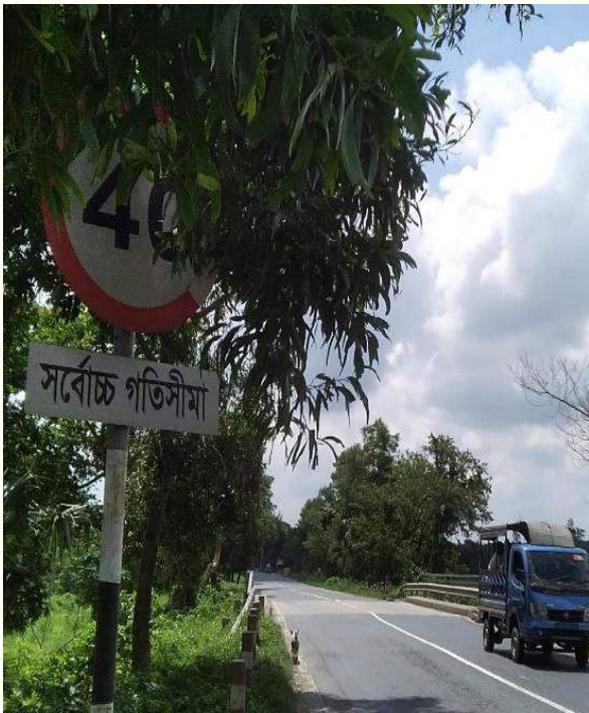
Less visible road sign within Ch.+58 to Ch.+60

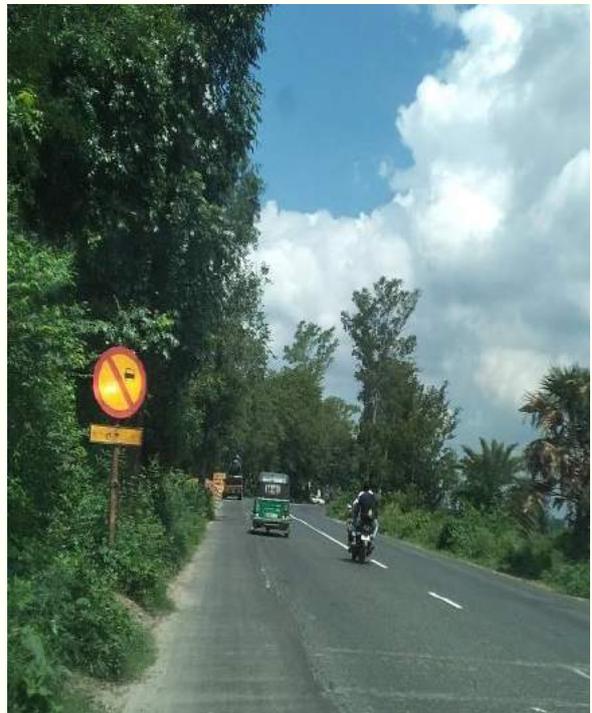
Faded and unknown road sign within Ch.+58 to Ch.+60

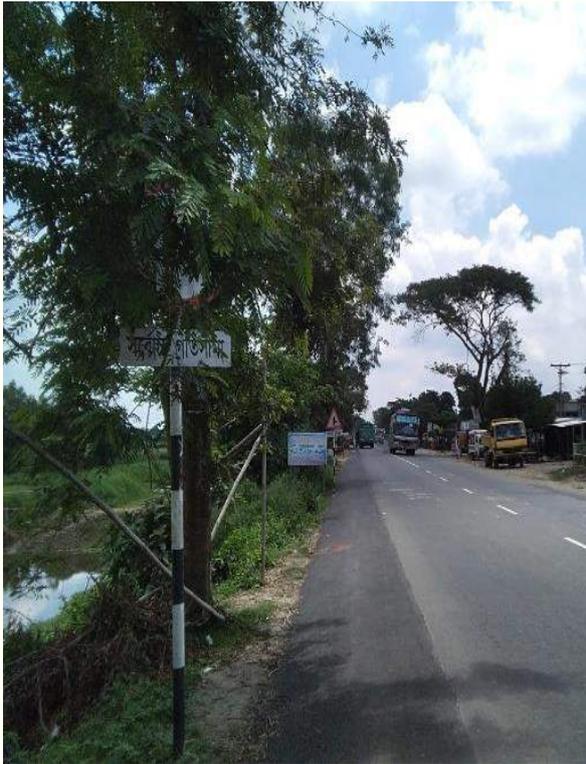
Less visible road sign within Ch.+60 to Ch.+62

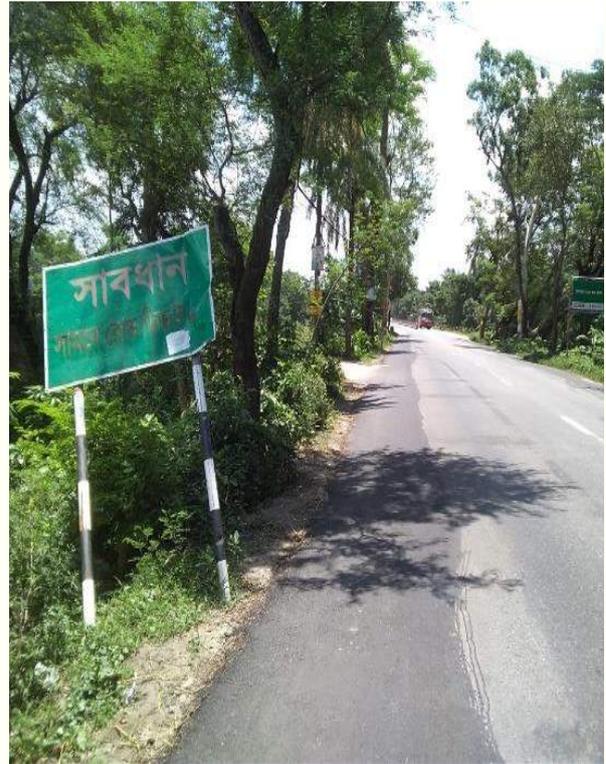
Disturbed road sign within Ch.+62 to Ch.+64

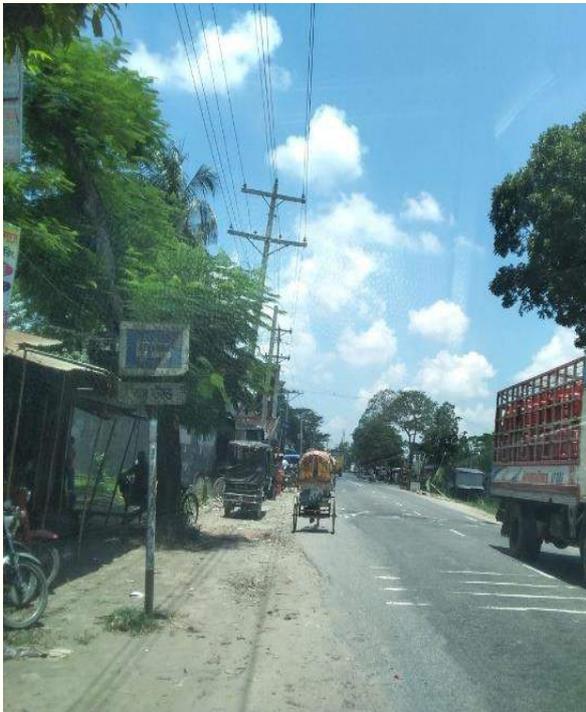
Less visible road sign within Ch.+64 to Ch.+66

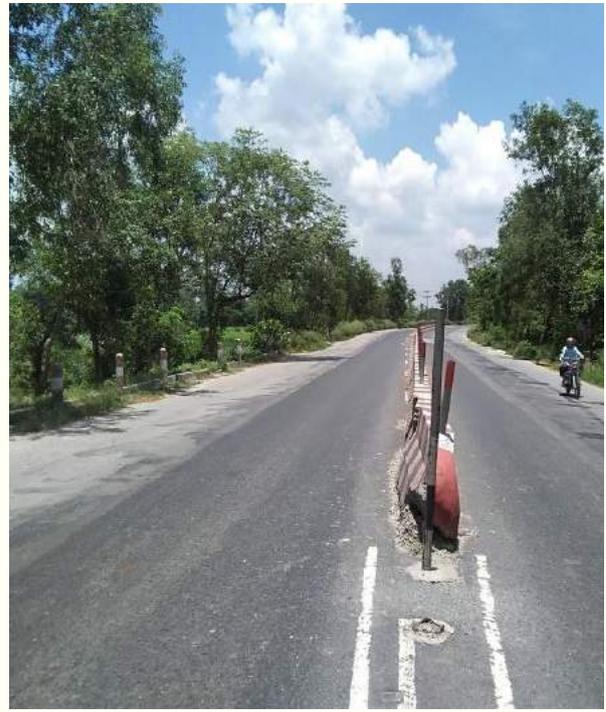
Disturbed warning sign within Ch.+66 to Ch.+68

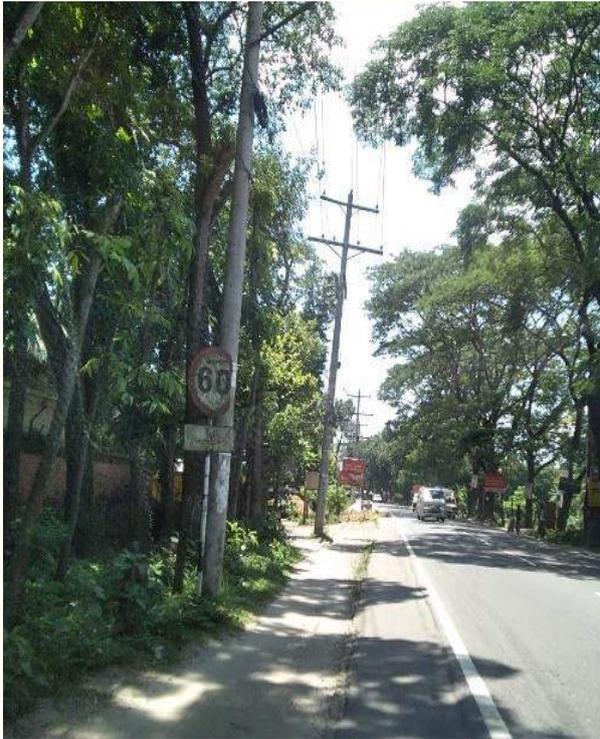
Faded road sign within Ch.+68 to Ch.+70

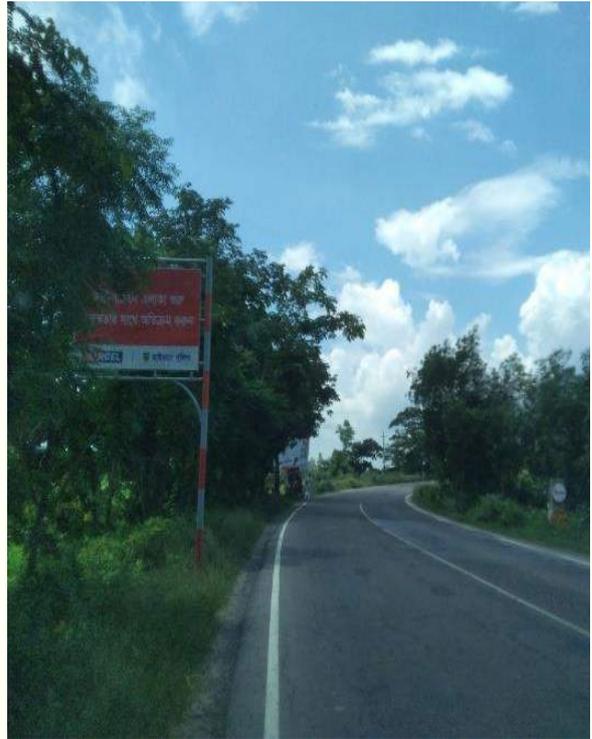
Unknown road sign at shoulder within Ch.+74 to Ch.+76

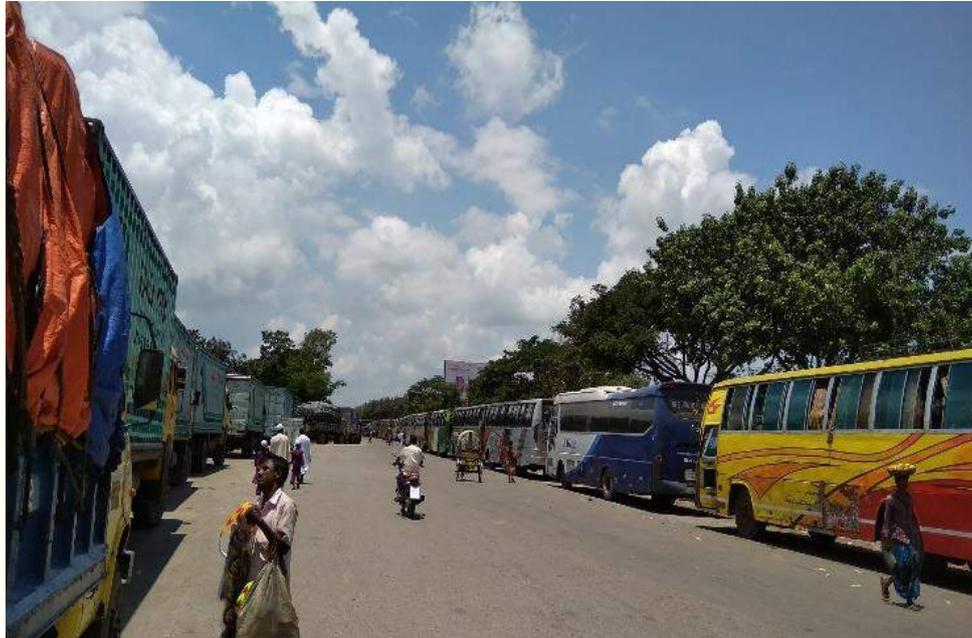
Illegal roadside parking at Ch.+78

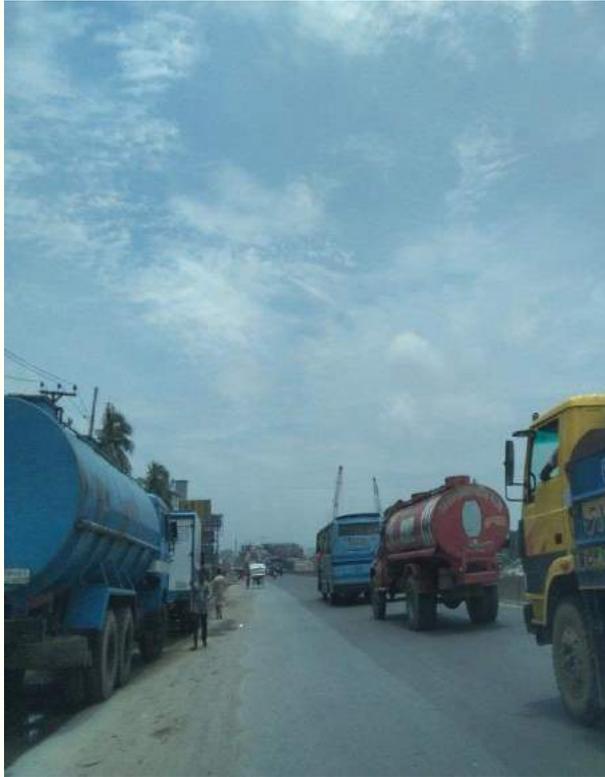
Unauthorized roadside activity within Ch.+ 7 to Ch.+9

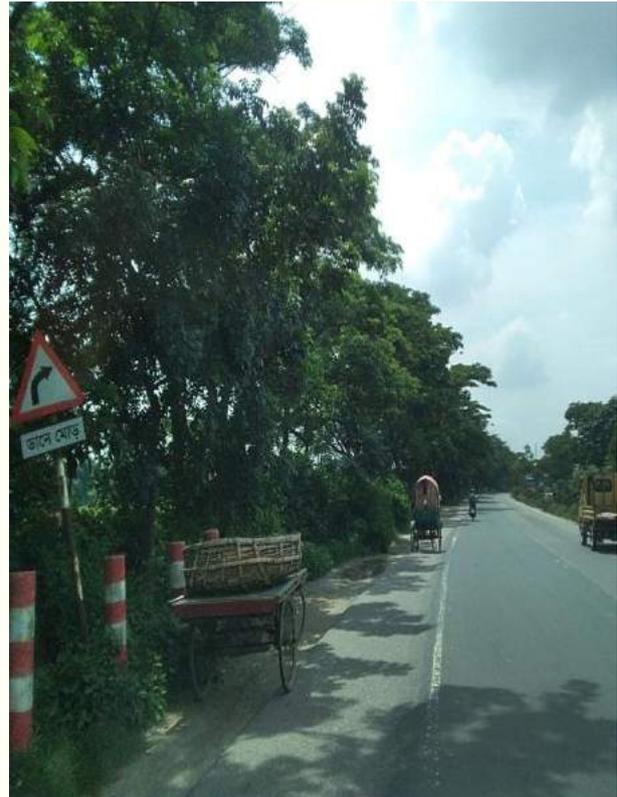
Disturbed sign within Ch.+15 to Ch.+17

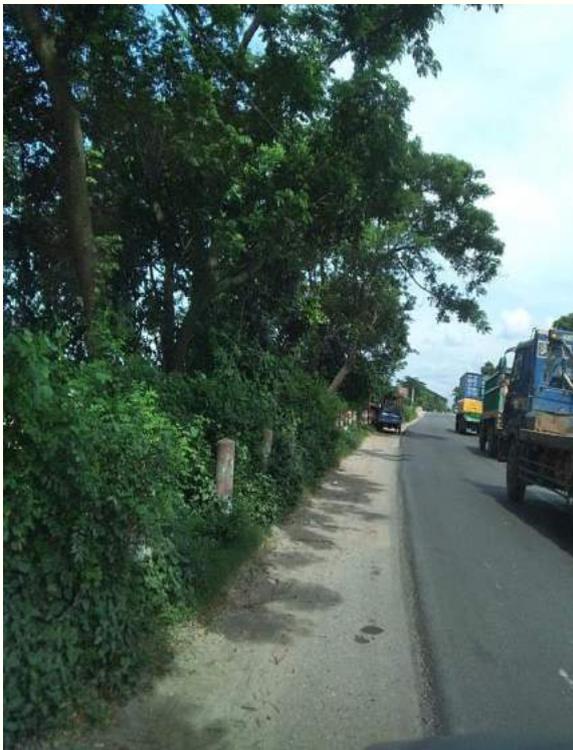
Invisible roadside posts Ch.+ 15 to Ch.+17

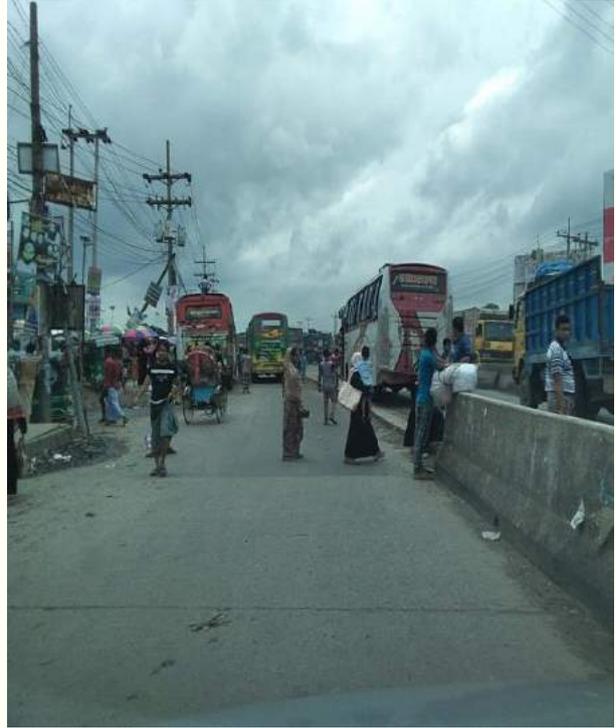
Illegal and risky road crossing activity within Ch.+ 19 to Ch.+21

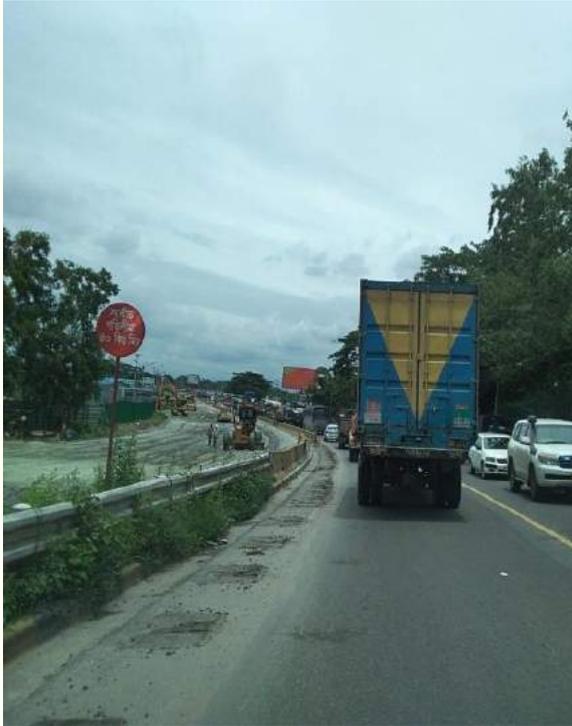
Wrongly designed sign within Ch.+23 to Ch.+25

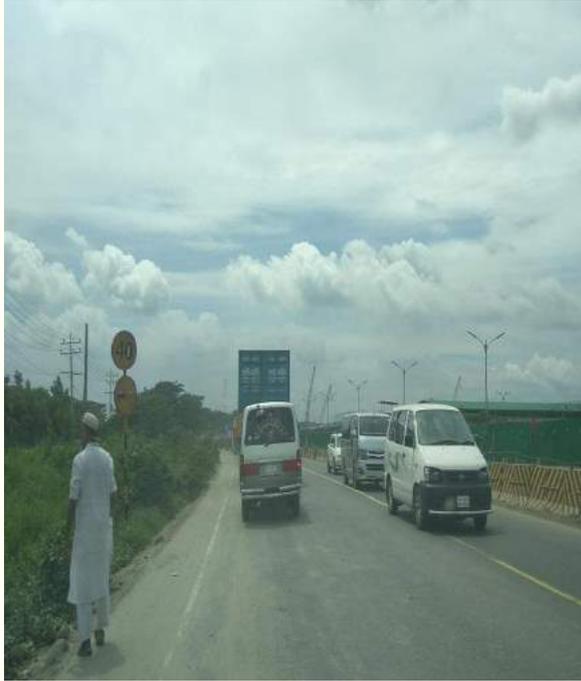
Pedestrian standing on busy road within Ch.+ 25 to Ch.+27

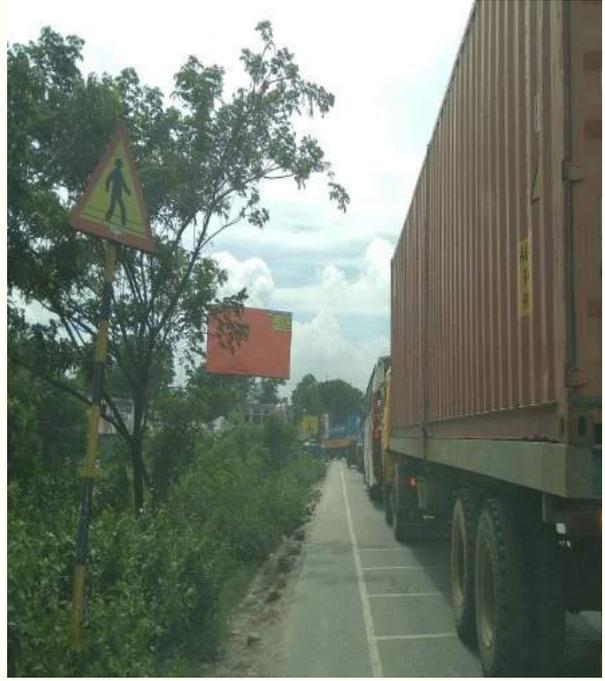
Wrongly designed sign within Ch.+25 to Ch.+27

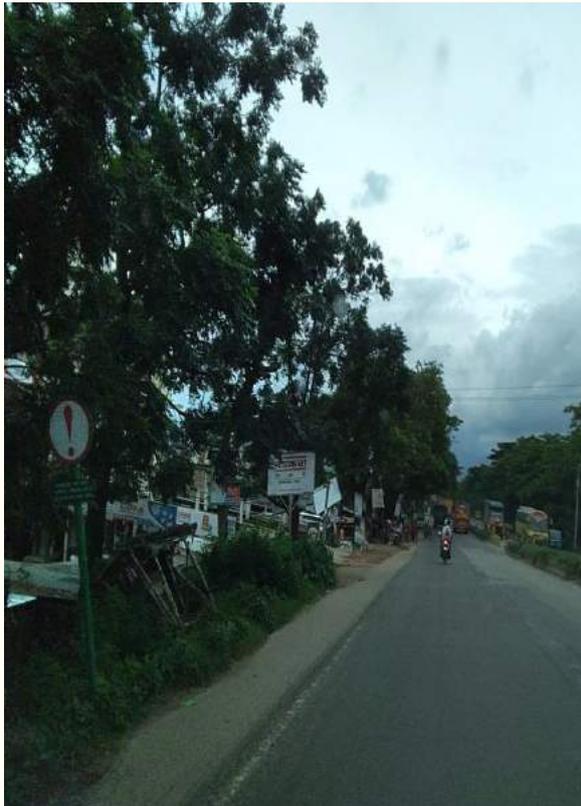
Wrongly designed road sign within Ch.+27 to Ch.+29

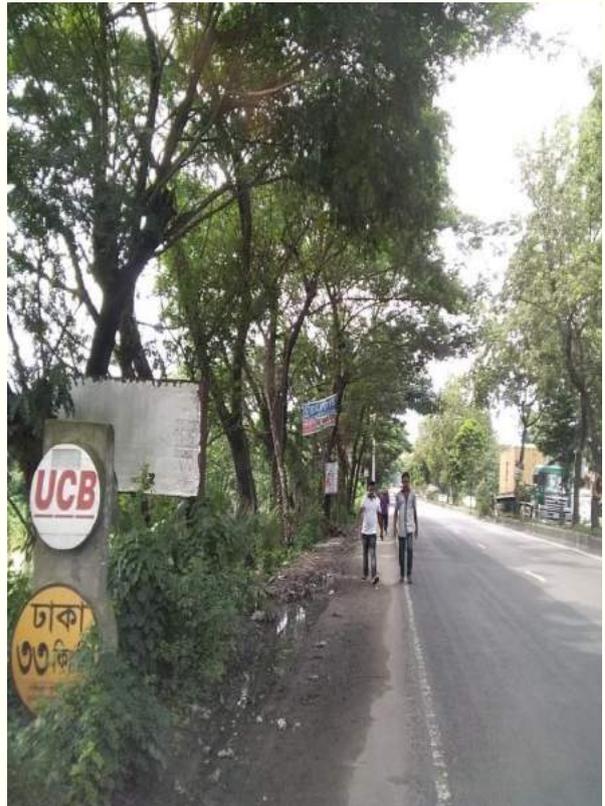
Pedestrians walking on road within Ch.+27 to Ch.+29

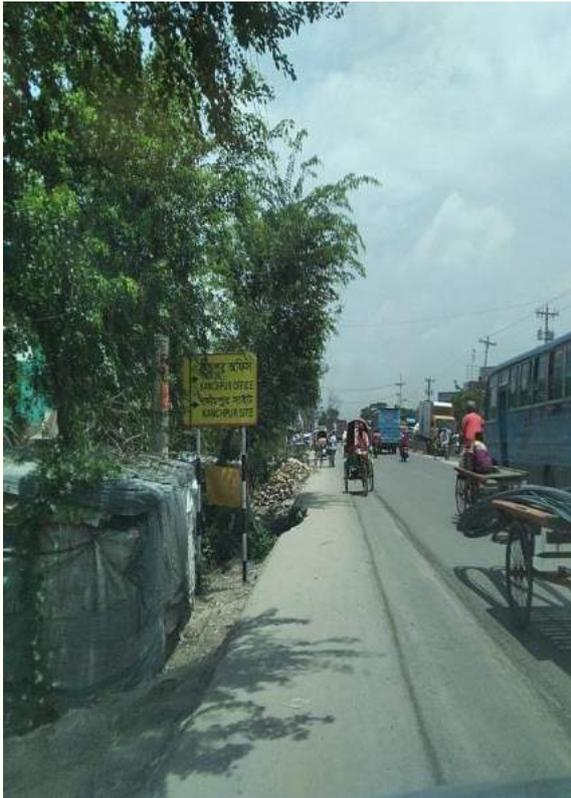
Risky drop and poor sign visibility within Ch.+ 9 to Ch.+11

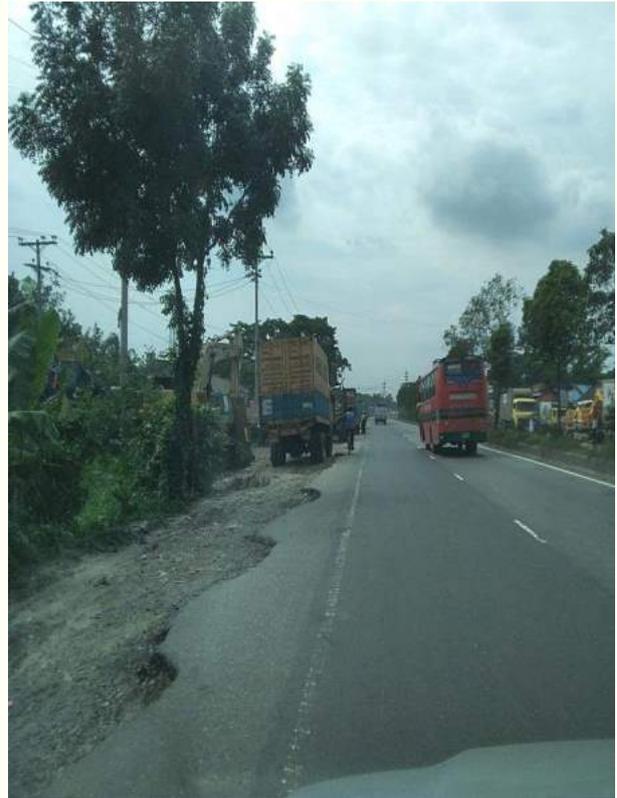
Poor and risky shoulder drop within Ch.+11 to Ch.+13

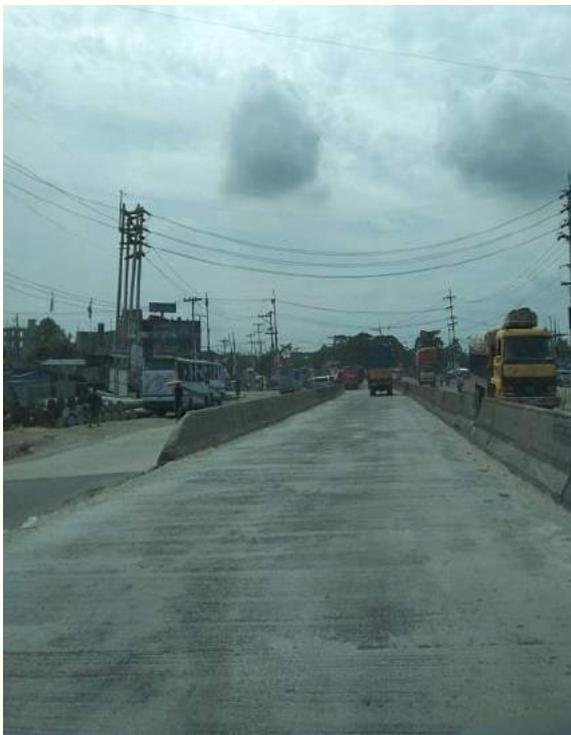
Median without proper protection within Ch.+11 to Ch.+13

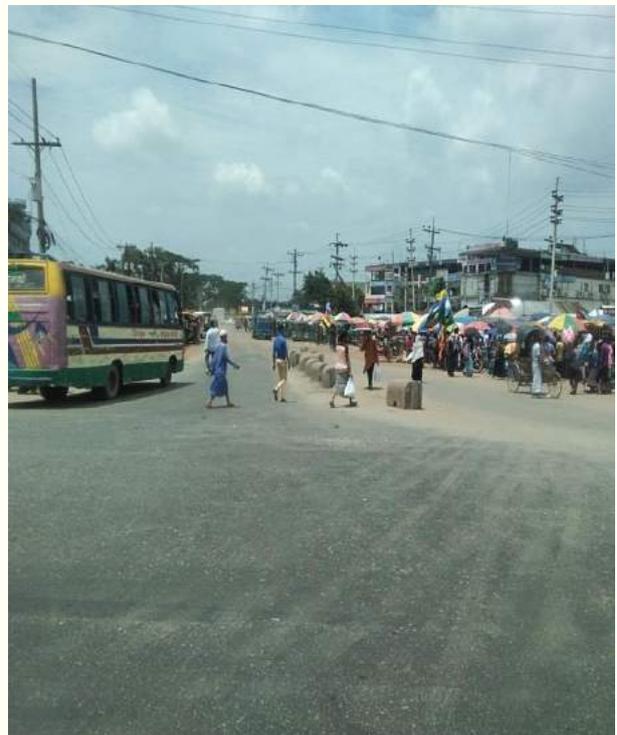
Lack of pedestrian facilities at Ch.+13 to Ch.+15

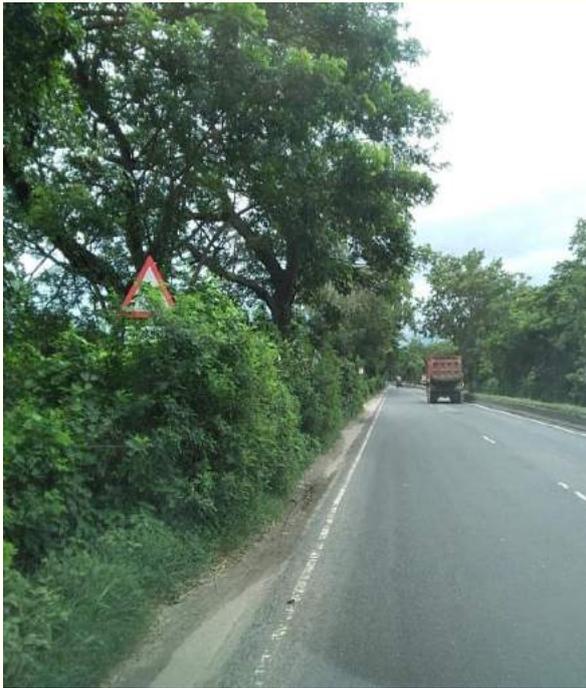
Invisible road sign within Ch.+29 to Ch.+31

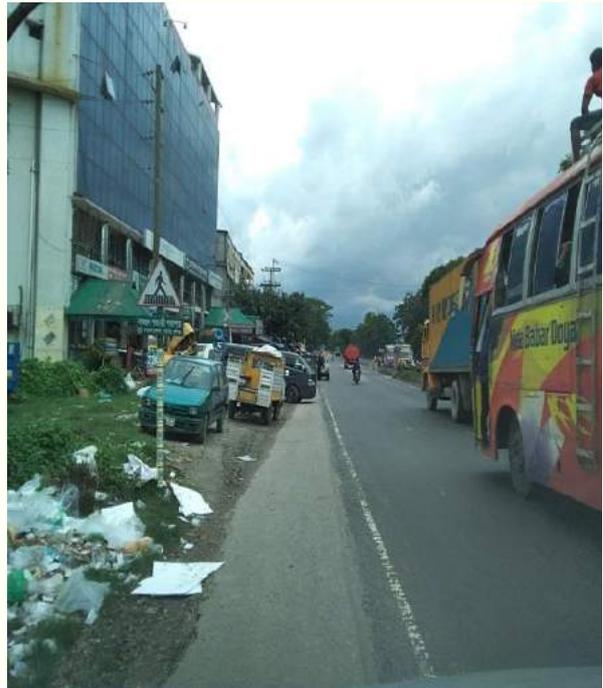
Wrongly designed road sign within Ch.+29 to Ch.+31

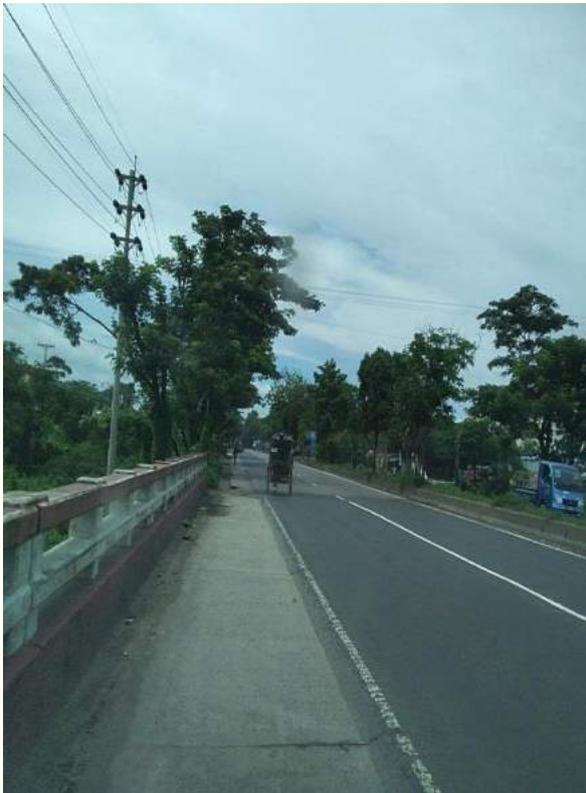
Unprotected pedestrian facility on bridge within Ch.+29 to Ch.+31

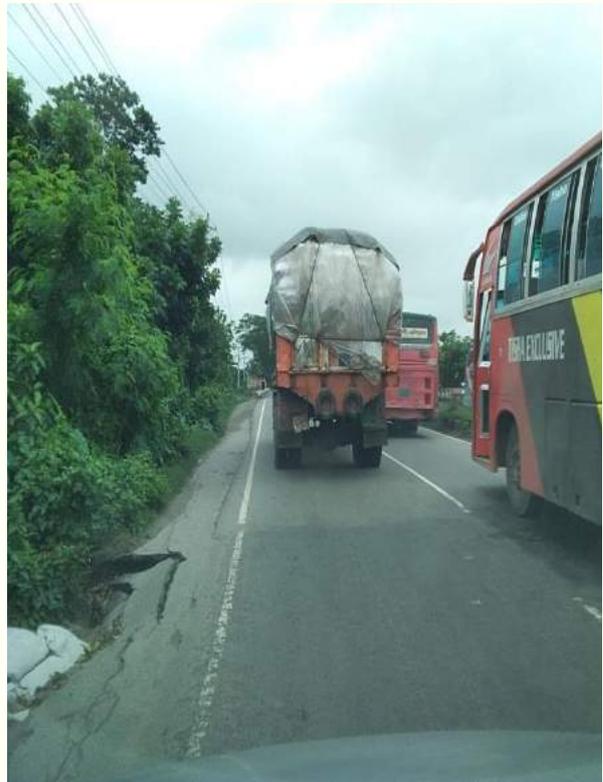
Risky edge drop within Ch.+31 to Ch.+33
