REPORT ON
DETAILED
ROAD SAFETY AUDIT
OF FIVE ROAD SECTIONS
(500 KM)

ROAD SAFETY AUDIT REPORT FY 2017-2018

Road Design & Safety Circle
Roads & Highways Department
Government of the People's Republic of Bangladesh
SARM Associates and HeptaTech Limited JV

Detailed Road Safety Audit of Road Sections of Joydebpur – Mymensingh (N3), Kanchpur- Daudkandi (N1) and Chattogram – Cox's Bazar (N1), Kashinathpur – Rajshahi (N6) and Dhaka – Aricha (N5) (Total 500 km) National Highway During FY 2017 -2018

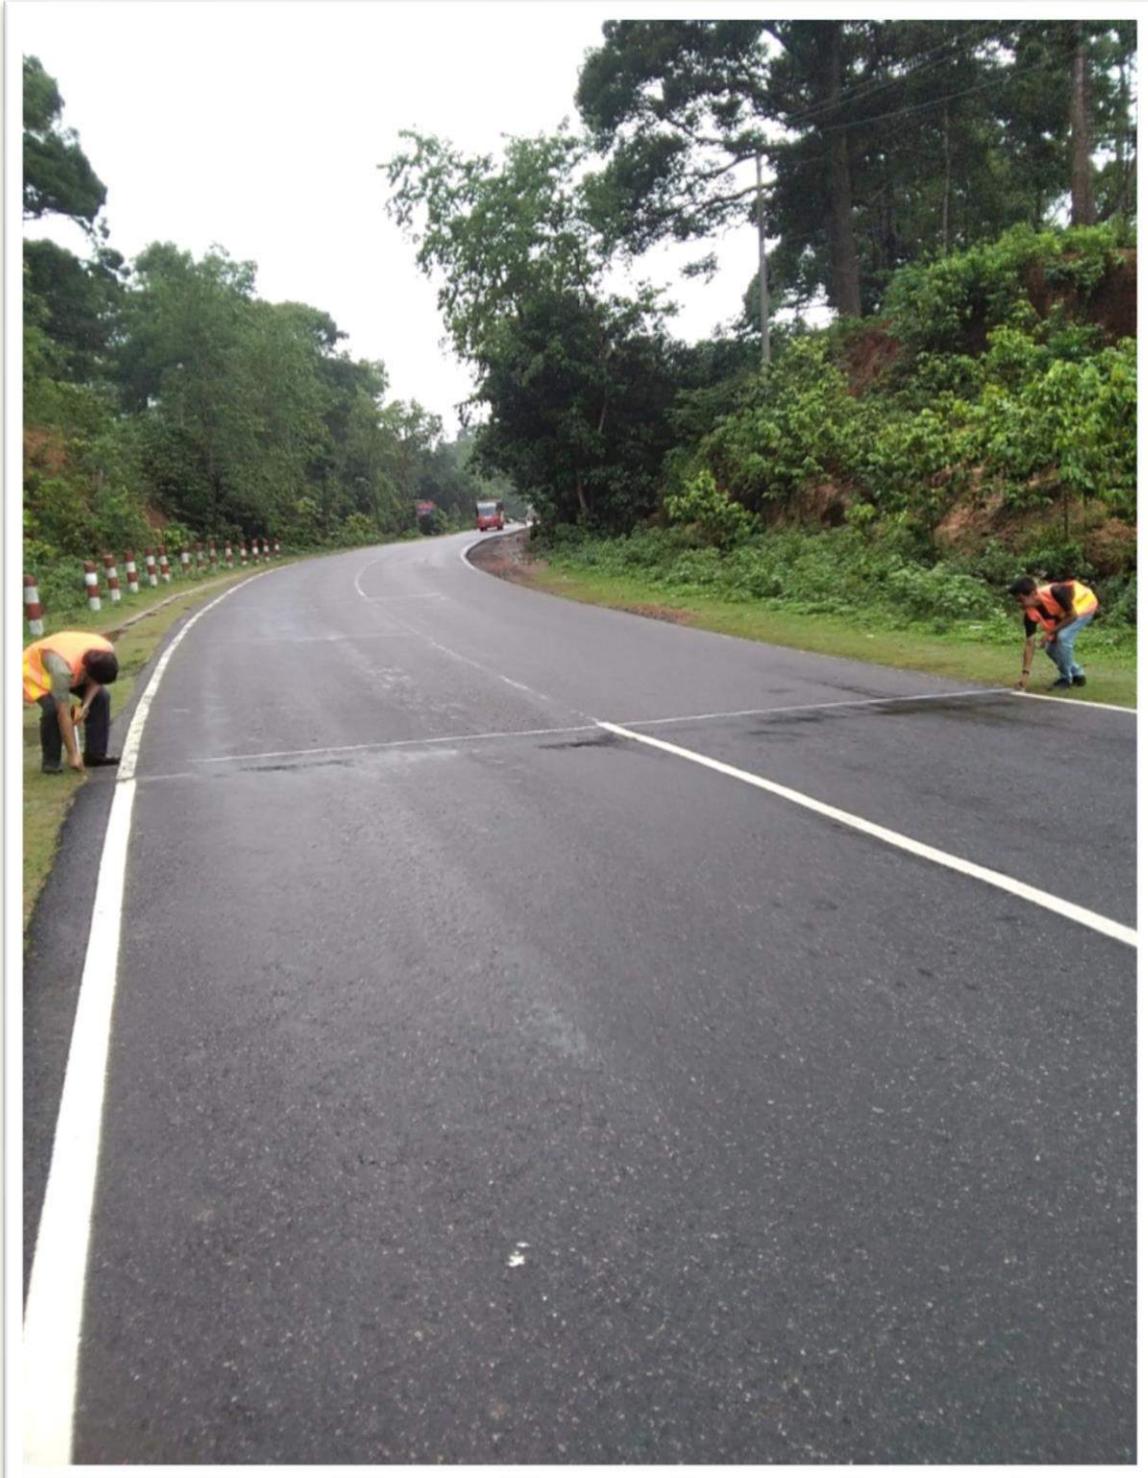
Figure-6: Mishaps on surveyed N3
