**Roads and Highways Department (RHD)
Bangladesh Road Research Laboratory (BRRL)**

**Final Report
on
Failure investigation, Design correction, Data collection,
Research resource collection etc under BRRL during the
year 2016-2017**

June, 2017

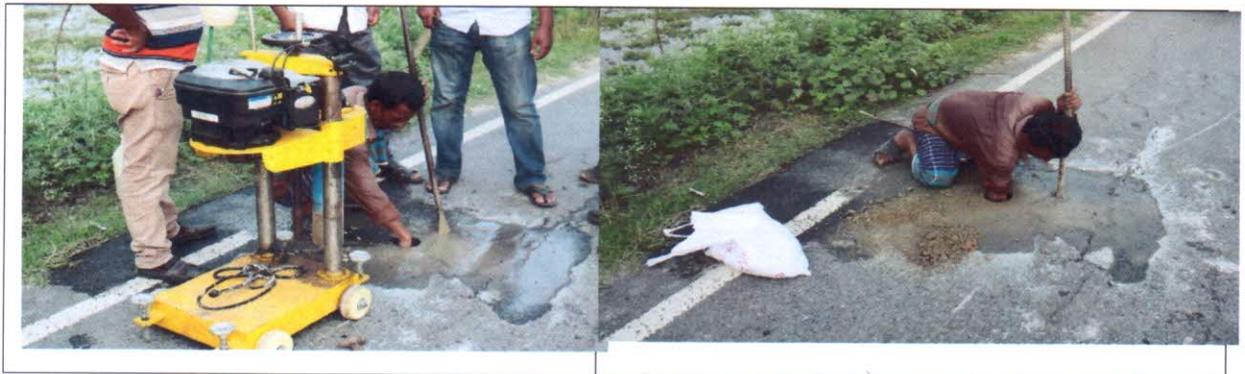
6. Core thickness is >120mm

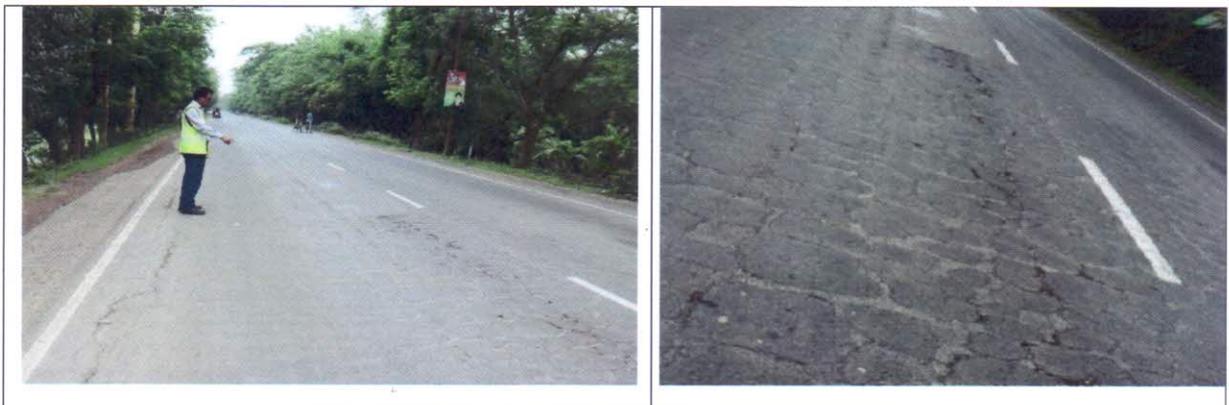
5. At ch 20+00 to ch 55+00 scenario is more or less same

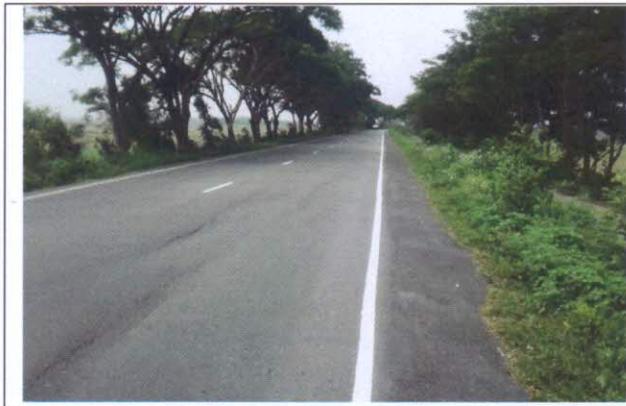
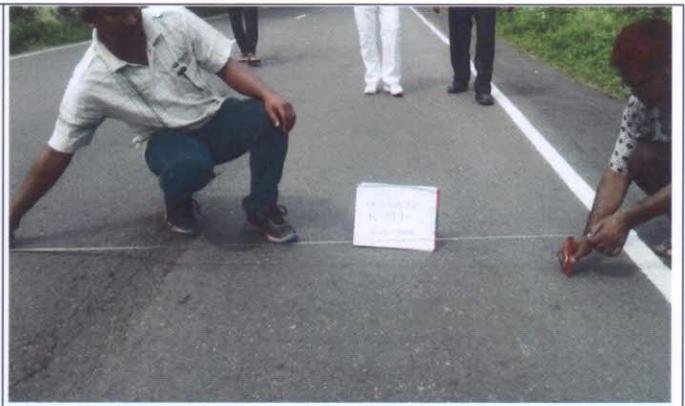
5. At around ch 23+500 (Settlement >100mm)

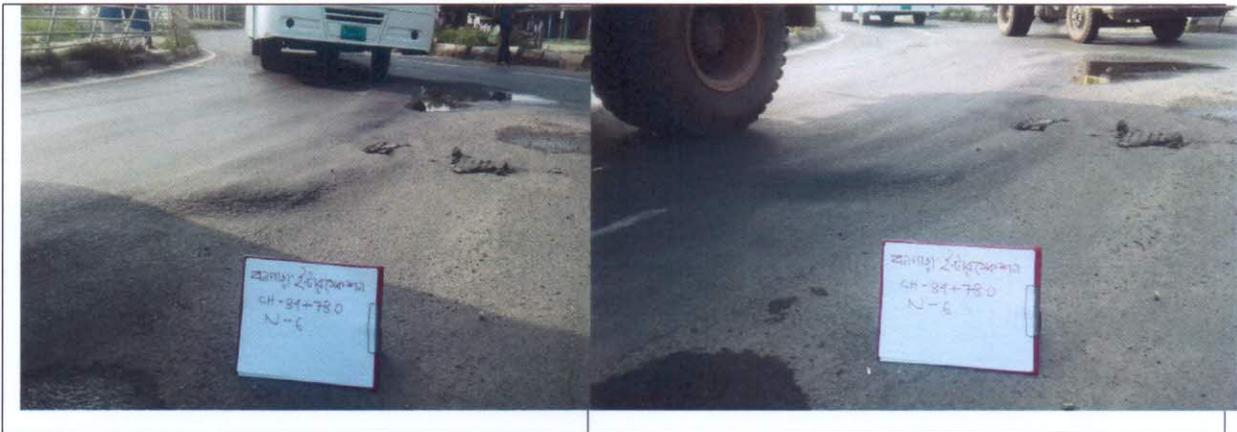
2. Potholes

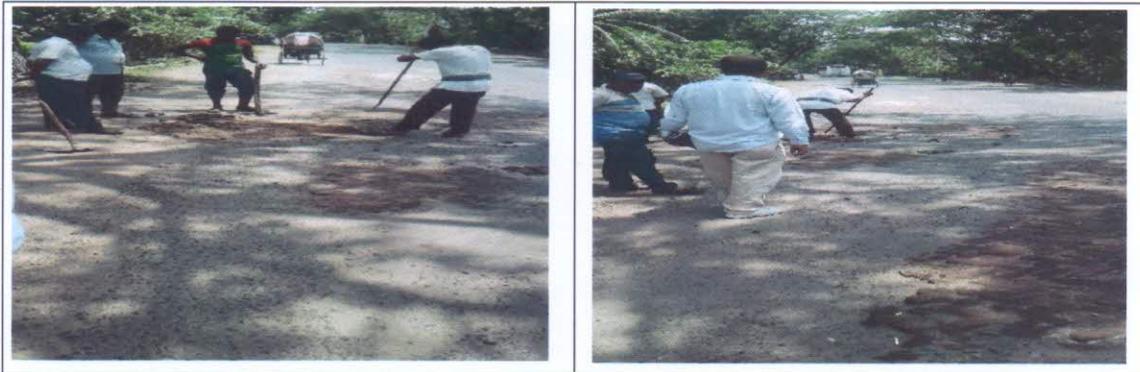
3. Damaged Pavement
